“At-a-Glance” Report Summary

Resource Name (per HRB naming policy): 4040 5th Avenue

Resource Address: 4040 Fifth Avenue, San Diego, CA

*P10. Survey Type: (Describe)
 Historical Resource Research Report

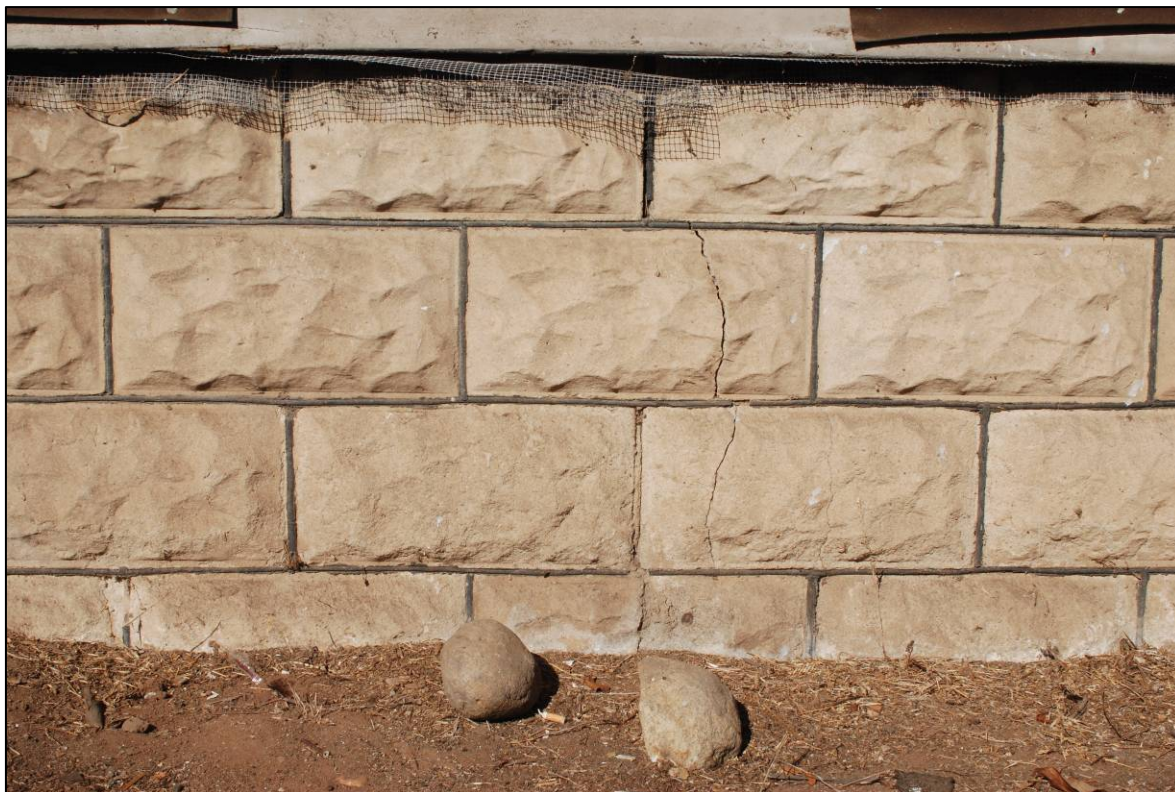
Photograph 2
Foundation,
Concrete
Block Formed
to Resemble
Dressed
Stone

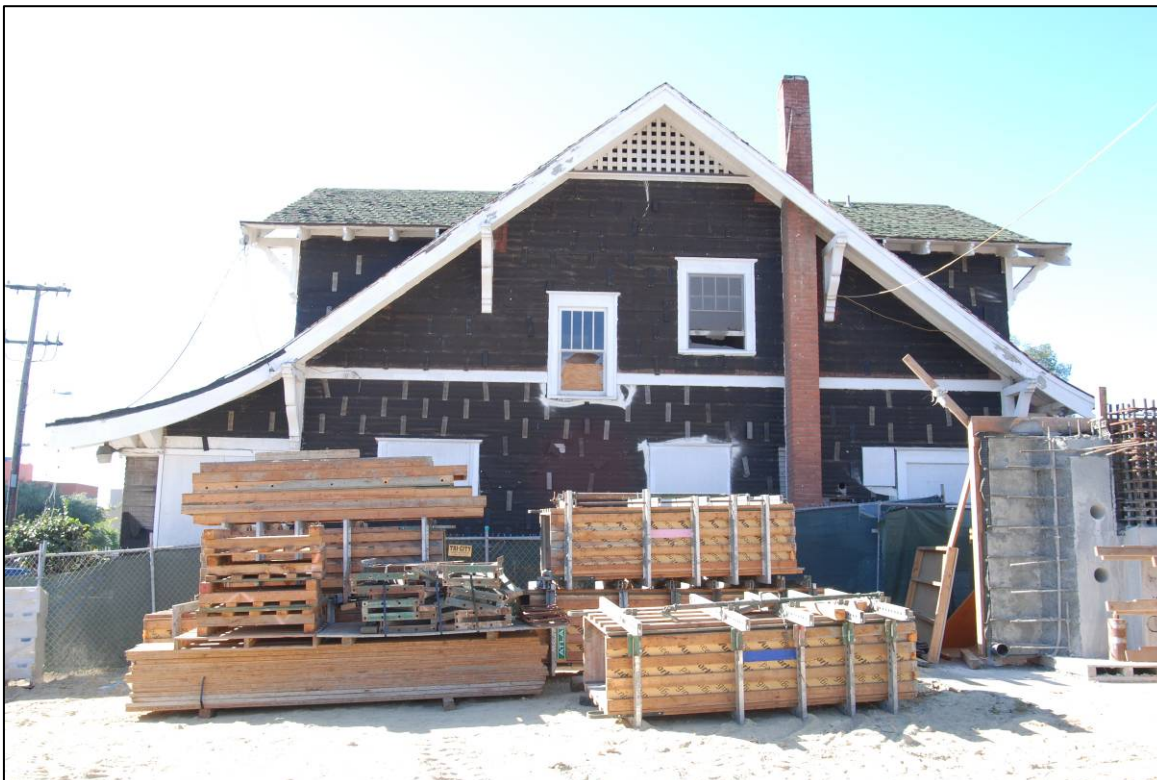
Photograph 4
North Side of
House, Showing
Location of Roof
Curve Relative to
Possible Front
Porch

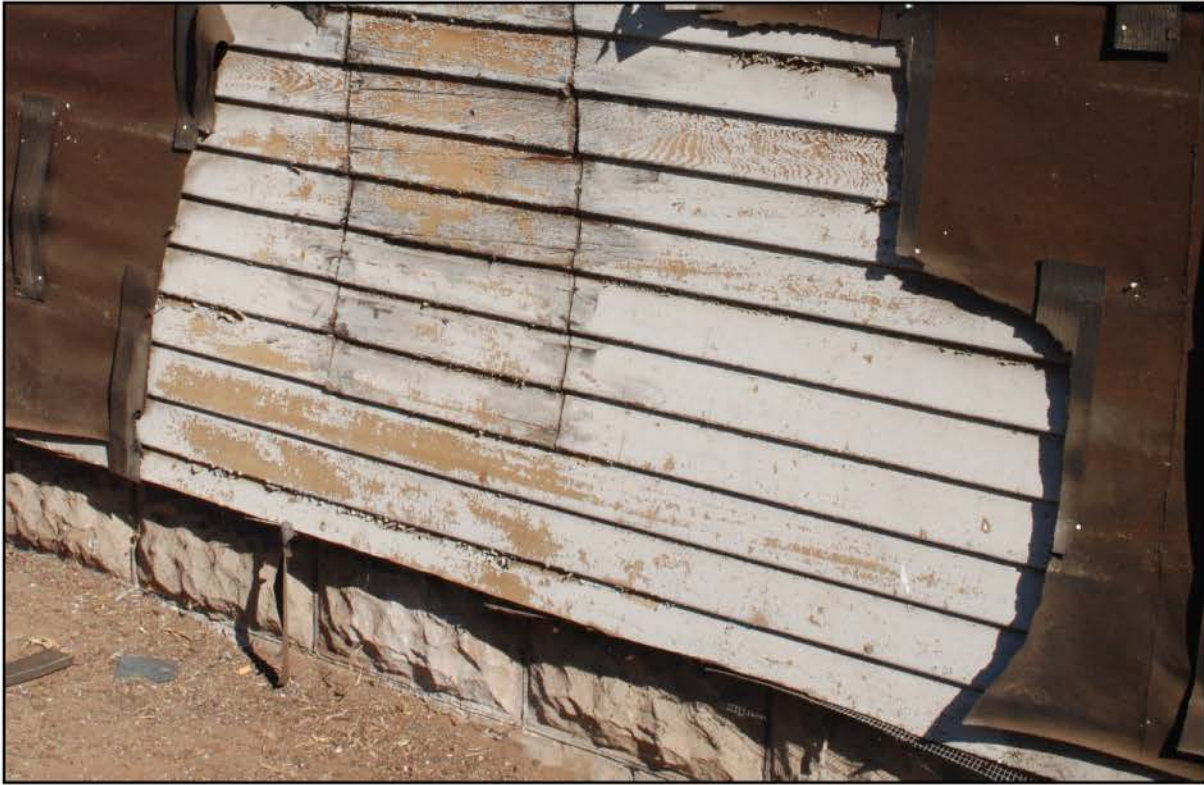
Currently the house is covered in tarpaper. In some areas the tarpaper has been removed and the siding beneath is revealed. Areas revealed on the first floor are clad in beveled clapboard siding. The clapboard is 4 inches wide and painted a light grey. Exposed areas of the second floor on the rear of the house are clad in shingle siding. The shingles vary in width and are painted a terra cotta color. The clapboard and shingles may be the original claddings of the house (Photo 6)

Photograph 6
Probable Original
Clapboard and
Shingles under
Tarpaper

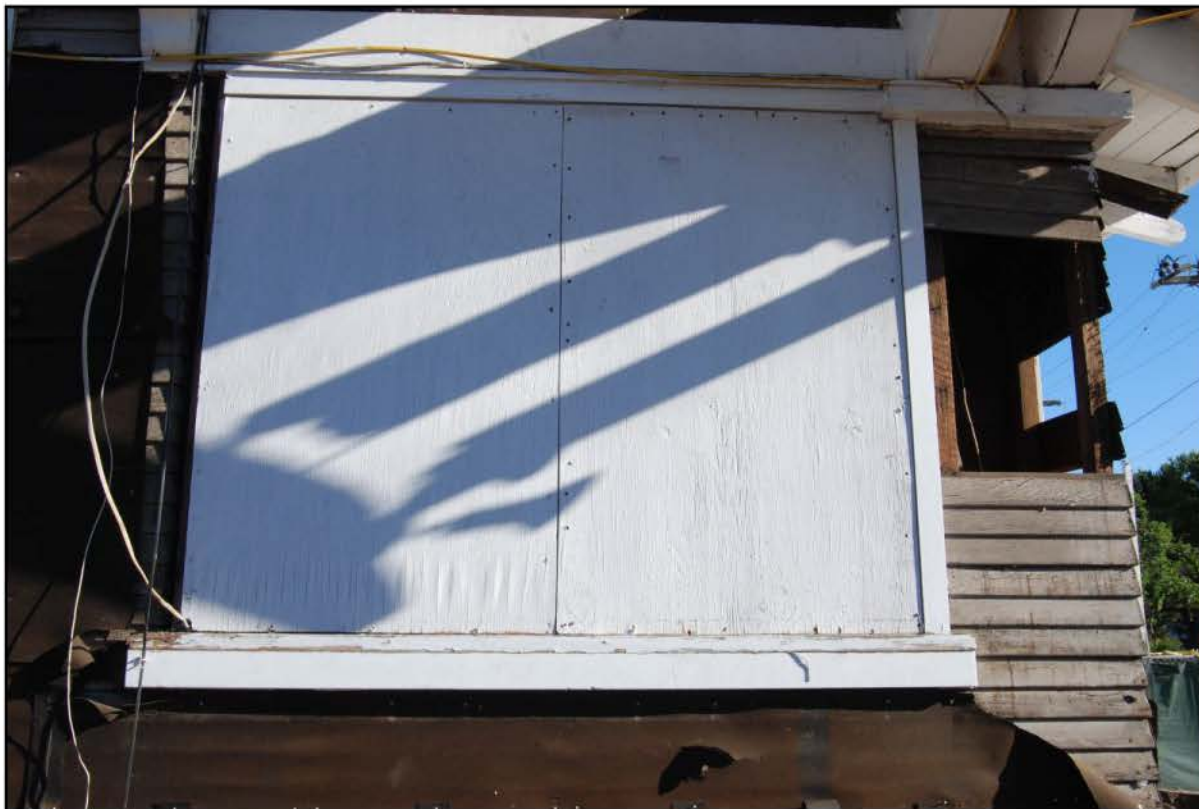
inches wide and 1 inch thick. The sills on the windows are two pieces, and measure 5 inches wide by 1½ inches thick. This casing matches the front side windows, but not the casing on the rest of the windows on the house (Photo 8).

Photograph 8
Window Casing
Detail on Front
Porch Windows,
Note Narrow Side
and Top Casing
Boards. This is
South Side Window

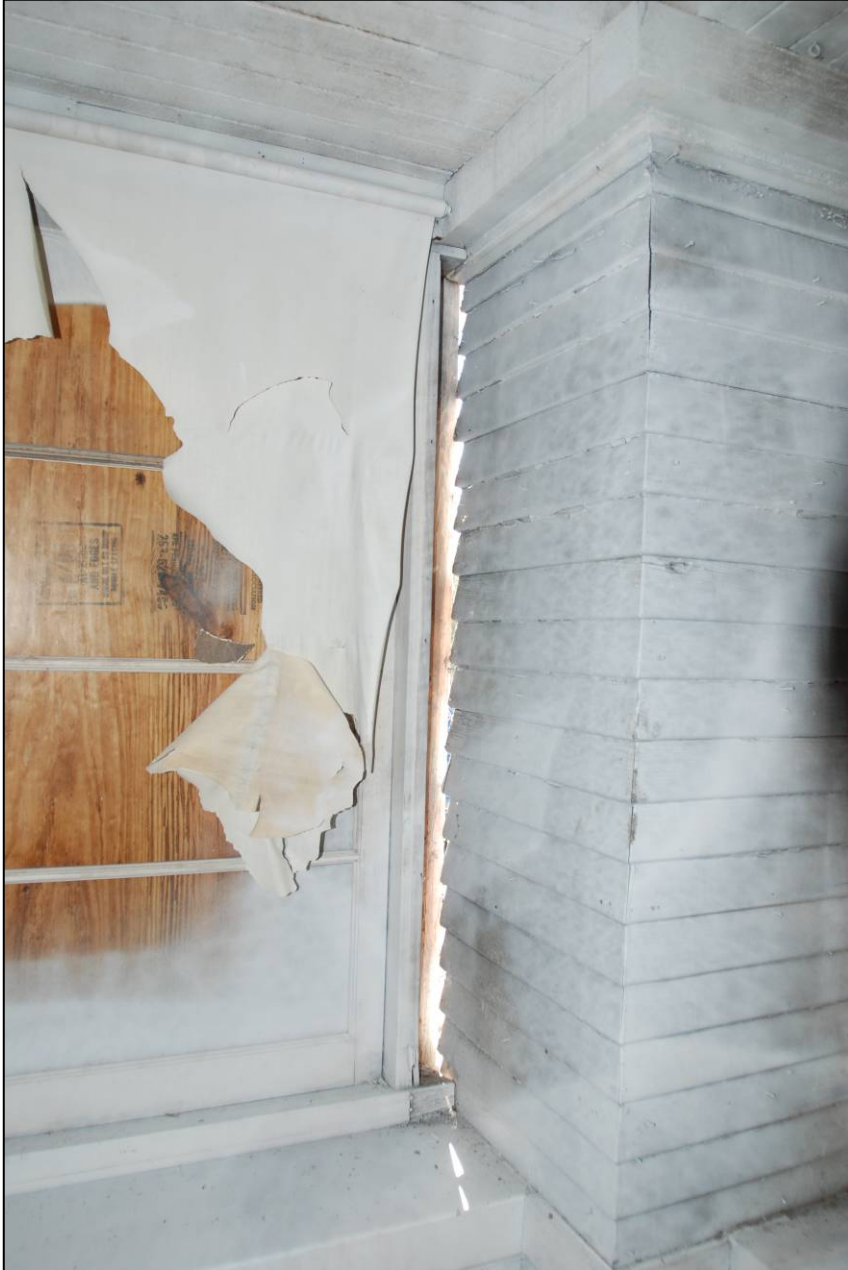
Photograph 11
Interior View of
Porch Window
Showing gap
Between
Window Frame
and Porch
Clapboard

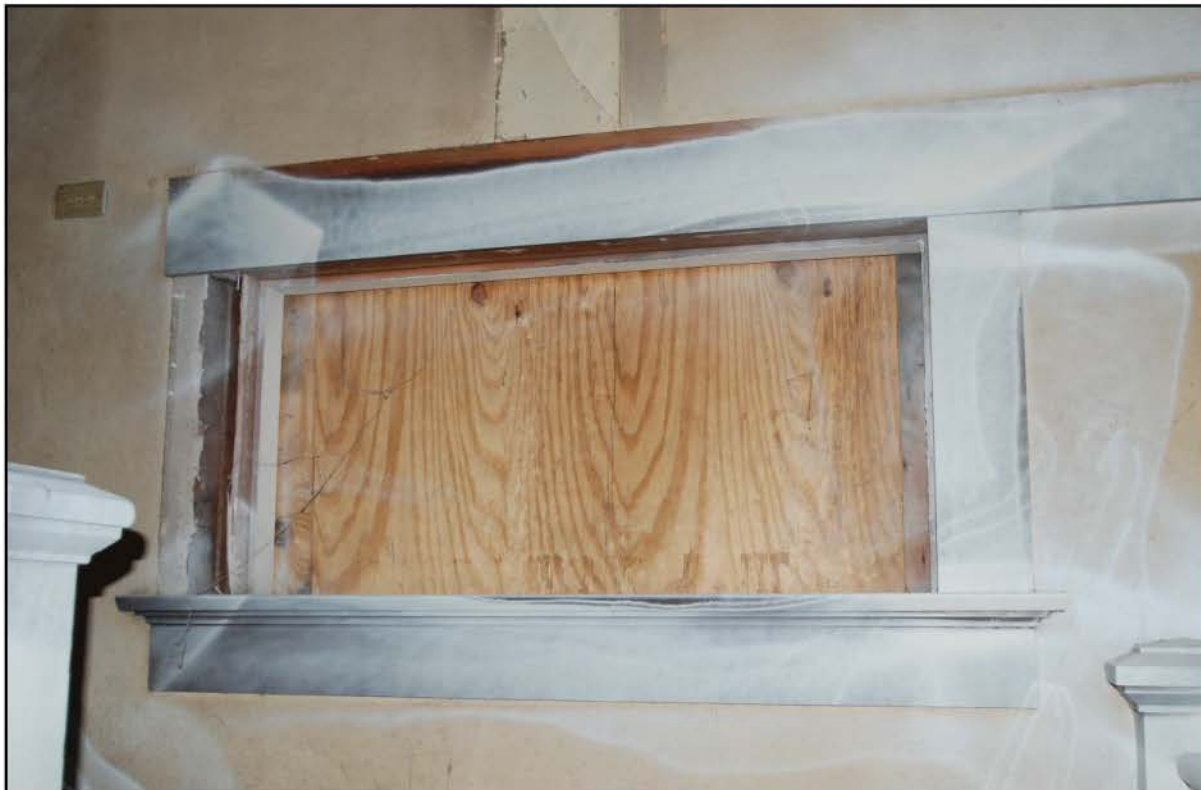
Photograph 15
North Side Window
2, Interior Shot,
Showing Missing
Sash

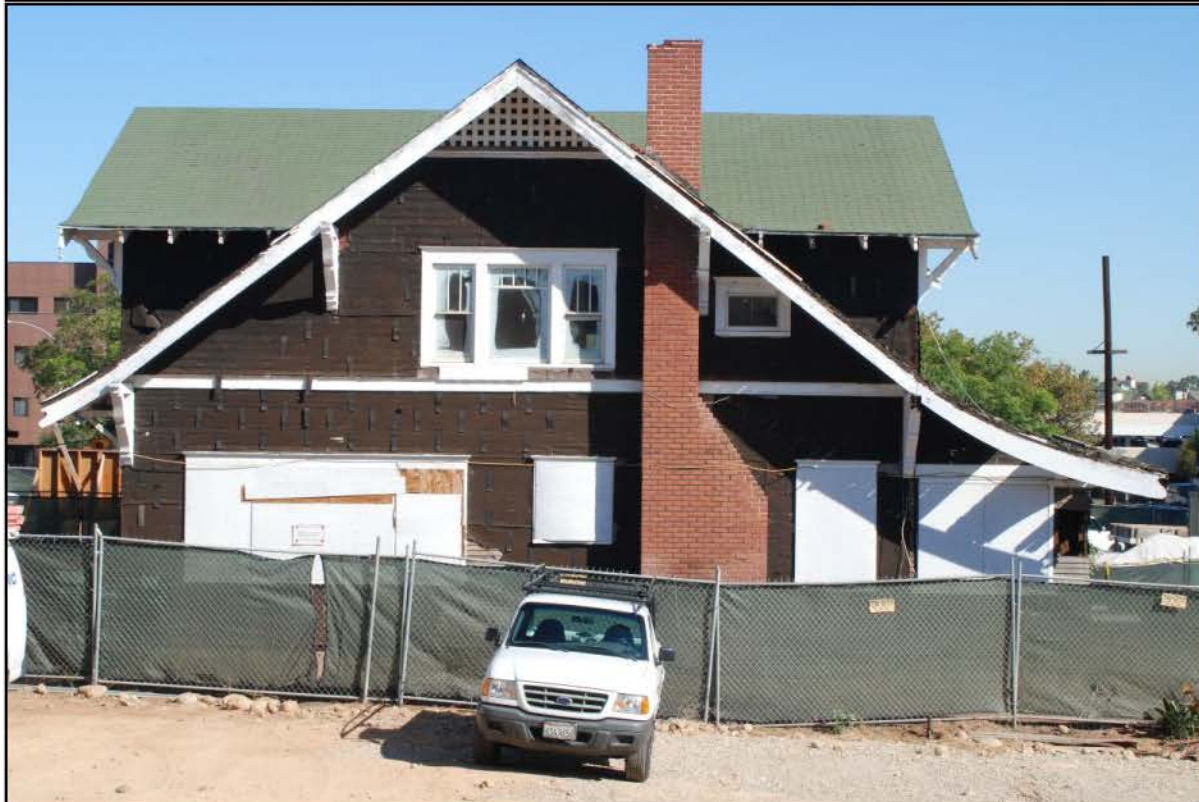
The south side of the house has four windows on the first floor, two on the second floor, and a large chimney (Photo 19). There is also a lath grated air vent at the peak of the gable. The window at the front of the south side is a porch enclosure window with narrow casings. The rest of the windows have the wider casing with decorative top trim discussed above. All of the first-floor windows are covered in plywood so no sash details are visible from the outside. Two first-floor windows of different size are situated on either side of the chimney, the shorter window to the west of the chimney. The window on the east side of the chimney (window 1) is double hung, with a single pane on the lower sash and a four light upper sash (Photo 20). The window on the west side of the chimney (window 2) appears fixed, and has four lights (Photo 21). The western window, close to the southwest corner of the building, is a three sash ribbon window. The central sash is fixed, with a large light and a row of eight small rectangular lights along the top

Photograph 19
South Side of
House, Showing
Window
Arrangement and
Chimney

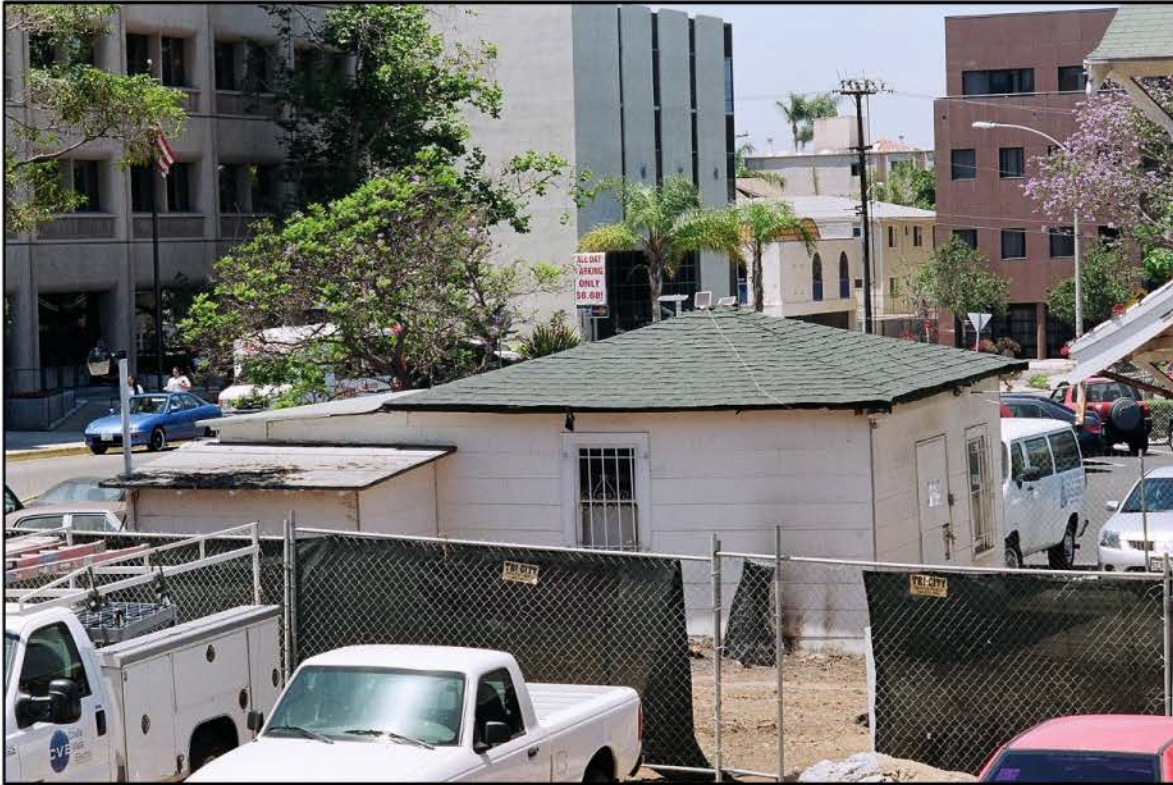
Photograph 28
Overview of
Garage Building,
Taken Before
Siding Was
Removed

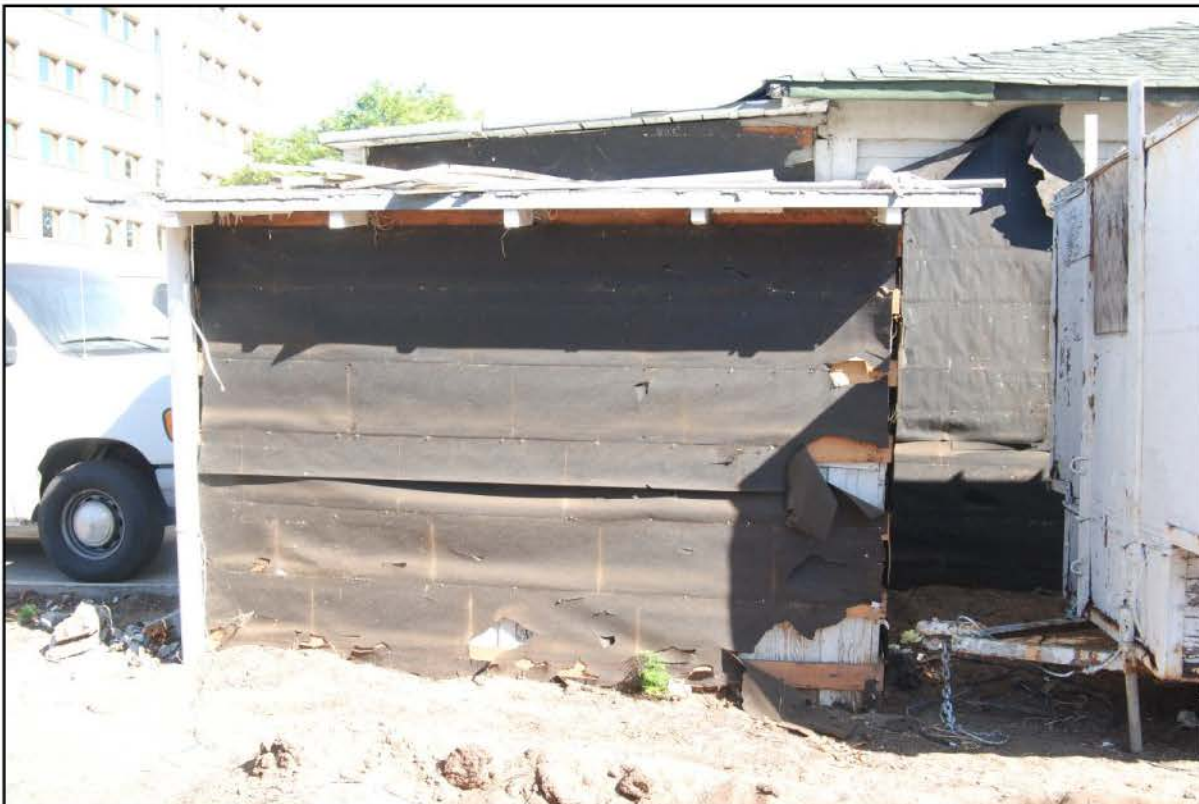
The north side of the garage is bare, with no windows or doors. The south side wall has a single window (Photos 30 and 31). It is centered in the wall of the original garage. The second addition has been added to the Fourth Avenue end of this wall, on the side of the first addition. This addition is 8 feet 6 inches wide and 6 feet 6 inches deep, with a very shallow pitched shed roof attached to the wall approximately 10 inches below the rafters. There are no windows in this addition. A single narrow door is located in the east wall facing the driveway, next to the main garage door.

Photograph 31
South Side of
Garage, Current
Condition,
Showing Addition
and Part of
Original Garage
