16 PRESERVATION BRIEFS

The Use of Substitute Materials on Historic Building Exteriors

National Park Service
U.S. Department of the Interior
Technical Preservation Services

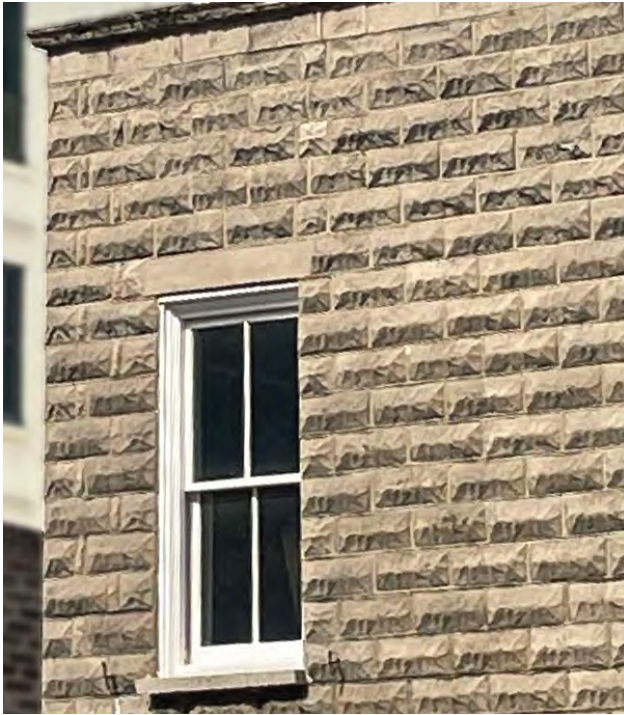
Figure 2a. Casting concrete blocks to mimic quarried stone was a popular late 19th- to mid 20th-century technique. Concrete masonry units could be completed by local craftsman, saving time and shipping costs. Photo: John Sandor, NPS.

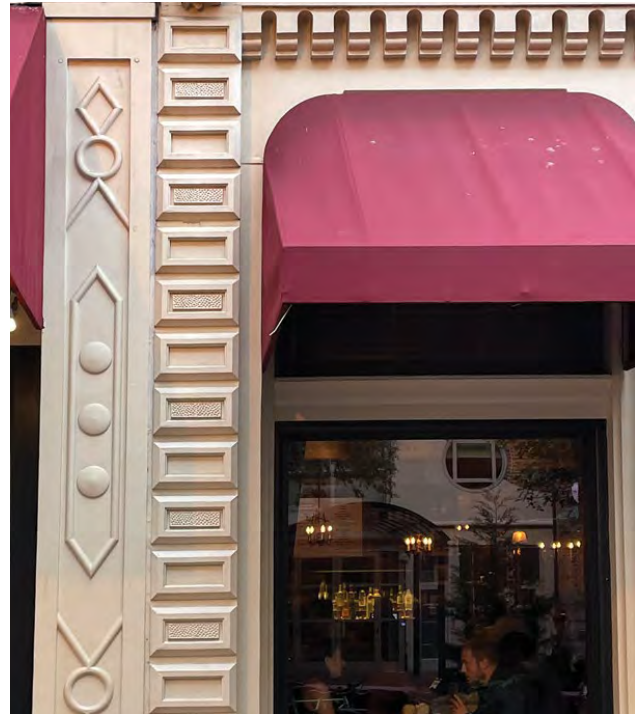
Figure 2b. The 19th century also produced a variety of metal products used to imitate other materials. Across the country, cast iron was used in storefronts to imitate stone. Photo: John Sandor, NPS.

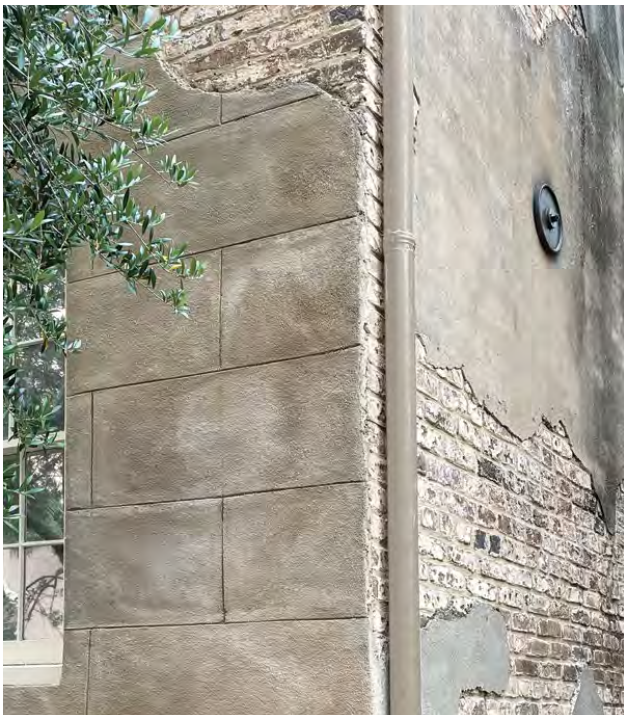
Figure 2c. Stucco has been used to imitate a number of building materials for many centuries. Seen here, stucco was applied to a brick structure and scored to represent a stone façade. Photo: John Sandor, NPS.

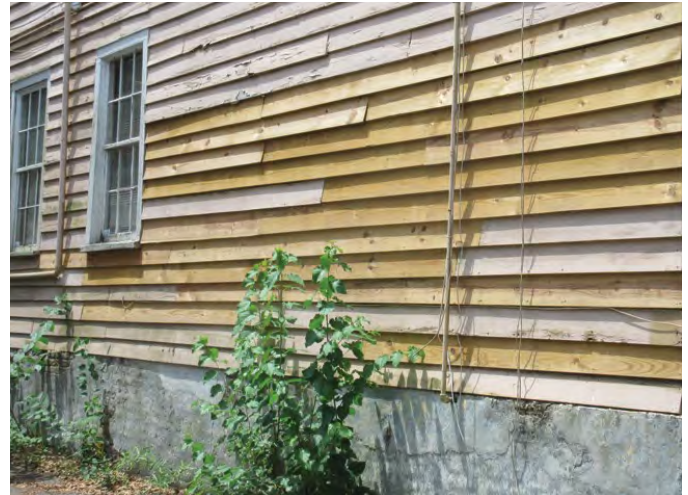
Figure 3: Incremental repair is best done using in-kind material to minimize differences in the performance characteristics that could negatively affect the overall assembly. Photo: NPS.

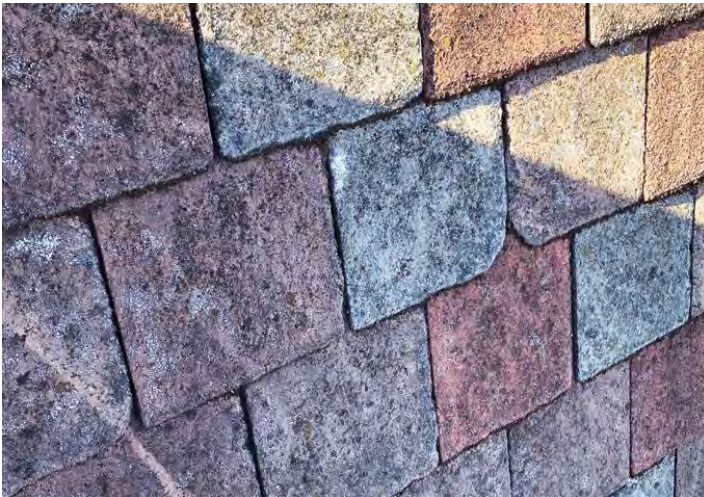
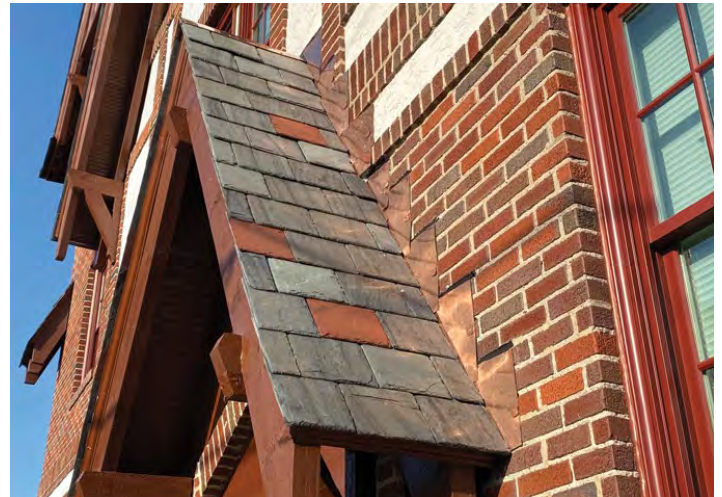
Figure 5. (Left) Asbestos shingles were often used as a substitute for traditional slate roof shingles. The historic asbestos roof on this rehabilitation project had reached the end of its lifespan and required complete replacement. (Right) Given the limited replacement materials available to match the historic asbestos shingles, utilizing natural slate was determined to be the best visual match for the original shingles and design intent in this instance. Photos: Crosskey Architects.

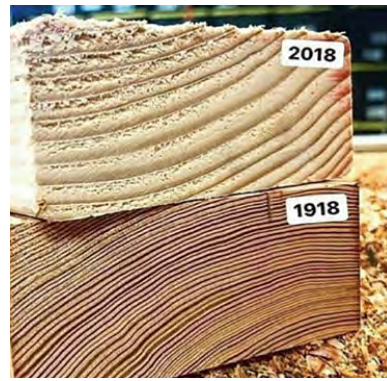
Figure 6. The dramatic difference in the number of growth rings between old-growth wood and wood that was recently harvested from second- or third-growth forests is indicative of the diminished dimensional stability and durability of most lumber currently available. Photo: Zachary Dettmore.

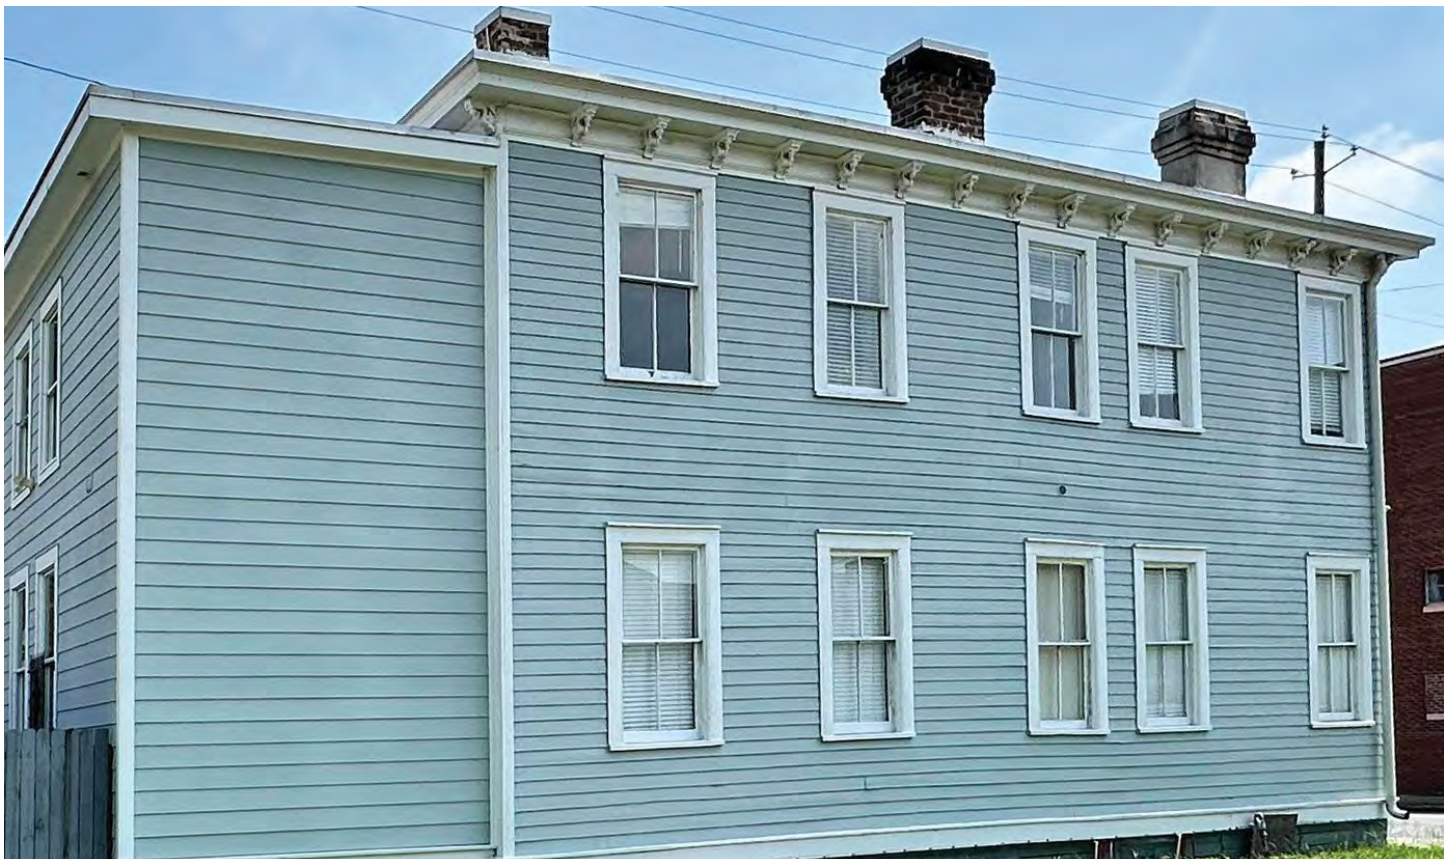
Figure 7. A new addition replaced non-historic construction on the rear elevation of this building. Fiber cement gives the addition a compatible appearance without replicating the exposure for thickness of the historic siding. Photo: Ward Architecture + Preservation.

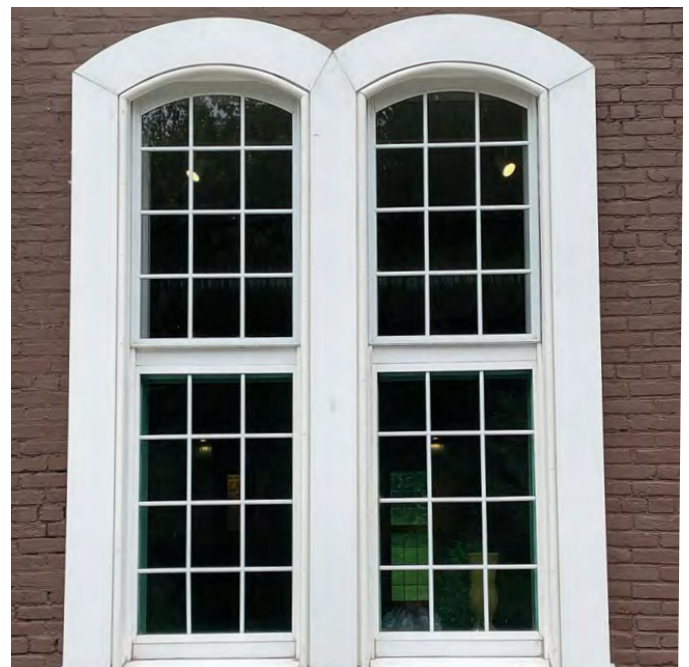
Figure 9. Previously bricked-in openings below the flood line were reopened and new aluminum windows installed with cellular PVC trim detailed to hold back moderate flood waters and survive exposure to water. Photo: John Sandor, NPS.

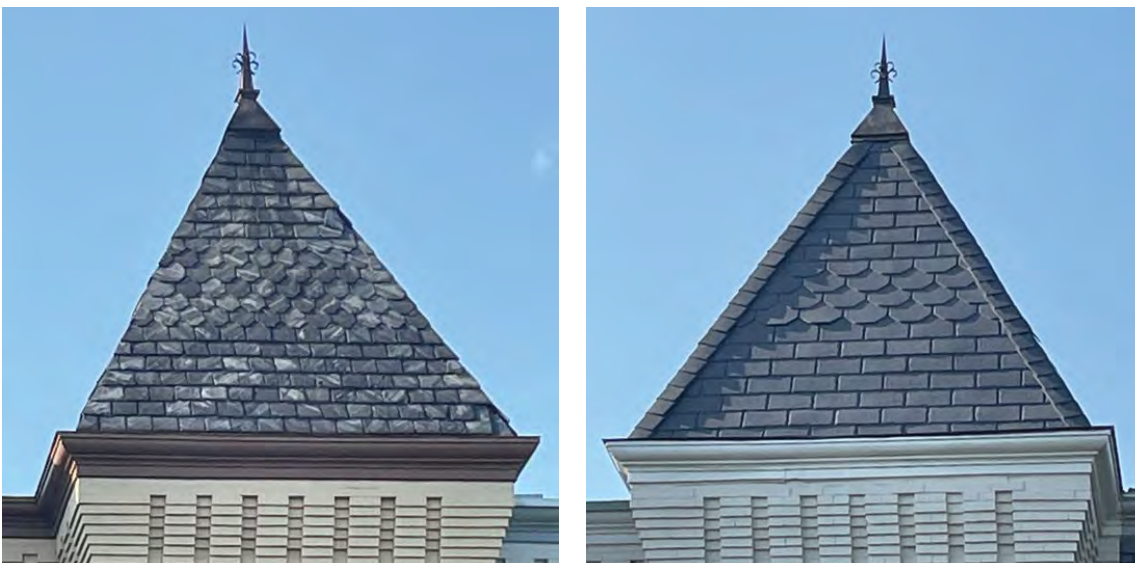
Figure 10a and 10b. Polymer slates offer a choice of shapes but not sizes, limiting their ability to achieve a good visual match for some historic slate. With the size of the polymer slates (Figure 11b) being nearly twice that of the historic slates (11a), the scale of the entire feature is incompatibly altered. The molded edges of this material, which contribute to its ability to replicate slate, would be lost if each shingle was resized by cutting. Photo: John Sandor, NPS.

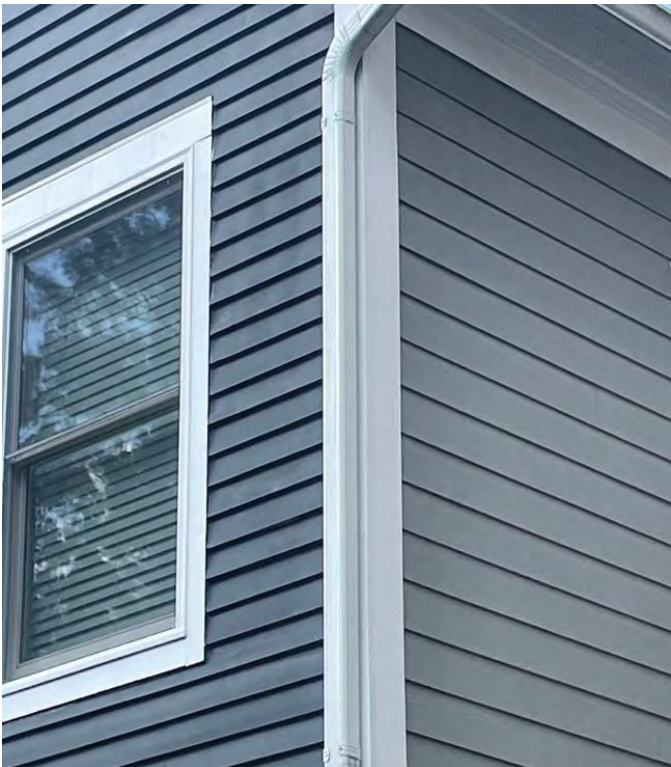
Figure 11. The thickness of the wood siding on the front (left) creates a deeper shadow line than is achieved with the fiber cement siding used on the side (right) elevation. While the exposure can be adjusted, fiber cement siding is not available in a matching thickness. Photo: John Sandor, NPS.

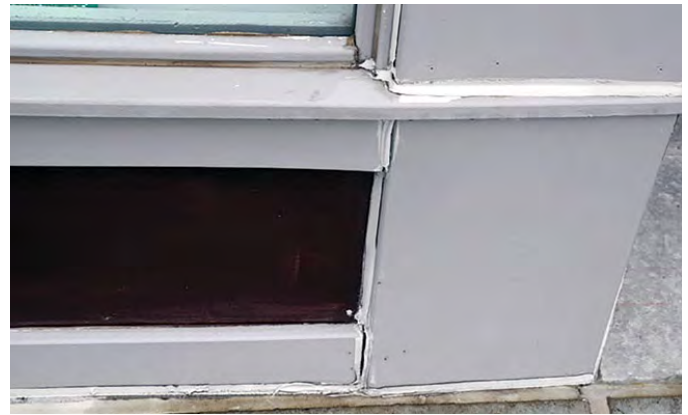
Figure 12. Cellulose composite materials, like wood, expand and contract with moisture. Here it was used to reconstruct a missing storefront. Unlike solid wood that is dimensionally stable parallel to the grain, this composite moves equally in all dimensions, resulting in gaps that were not adequately anticipated in the design. Photo: John Sandor, NPS.

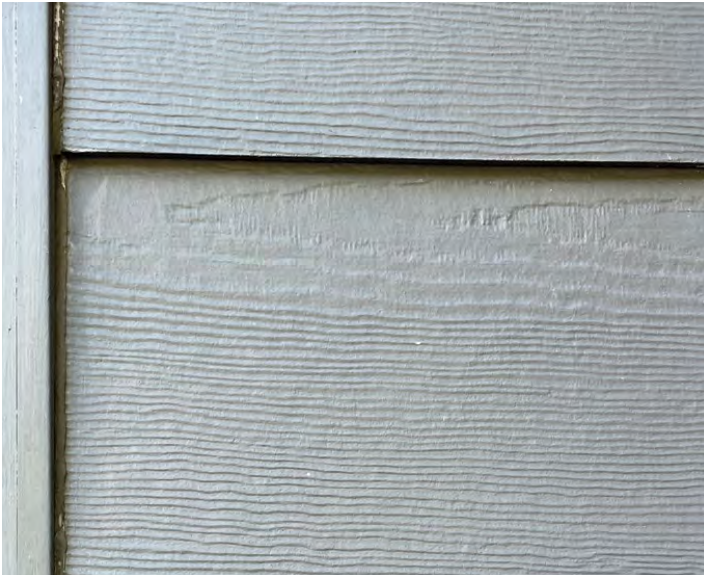
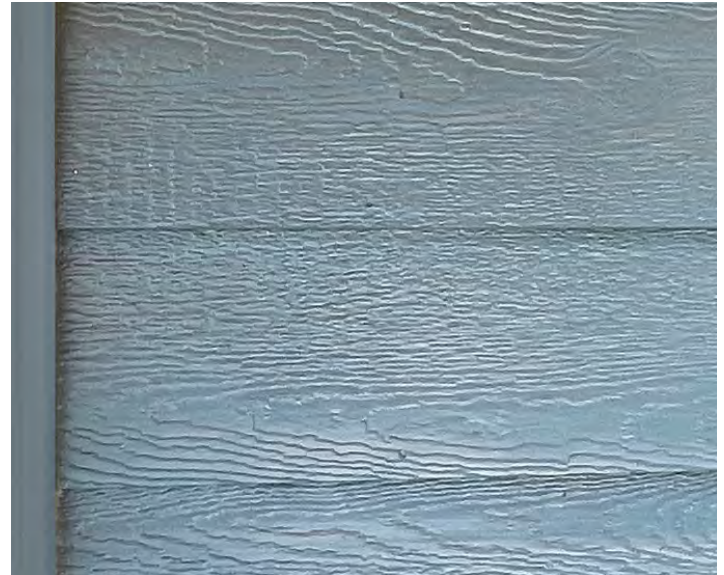
Figure 14. Surface texture is an important aspect in matching the appearance of a historic material, especially when a material is viewed at close range. As seen in these two images, many of the substitute materials produced for siding and trim have an embossed wood grain, making them incompatible for replacing historic wood that was typically planed to a smooth surface. Some substitute products are available with a smooth surface as well. Photos: John Sandor, NPS.

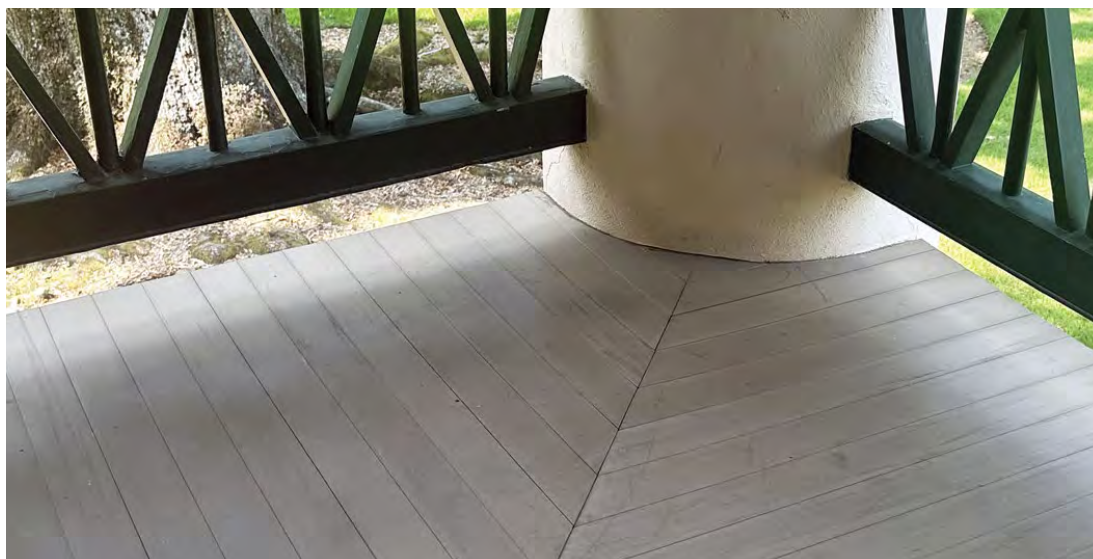
Figure 15. Tongue-and-groove porch flooring is manufactured in several different substitute materials. Each type has different properties, though most are more moisture-resistant than wood. The prefinished product shown can be painted when worn, but repainting is not recommended for some product choices. Photo: Oak Alley Foundation.

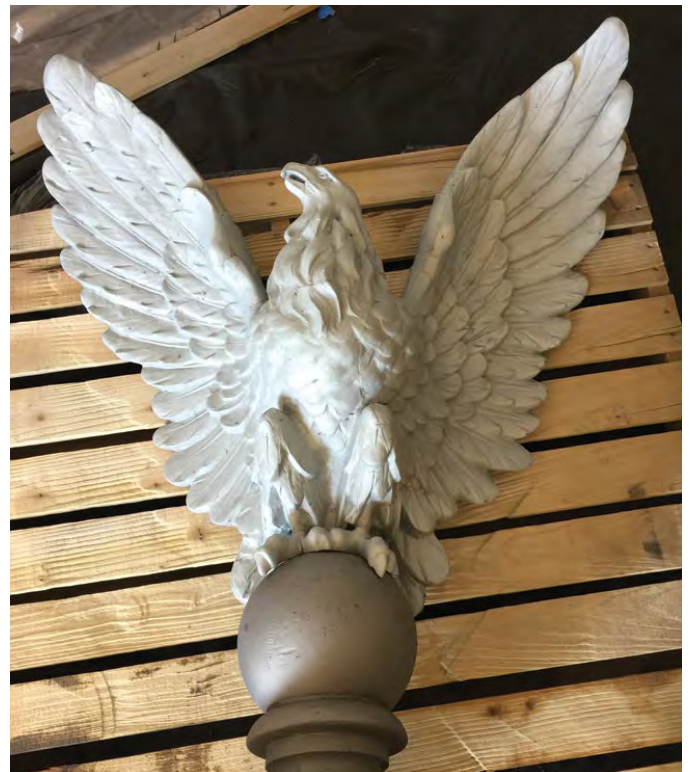
Figure 16. Aluminum is a highly corrosion-resistant metal that is commonly used as a substitute material for cast iron. Aluminum can be a more affordable and lightweight alternative to cast iron that retains a similar texture, shape, and maintenance cycle. Photo: NPS.

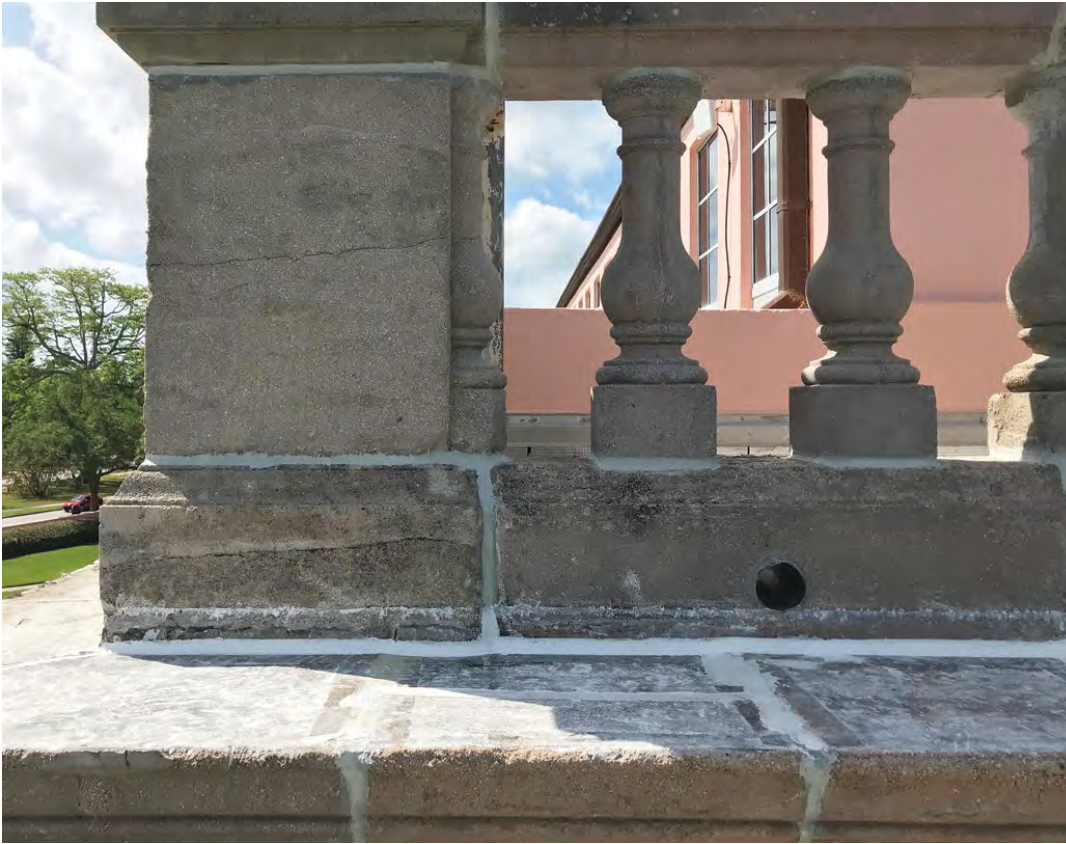
Figure 17. The balustrade consists of multiple prior campaigns of using cast stone to replace the natural stone. The effective match for the surface texture and color of the original stone allowed individual elements to be incrementally replaced only when they had failed, thus retaining the maximum amount of original material as long as possible. Photo: EverGreene Architectural Arts.

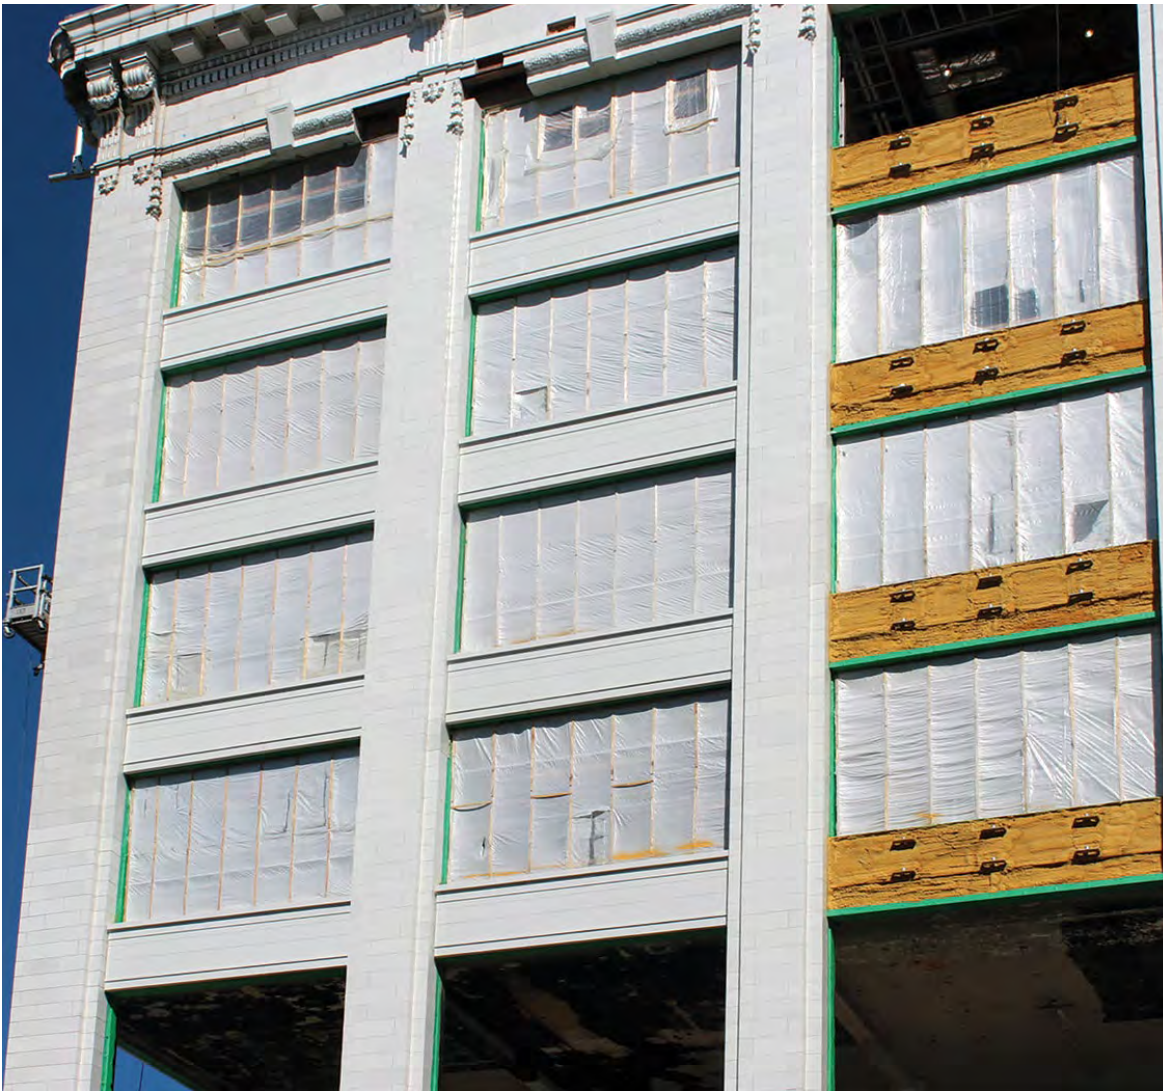
Figure 18. Missing historic terra cotta spandrel panels on all floor levels were recreated utilizing glass fiber reinforced concrete (GFRC) replacements. New spandrels were fabricated as individual components and attached with metal terra cotta piers. Photo: Kris Frail, Dewberry.

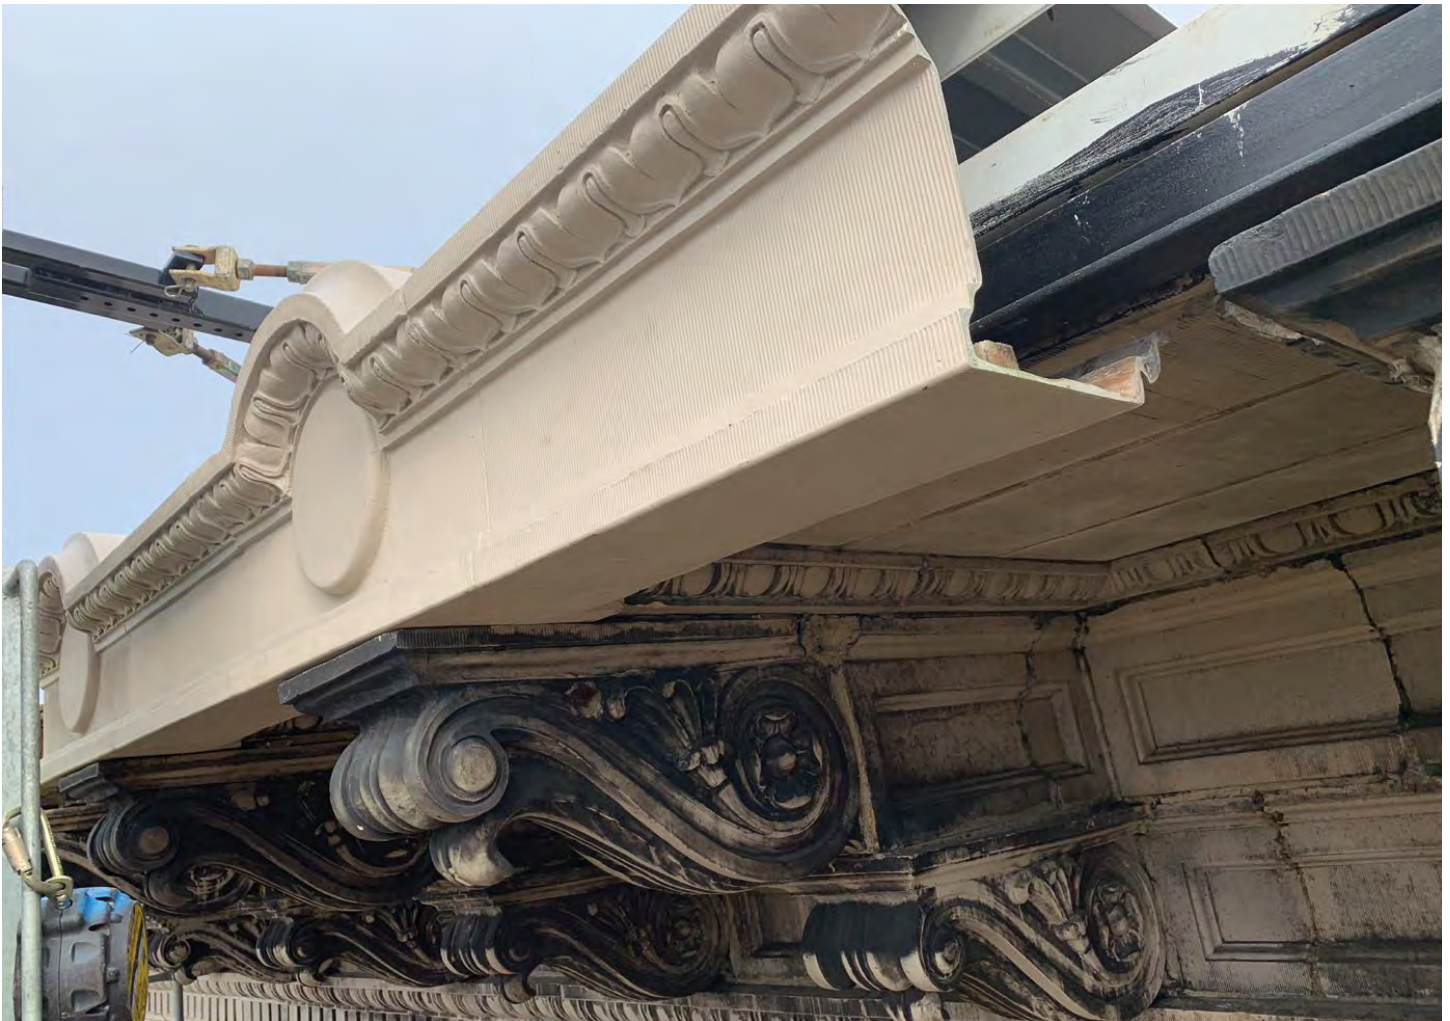
Figure 19. A new, lightweight fiber reinforced polymer is attached to a new metal armature to replicate damaged and missing elements of a terra cotta cornice. Photo: Quinn Evans.

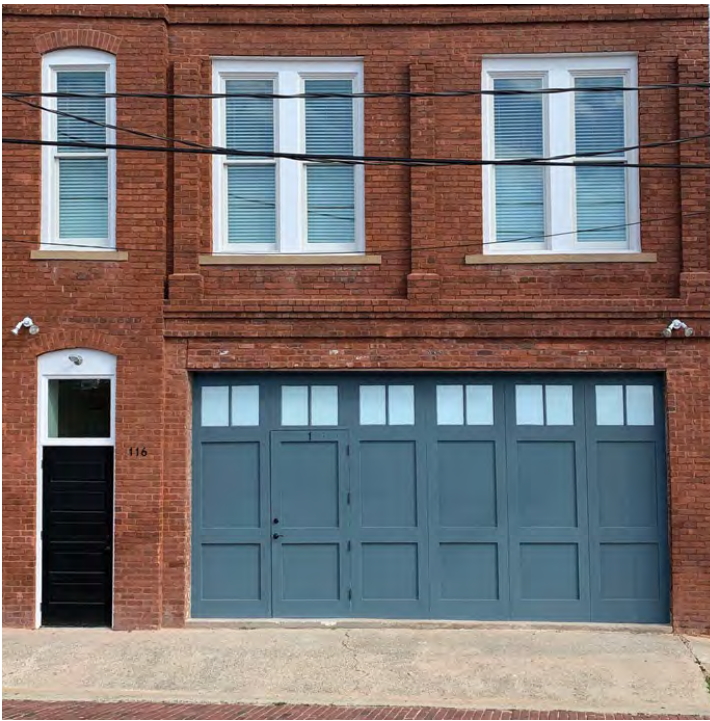
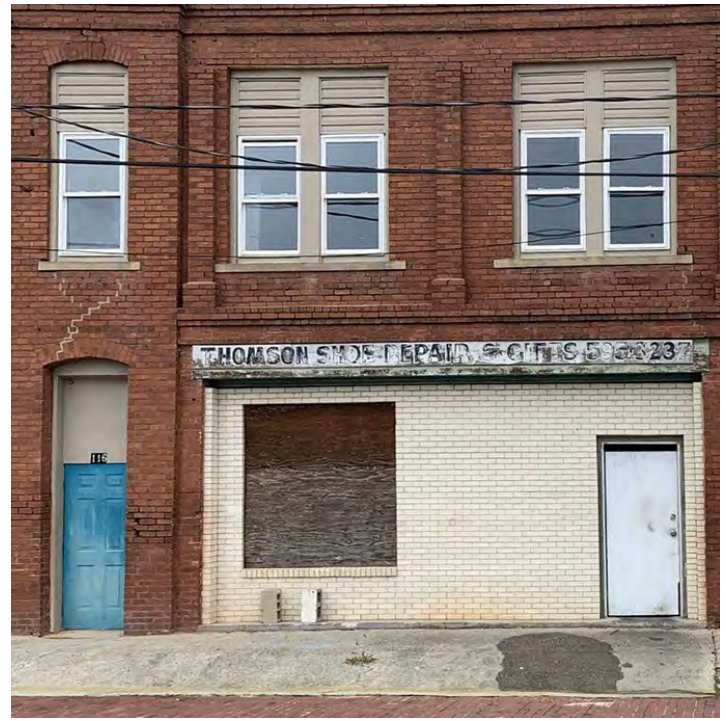
Figure 20. Cement board was used to replace a non-historic infill and mimics the configuration of a typical vehicular door of the period.
Photos: Historic Augusta.

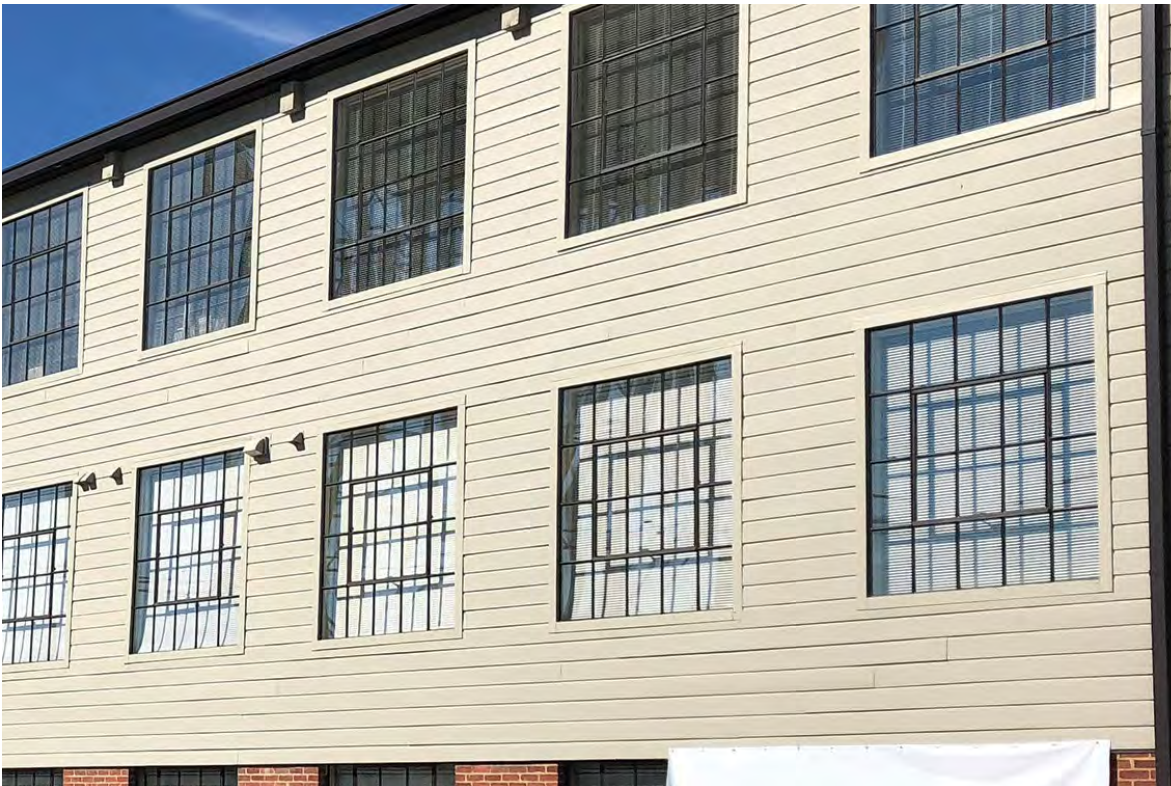
Figure 21. A mineral polymer composite siding was available in the profile very similar to the historic siding. The replacement siding was used where the original material was almost completely missing beneath a more modern covering. Areas where the original wood were largely intact were replaced with matching wood to sustain more of the material integrity of the building. Photo: Belk Architecture.

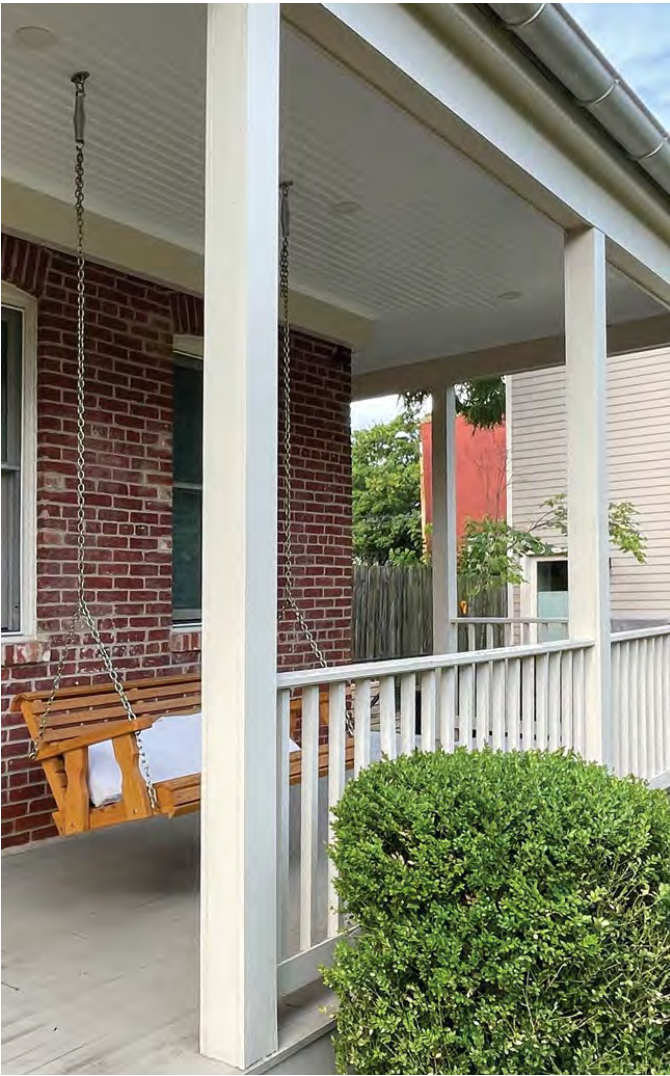
Figure 22. A porch was reconstructed using posts fabricated on site from a smooth-surface cellulose/polymer composite material. Though the face of the posts are painted, the lack of paint on the bottom at the cut ends is not consistent with manufacturers' recommendations. This treatment will allow moisture to be absorbed, shortening the life of the new replacement feature. Photo: John Sandor, NPS.

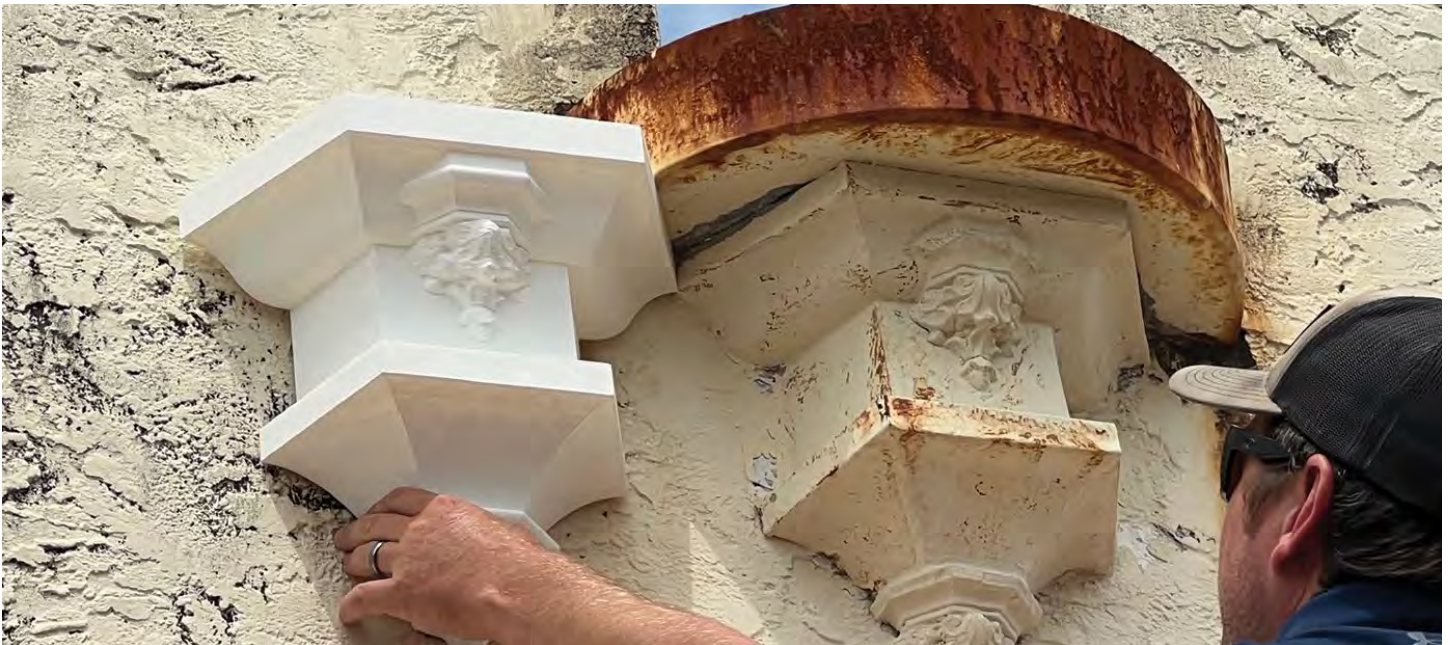
Figure 23. 3-D printing using various polymers is occasionally used to replicate missing metal or wood features. This new application is continually being refined, but the application can be successful when a painted, lightweight feature needs to be replicated. Photo: NPS.

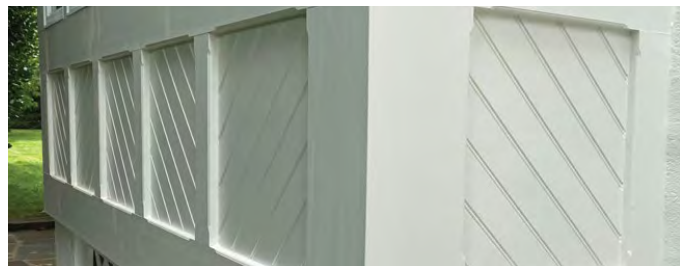
Figure 24. Cellular PVC when painted can be used to replace deteriorated wood features. This beadboard set in a wood frame was not historically designed to shed water effectively and had deteriorated. Cellular PVC was able to match the appearance of the wood details, while its properties were well matched to the shady location, painted finish, and limited size and configuration within the overall assembly; thus, it should provide a long-lasting solution for this application. Photo: Jennifer Balson Alvarez, NPS.
