The Secretary of the Interior's Standards  
for the Treatment of Historic Properties

with Guidelines for  
Preserving, Rehabilitating  
Restoring & Reconstructing  
Historic Buildings

Kay D. Weeks and Anne E. Grimmer

U.S. Department of the Interior  
National Park Service  
Cultural Resource Stewardship and Partnerships  
Heritage Preservation Services  
Washington, D.C.  
1995

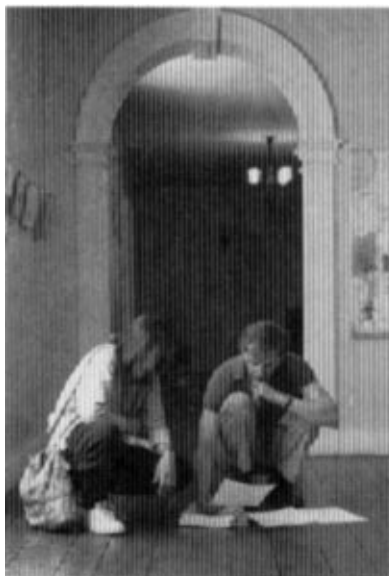
*Careful documentation of a building's physical condition is the critical first step in determining an appropriate level of intervention. (a) This may include relating the historical research to existing materials and features; or (b) documenting a particular problem such as this cracked ceiling. Photo (a): Jean E. Travers; Photo (b): Lee H. Nelson, FAIA.*

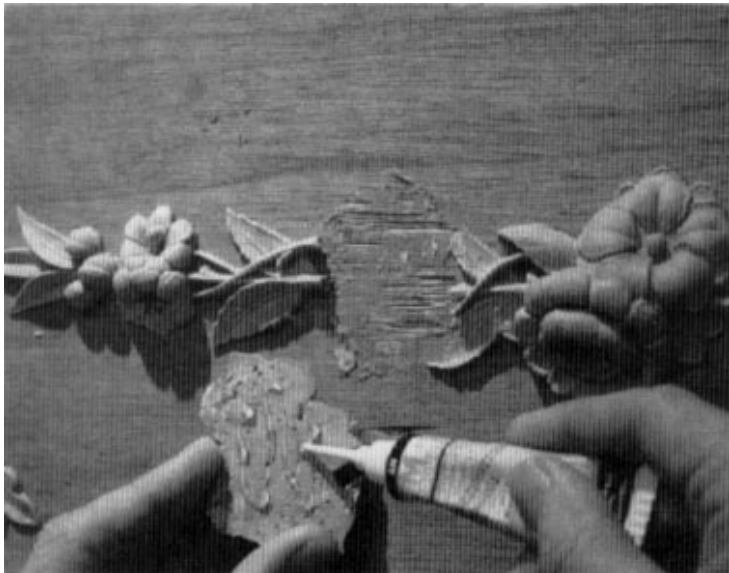
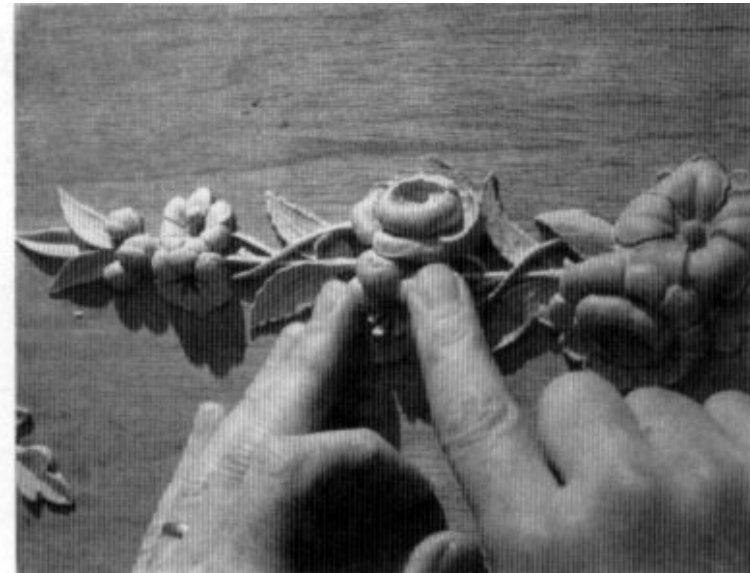
*In Preservation, an appropriate level of intervention is established prior to work in order to maximize retention of historic materials.*  
 (a) A conservator is applying adhesive to 19th century composition ornament that has delaminated from its wood substrate.  
 (b) The compo fragment is carefully held in place until the quick-setting adhesive takes hold. Photos: Jonathan Thornton.

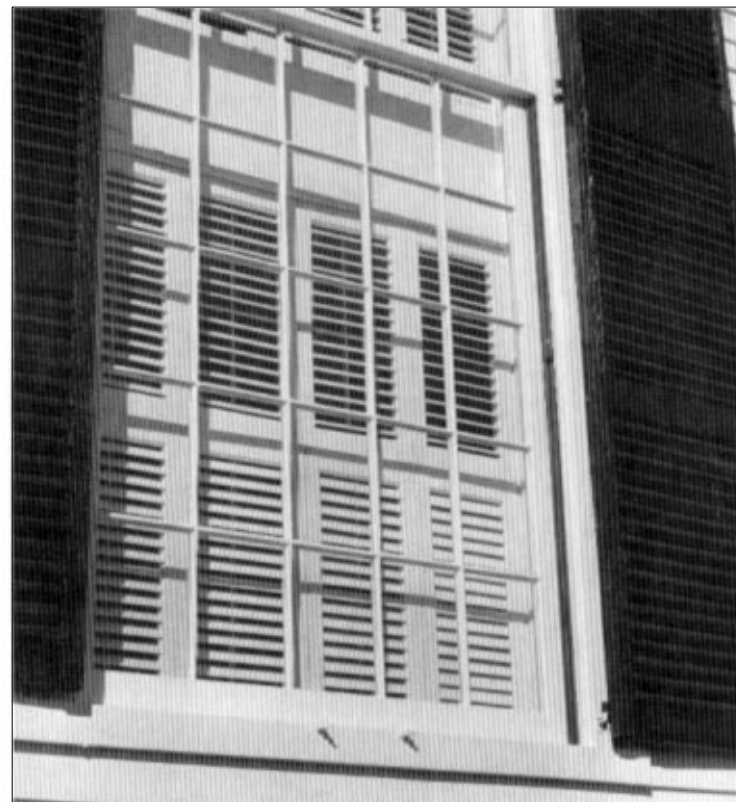
*According to the Standards for Rehabilitation, existing historic materials should be protected, maintained and repaired. In an exemplary project, the windows and shutters of this historic residence were carefully preserved.*

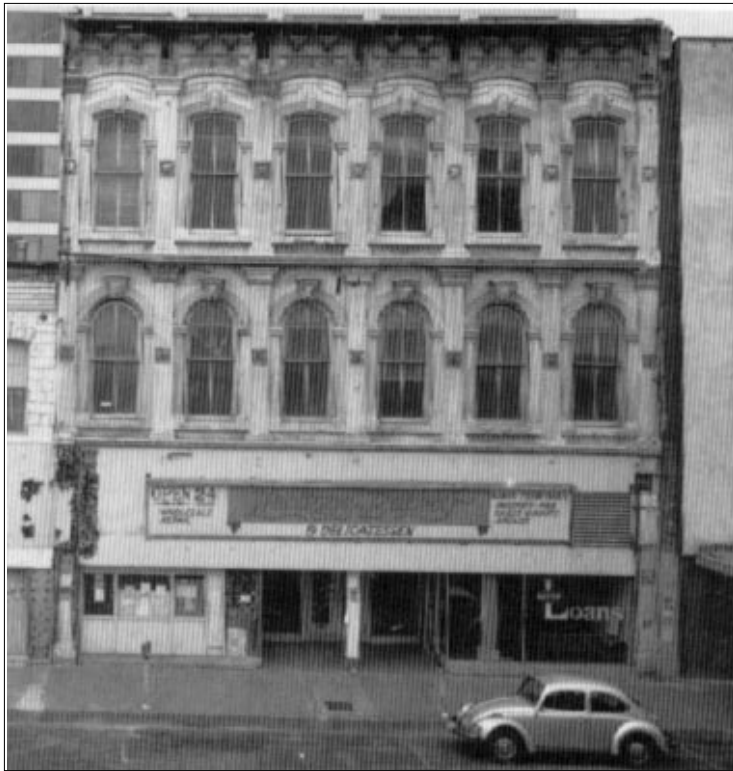
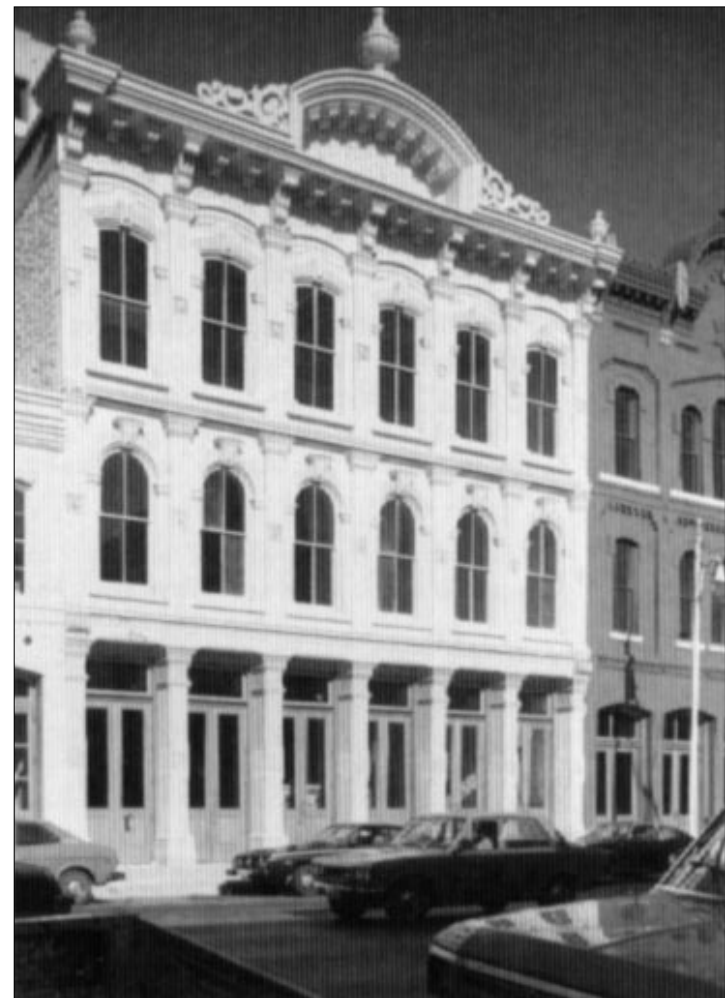
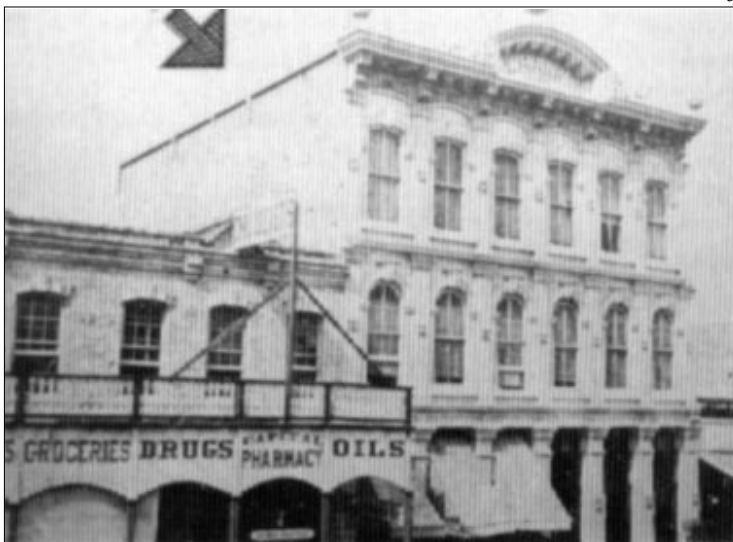
*In the treatment, Rehabilitation, one option for replacing missing historic features is to use pictorial documentation and/or physical evidence to re-create the historic feature. (a) In this example, the ornamental cornice of an 1866 limestone building was missing; and the ground level storefront had been extensively altered. (b) and (c) Based on the availability of photographic and other documentation, the owners were able to accurately restore the cornice and storefront to their historic configuration. A substitute material, fiberglass, was used to fabricate the missing pressed metal cornice, an acceptable alternative in this project. All work met the Standards.*

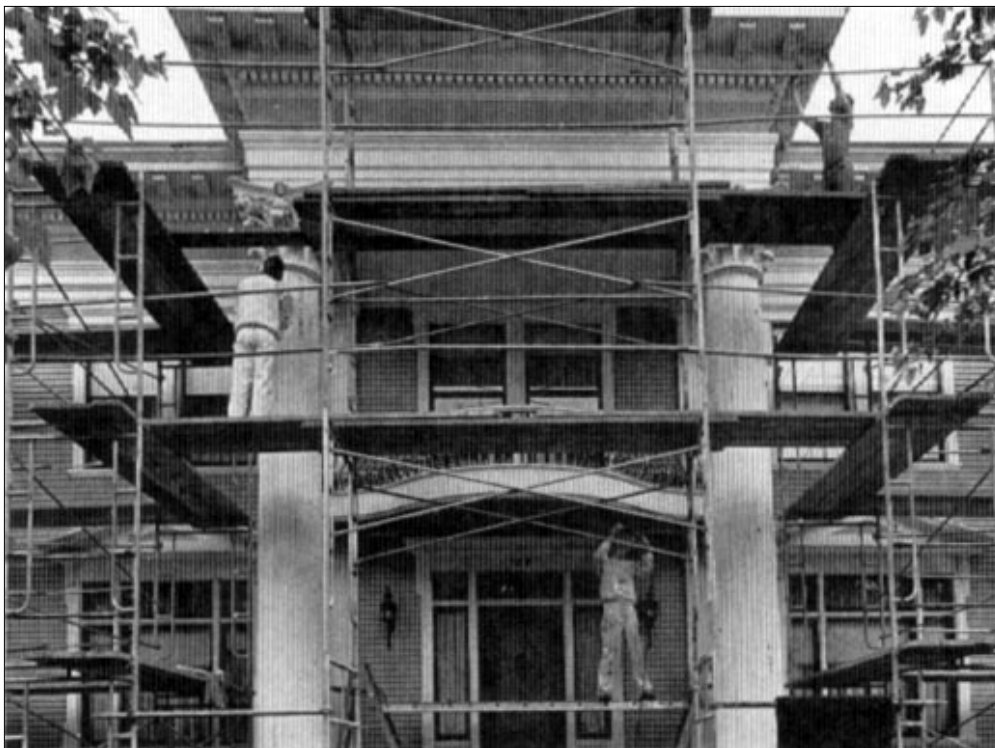
*Ongoing work at this house focuses on the maintenance and repair of exterior wood features from the restoration period. After scraping and sanding, the wood was painted in colors documented to the Restoration period. Photo: ©Mary Randlett, 1992.*

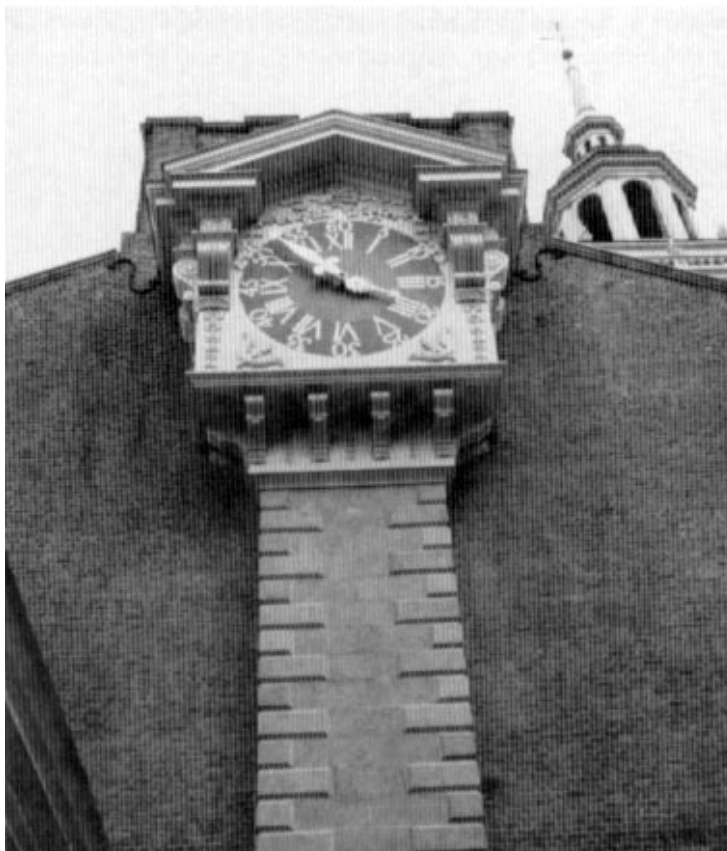
*The Standards for Restoration call for the repair of existing features from the restoration period as well as the re-creation of missing features from the period. In some instances, when missing features are replaced, substitute materials may be considered if they convey the appearance of the historic materials. In this example at Philadelphia's Independence Hall, the clock was re-built in 1972-73 using cast stone and wood with fiberglass and polyester bronze ornamentation. Photo: Lee H. Nelson, FAIA.*

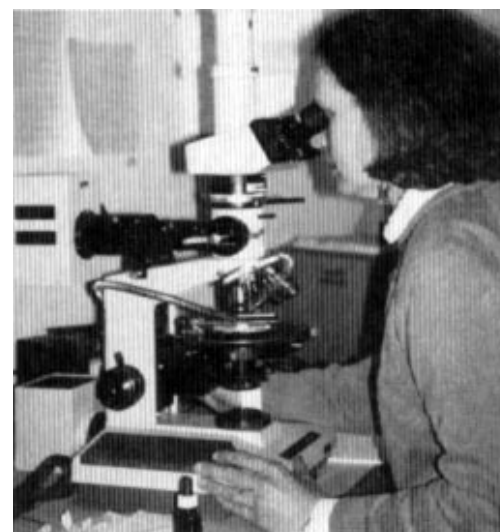
*A complete paint investigation often needs to be conducted during Restoration. Paint samples are carefully collected onsite. In the laboratory, an ultra violet light is used to identify pigment and binding media. Paint samples are then photographed. Physical evidence documented through laboratory research provides a sound basis for an accurate restoration of painted finishes, such as the complex stencilling pictured here. Photo left: Courtesy, Alexis Elza; Photo right: Courtesy, Andrea Gilmore.*

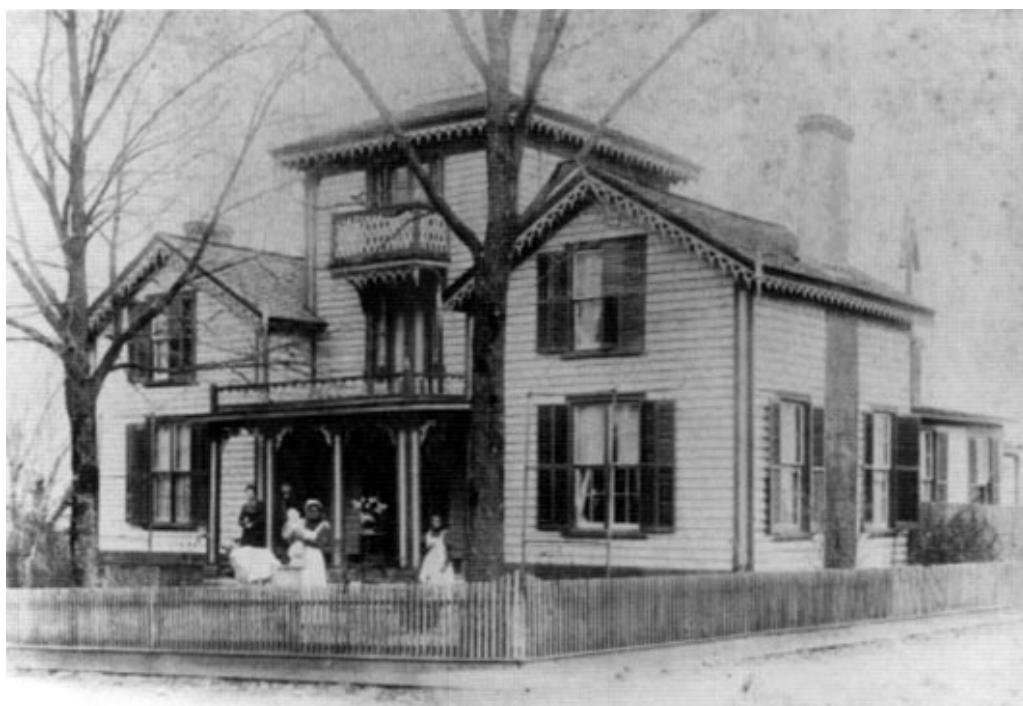
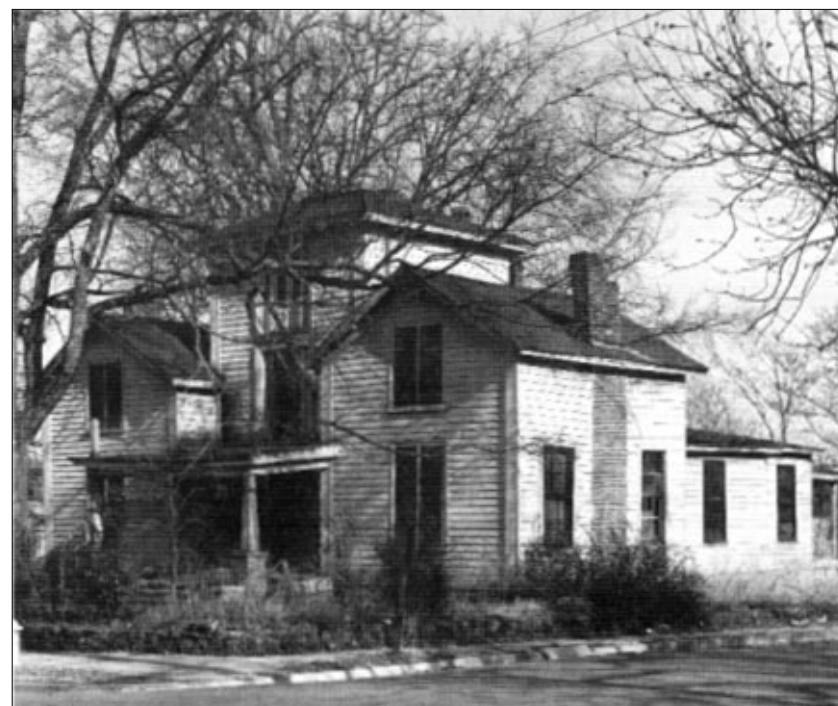
*This ca. 1900 photograph (left) would be invaluable to guide restoration of the deteriorated house (right) to its documented earlier appearance, complete with decorative trim, shutters, polychromed exterior, and fencing. Photos: Courtesy, North Carolina Department of Archives and History.*

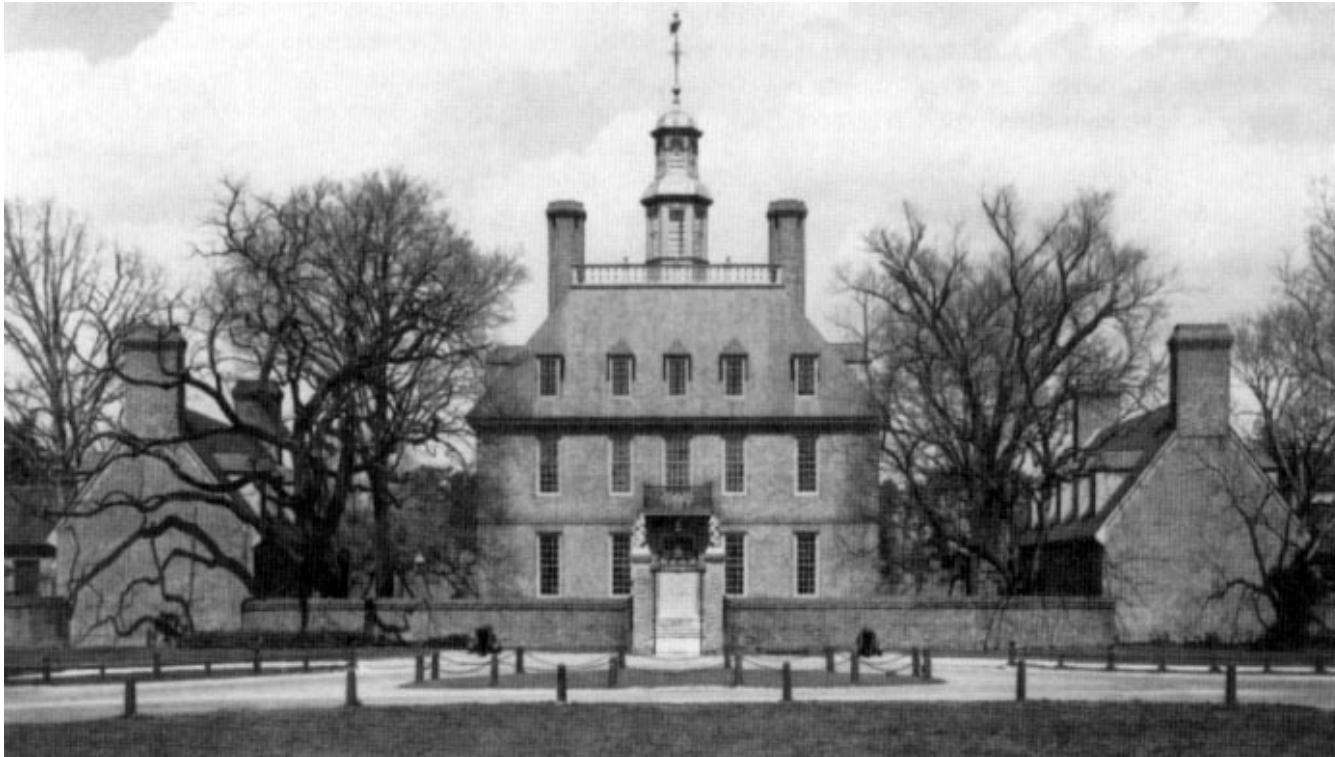
*In the 1930s reconstruction of the 18th century Governor's Palace at Colonial Williamsburg, Virginia, the archeological remains of the brick foundation were carefully preserved in situ, and serve as a base for the reconstructed walls.  
Photo: The Colonial Williamsburg Foundation.*

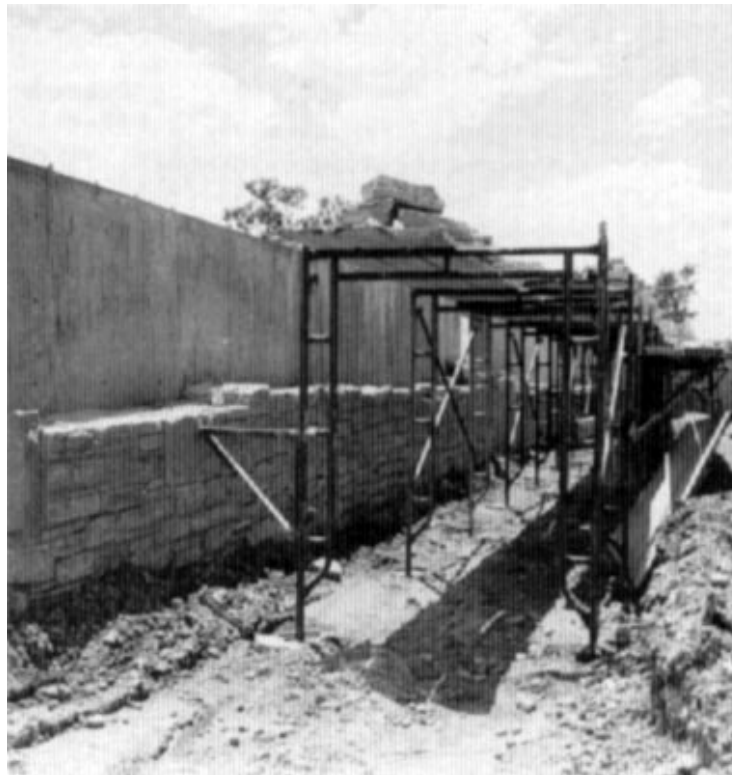
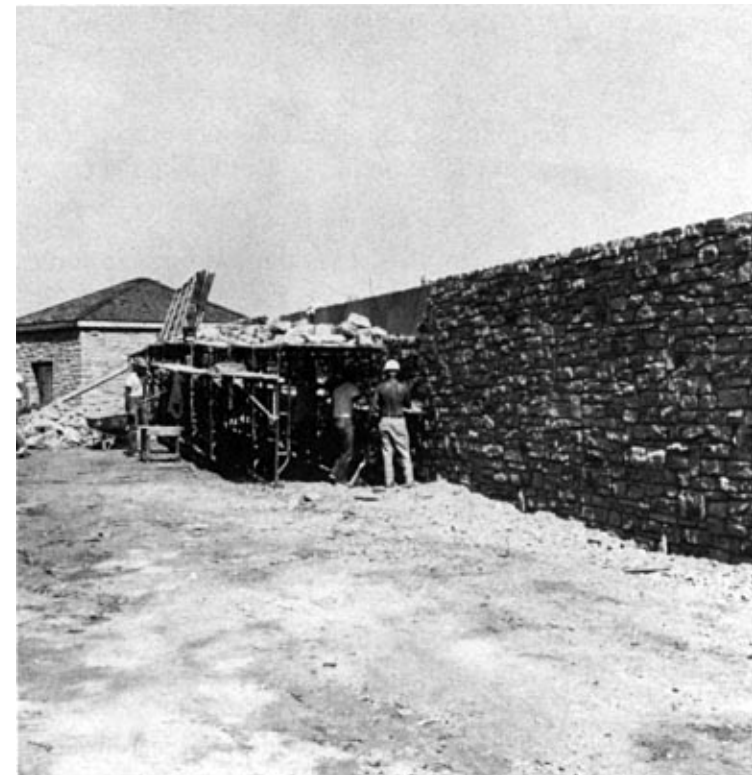
*(a) and (b). Two photos illustrate the use of contemporary construction materials and techniques within the treatment, Reconstruction. Because Reconstruction is employed to portray a significant earlier time, usually for interpretive purposes, substitute materials may be appropriate if they are able to convey the historic appearance.*

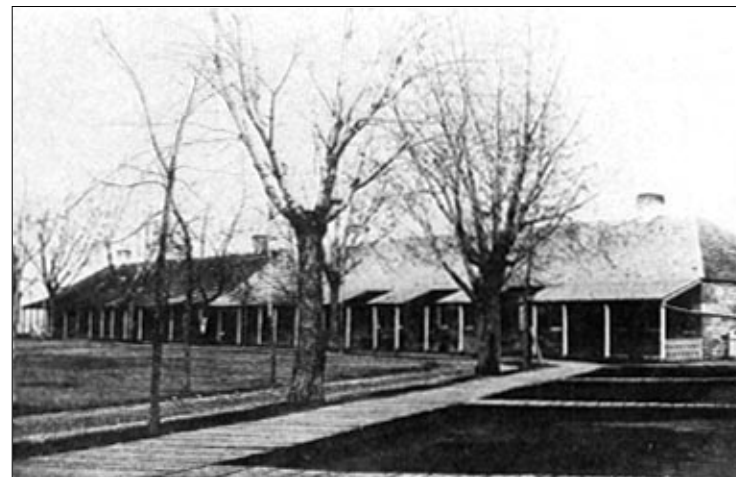
*(a) and (b). Two views of the Officers' Quarters at Fort Snelling (ca. 1885 to 1900) not only provide information on the materials and form of the historic block, they document the wooden walkways and other landscape features such as stairs, railings, and tree placement. Historical and pictorial evidence would need to be combined with specific physical evidence in order to make the case for Reconstruction as a treatment.*
