History Uncovered

The Hotel del Coronado Restoration

A commemorative publication celebrating the restoration, rehabilitation, and preservation of the historic Hotel del Coronado.

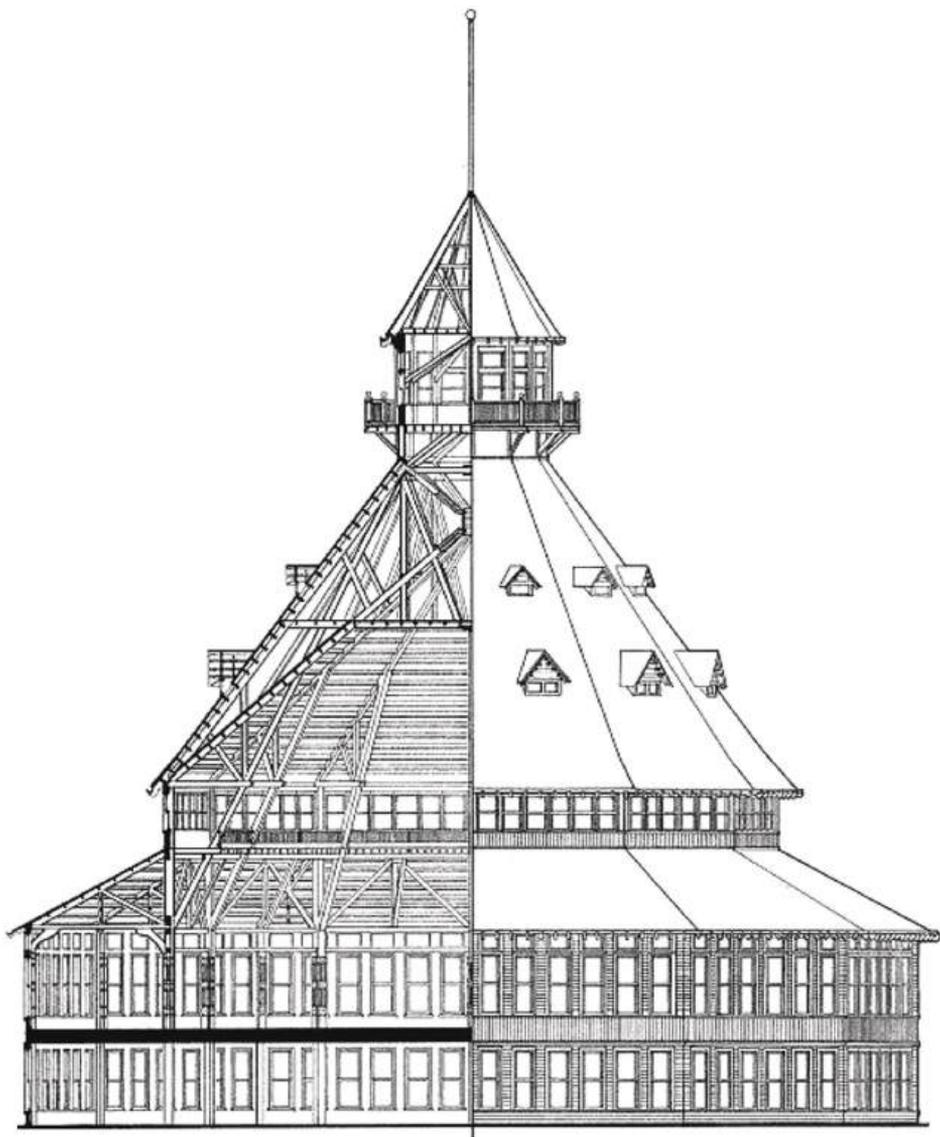
SURVEY NO. CAL 1958	HISTORIC AMERICAN BUILDINGS SURVEY SHEET 7 OF 8 SHEETS	LETTERS OF COPYRIGHT WHERE APPLICABLE
----------------------------------	--	--

Ballroom section/elevation. This HABS drawing of the ballroom is based on the original drawings, early photographs, and field measurements.

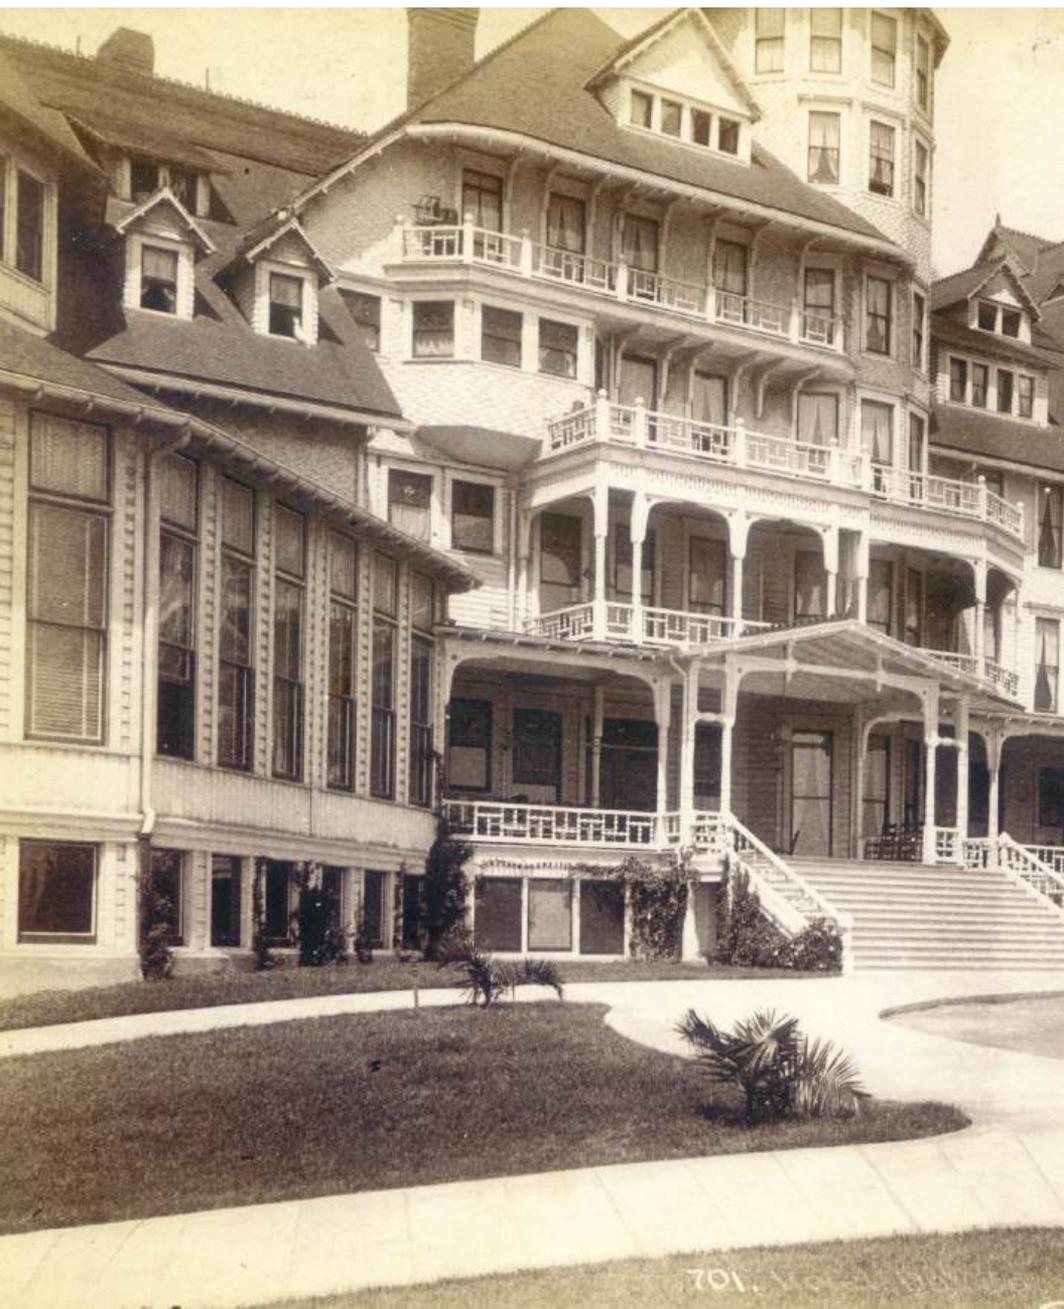
South facade and entry veranda shortly after The Del was completed, c. 1890.

When the Hotel del Coronado originally opened, its south facade showcased a stunning covered porch, or veranda, a hallmark of its Queen Anne Victorian architecture. This feature included two entry staircases (one reserved for unmarried ladies), an exposed wood roof with

turned columns, ornate railings, and decorative Victorian “gingerbread” elements. A 12-sided turret with a conical roof and a grand chimney adorned the facade, highlighted by stained-glass windows, including the iconic Coronado Window on the second floor.

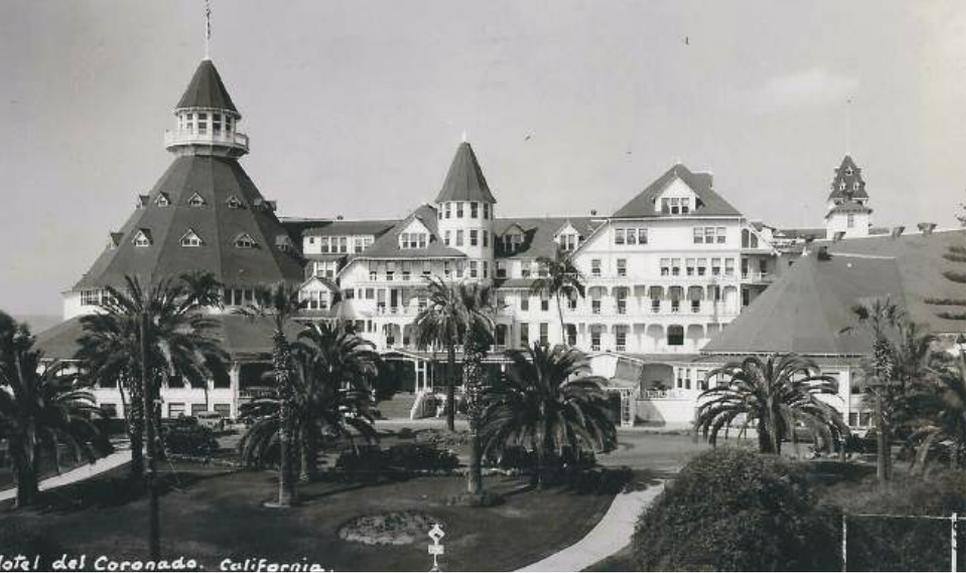
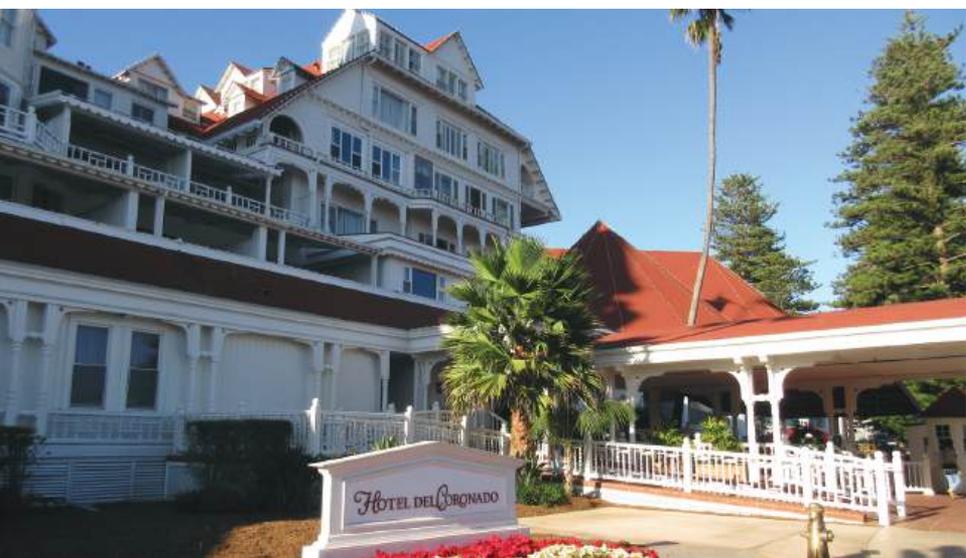
Top View of the south facade, 1935; *bottom* Before view, after removal of some landscaping, showing the office walls and false Veranda columns, 2018. *Facing page* Original turned balcony columns and grillwork (upper right) that had been encased when the second-floor balconies were infilled.

Over the decades, the south facade underwent significant changes. As early as 1910, double-hung windows were replaced with larger picture windows and a revolving door was installed at the main entrance. From the 1930s to the 1950s, the building saw the removal of chimneys, the addition of roof dormers, changes to railings, and other alterations. The original veranda was expanded and altered multiple times, extending 30 feet south through a cycle of infilling and extensions. By the 1990s, the veranda had disappeared entirely, replaced by walls with false columns in front.

Restoration efforts began with the demolition of non-historic additions, such as the 1979 porte cochère. Historic features, including wood siding, ceiling coffers, and guardrails, were carefully documented, labeled, and salvaged for later restoration and reinstallation.

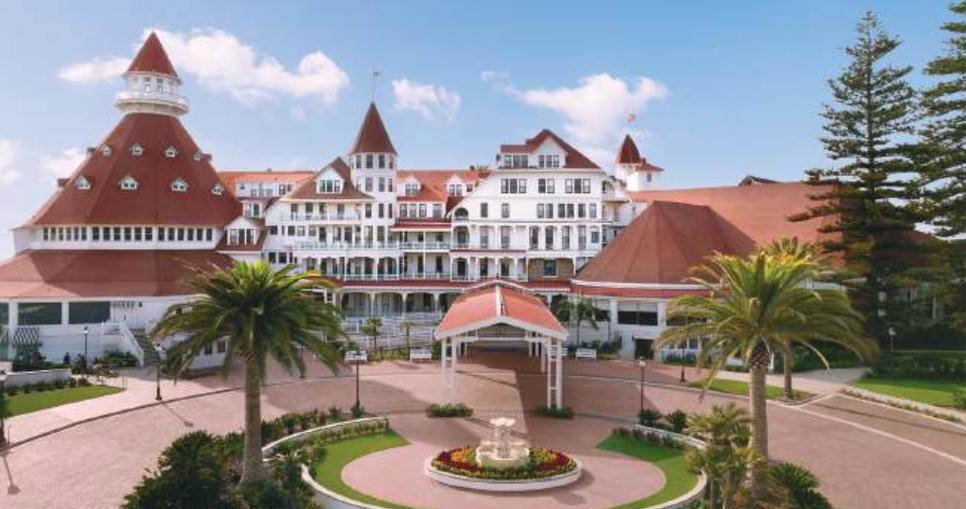
South facade and porte cochère after restoration, 2021.

A key goal was to restore the original size and shape of the historic entry veranda and facade. To achieve the authentic look, the south first-floor walls and entry veranda were reconstructed. This approach also included the reconstruction of both original entry stairs, with an ADA ramp placed between them.

Additionally, wood double-hung replicas were installed on the upper floors, replacing over 90 non-historic windows. Mockups were used throughout the project to verify the accuracy of replicated components, allowing for comparisons with historic photos. This process was particularly effective in refining the design of decorative woodwork and the brick patterning of the grand chimney.

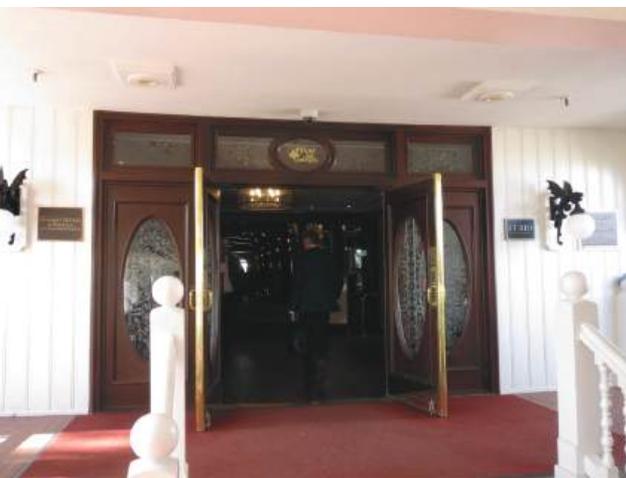
Before - 1980's non-historic main entry doors and gargoyle sconces, 2018

Same view after restoration, 2022

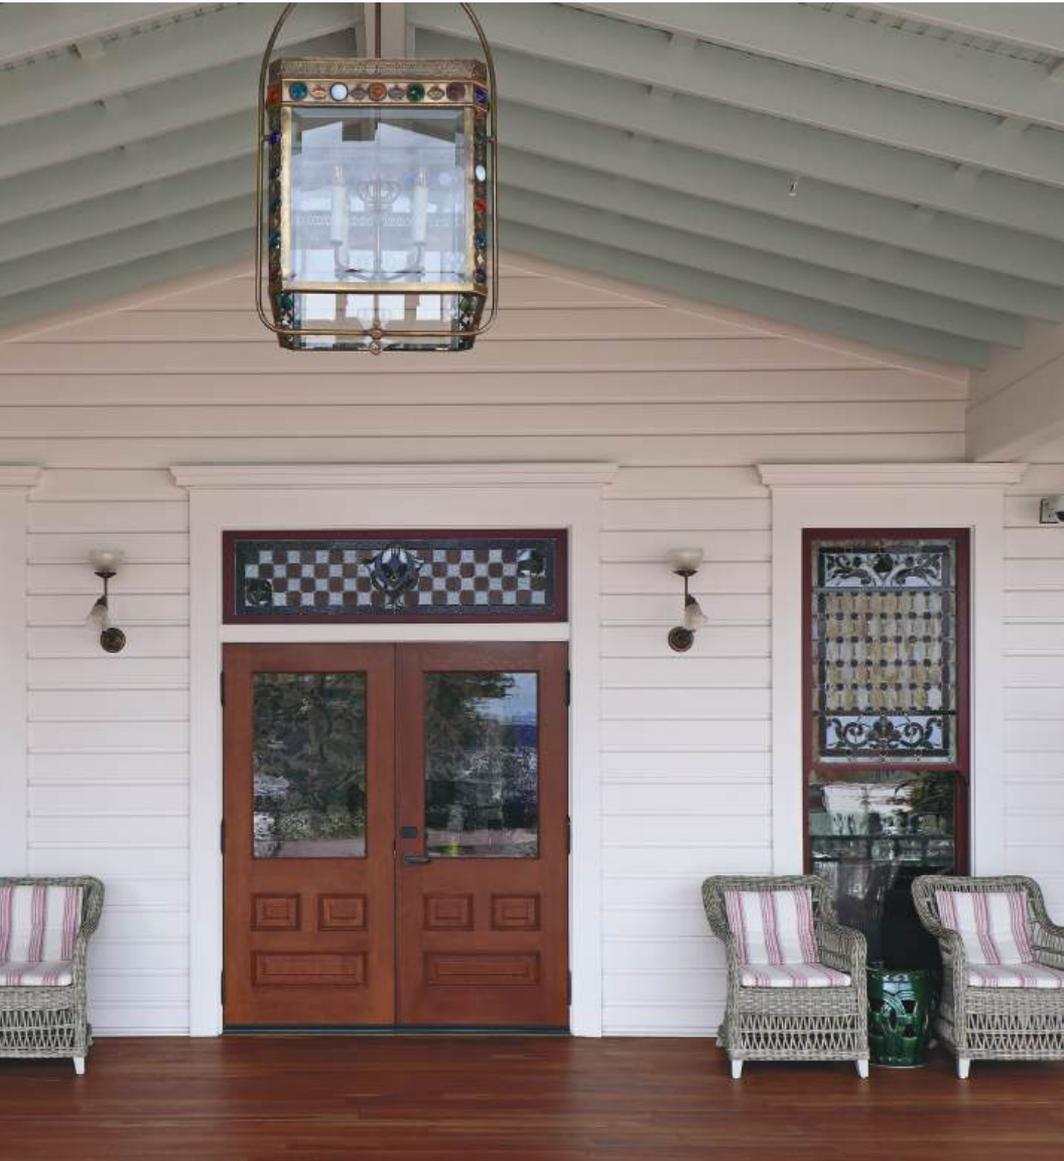
Below Restored ladies' entrance, 2022

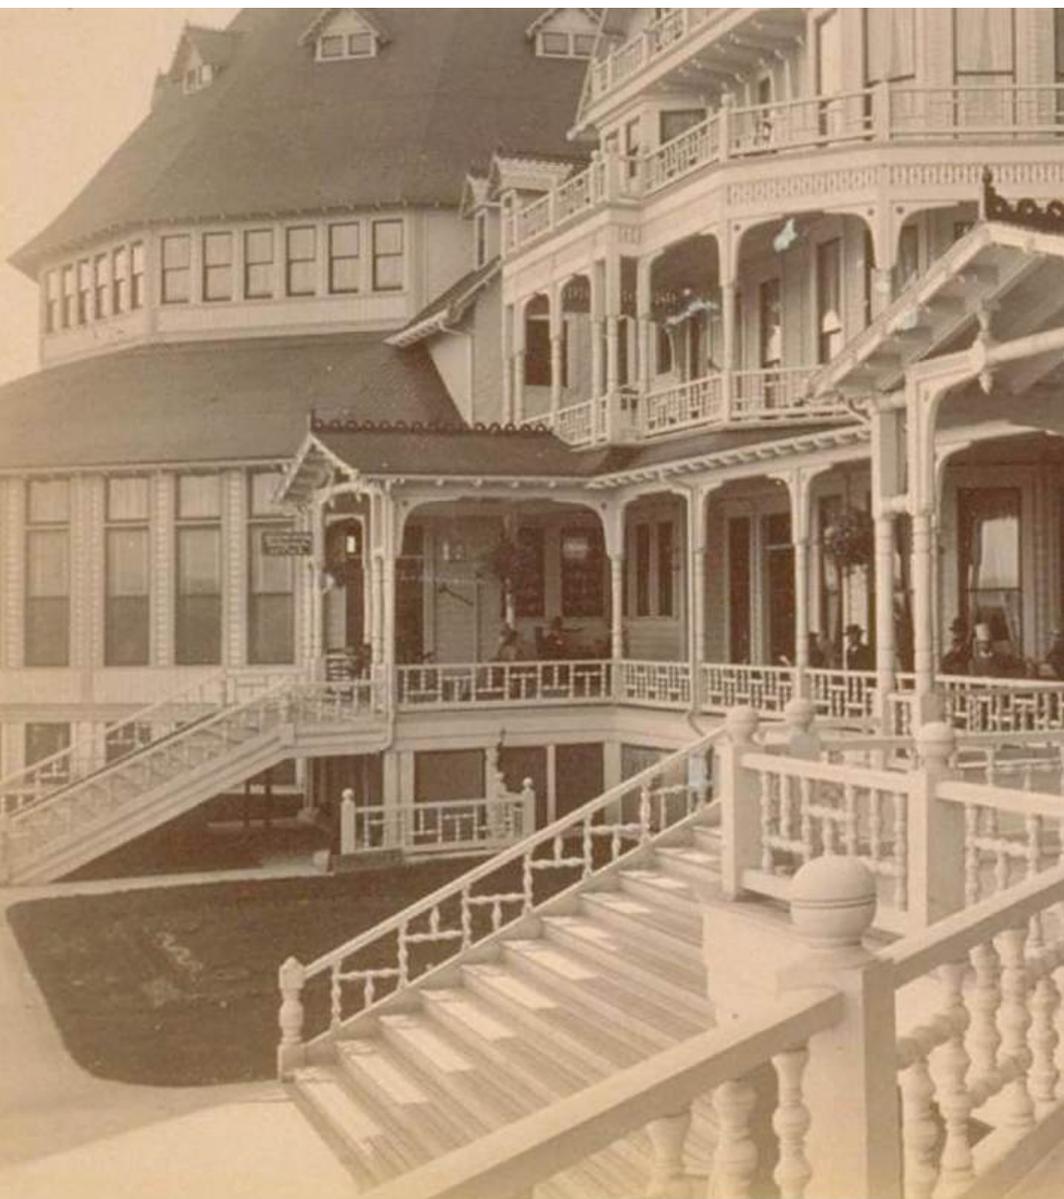
Entry veranda, c. 1890. Note the two sets of stairs and wood floor. Also note the roof ridge cresting and many stained-glass windows.

Recreating the missing front veranda was the centerpiece of the entry restoration project. Due to modern constraints, it had to be rebuilt 15 feet further south of its original location, but the size, footprint, materials, and detailing, as well as the window and door placements, have been faithfully

restored to their 1888 appearance. A final touch was the reconstruction of the veranda's decorative ridge creasing, a prominent feature in historic photos. The original wooden creasing had deteriorated by the 1930s.

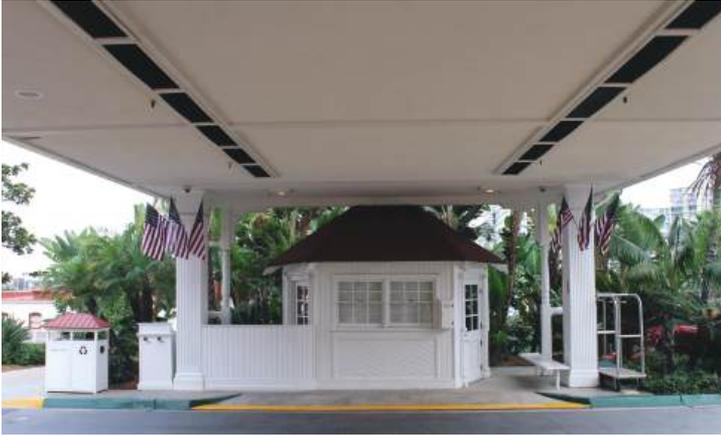
Before

The gable roof at the main entry suffered several alterations, and by 1979 had evolved into an open-air porte cochère extending over multiple lanes of the entry drop-off. The design with its flat stucco ceiling, oversized square posts, and recessed fluorescent lighting was out of place.

The new porte cochère was reimagined to better align with The Del's Victorian aesthetic, while also being taller to accommodate buses and fire trucks. This blend of modern functionality and historical sensitivity has restored the grandeur of the hotel's main entrance and has opened up views to the south.

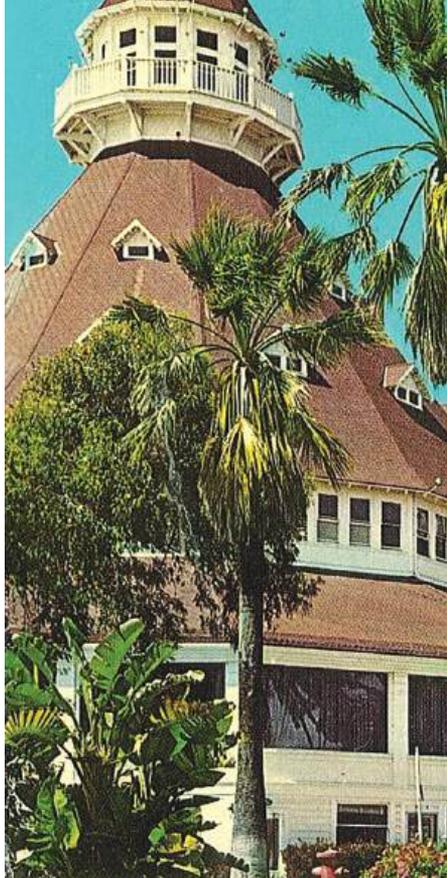
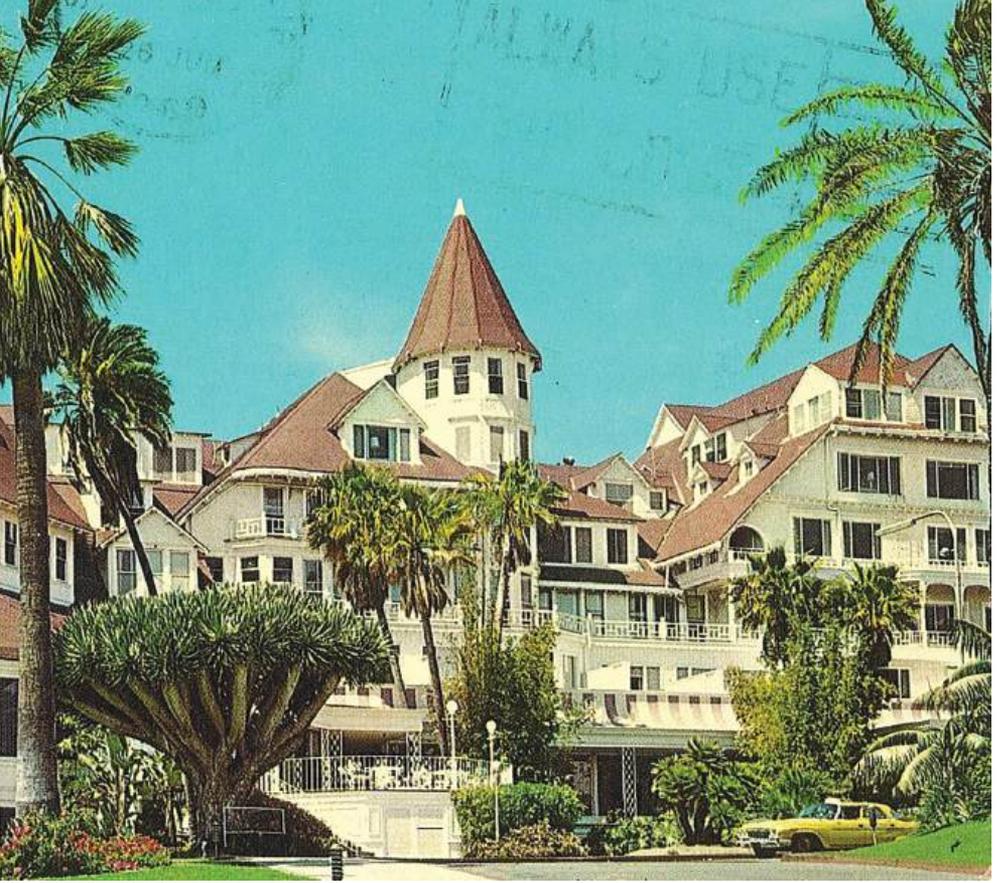
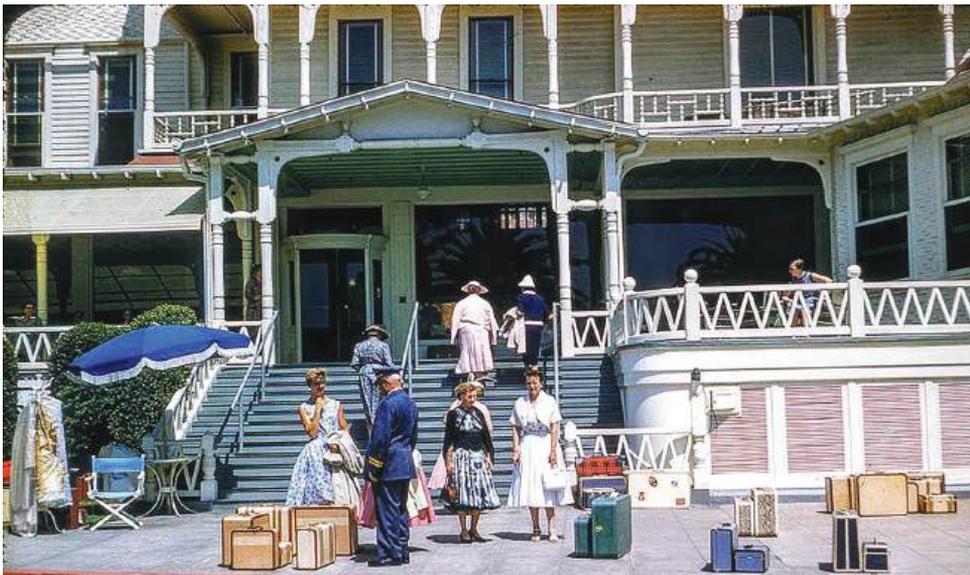
Top Postcard of the south facade, c. 1960. Note the extended ballroom, additional picture windows, added deck with metal railings, and extended veranda. *Bottom* Entry veranda, c. 1950. Note the altered “zig-zag” railings, additional picture windows, soffited ceiling, and extended veranda on the left.

Few original windows remained on the south facade. Many had been replaced by larger picture windows as early as 1910, and more windows were added to new walls and roof dormers. The restoration required removing the non-historic windows and replicating the missing double-hung windows to recreate the historic appearance of the facade. While some windows would be restored, more than 90 new windows had to be fabricated, featuring historic details, replica hardware, wavy restoration glass, and custom casings. To match the functionality of the original windows, these replicas also included pulleys, sash cords, and lead counterweights, just like their 1888 counterparts.

None of the original first-floor exterior doors had survived. However, historic photos revealed the original design: three recessed panels in the lower half with a single glass panel above. The discovery of an 1888 panel door on the third floor provided the original molding profiles to serve as the basis for duplicating the restored entry.

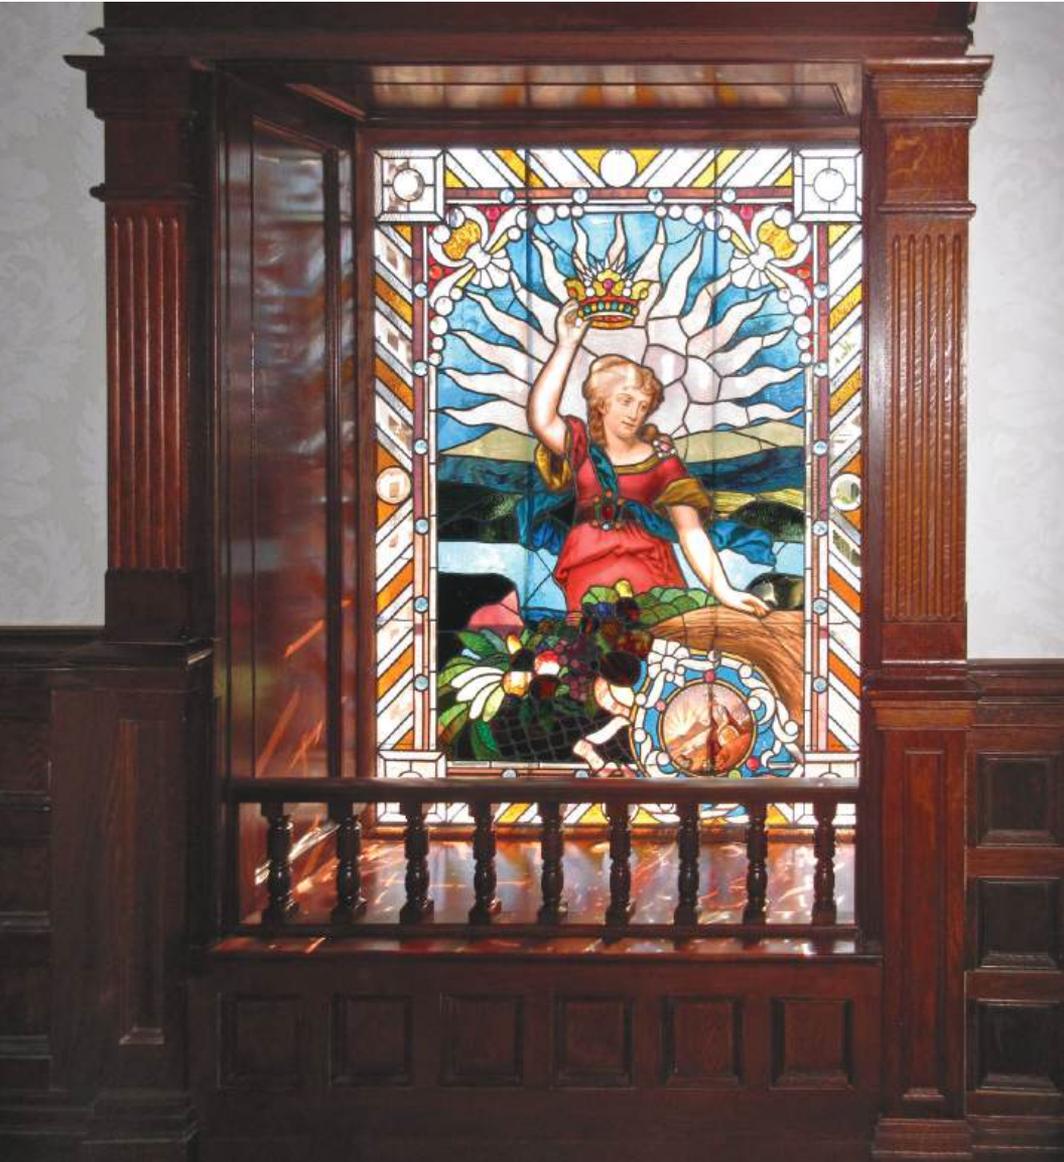
Described by its designer, architect James Reid, as an “allegorical representation of Coronado,” it features a landscape background symbolizing “mountains, valleys, and a bay.”

The window is referred to by two names: “Coronado,” inspired by 19th-century promotional literature and the imagery it depicts, and “Coronation,” as mentioned in an 1880s *San Diego Union* article. Regardless of which name is used, there’s no dispute that this window is the crowning jewel of The Del’s collection of 25 stained-glass windows.

The window was carefully removed and transported to Bera Stained Glass Studios, where it underwent a full restoration. It was then reinstalled in its historic location, properly oriented, and framed by replica chimney bricks.

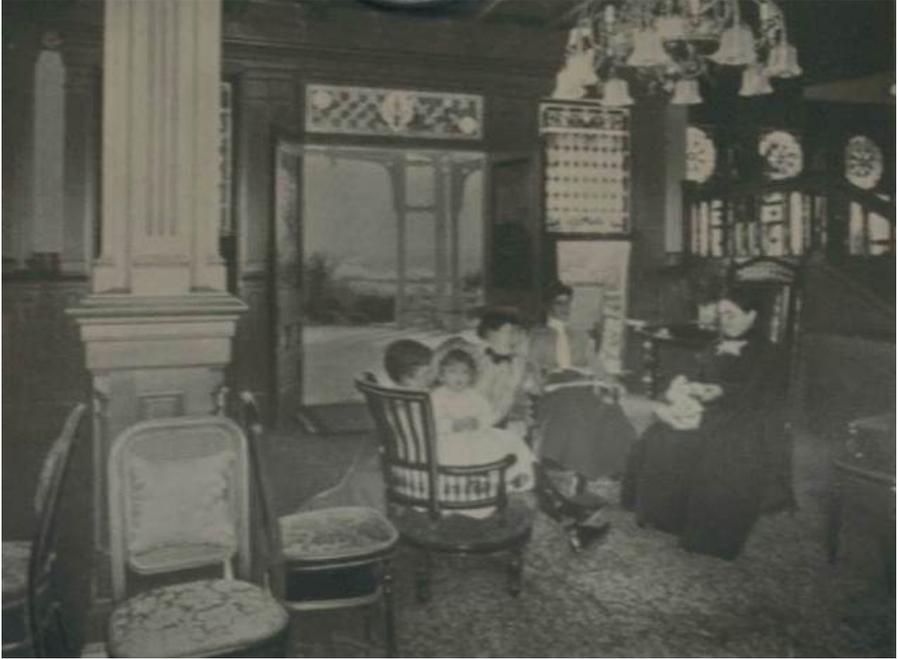
This 1890s low-resolution historic interior photograph of the ladies' parlor highlights the challenge of designing the new windows using early images. The image offers a glimpse into the building's past architectural elegance and serves as a reminder of the hotel's rich visual heritage.

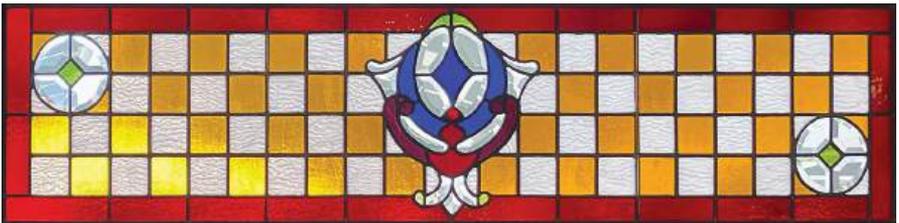
The transom and larger window (right) are the result of the team's careful analysis of historic photos, paired with their knowledge of 19th-century window design and expert judgment. The interplay of color, light refraction, and subtle fragmentation creates a dynamic effect, transforming the way light passes through the glass.

This vividly colored stained-glass window features geometric patterns, floral designs, and jewel insets. The process starts with a drawing, known as a cartoon, which guides the meticulous selection and placement of colors. Pieces of colored glass are cut and assembled, with lead strips holding the pieces together.

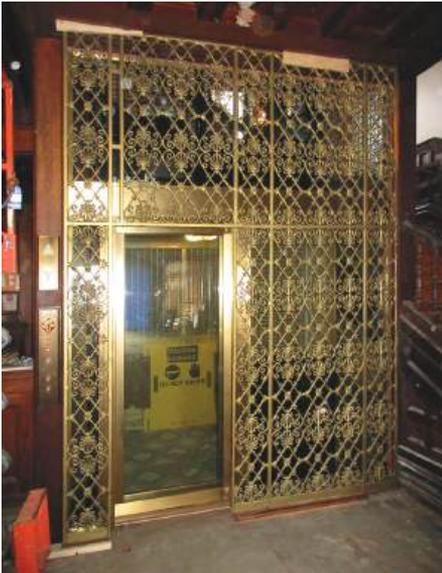
Before

Facing page left A decorative metal grille was installed at the lobby elevator in the 1960s and was not historically appropriate. *Right* Originally, the elevator shaft had simple screens, as seen in the historic photo. The elevator rehabilitation incorporated a recreation of the original lobby screen.

Not to be left out, the iconic 1888 birdcage elevator also underwent rehabilitation. The non-historic metal accordion-style gate was replaced with glass panels that meet modern safety codes. The original open, screened elevator shaft was preserved to maintain its historic feel.

The screens, with their simple grid design, twisted bars, and chicken wire backing, remained mostly intact except for the first-floor south-facing entry. The decorative metal grille added to the lobby in the 1960s was historically inaccurate and has been replaced with a replica of the original.

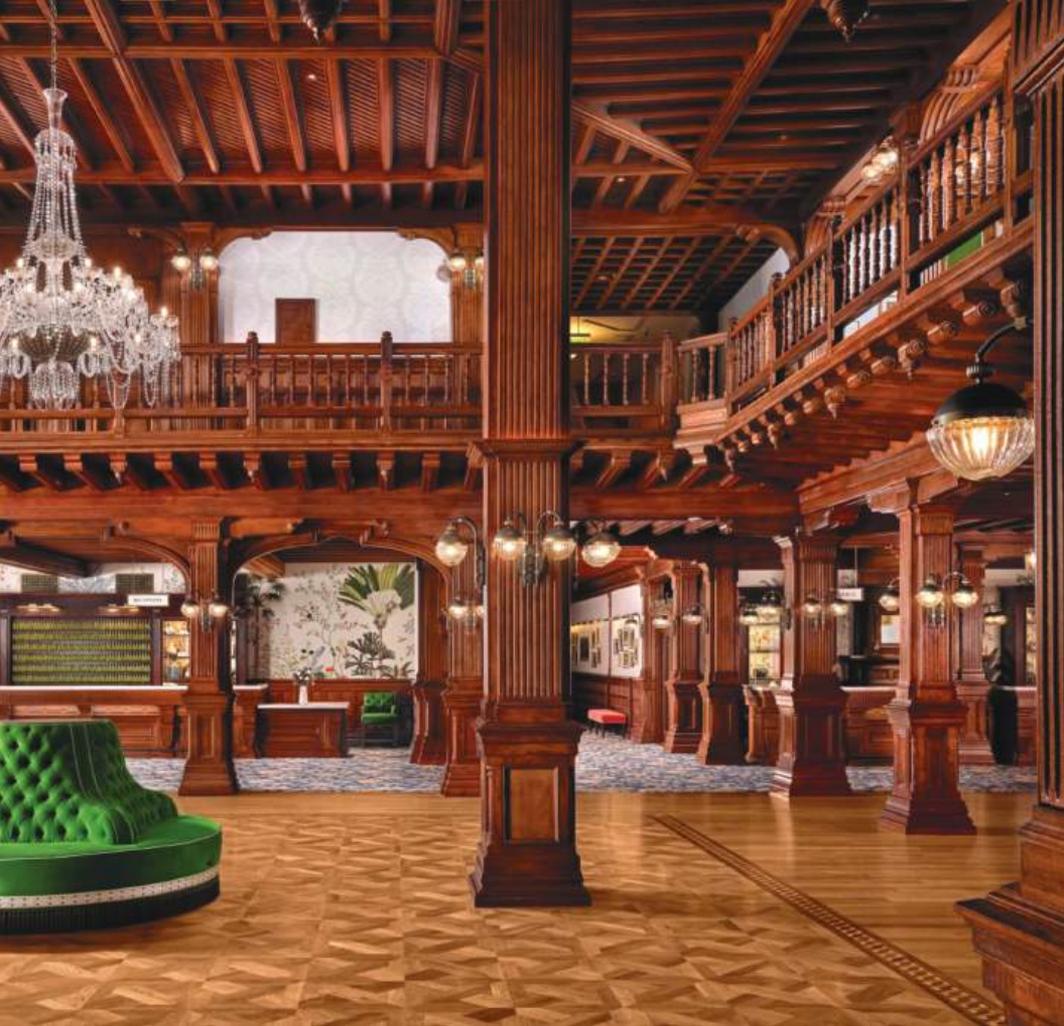
Above The restored and enlarged lobby and front desk, looking west.

The current front desk area was originally the ladies' billiard room, featuring an ornate fireplace and many decorative elements, most of which were removed long ago. However, the room's white oak coffered ceiling remained intact. As new steel beams needed to be added to make the area column-free, the two original ceiling bays were reinstalled after the infrastructure work was completed.

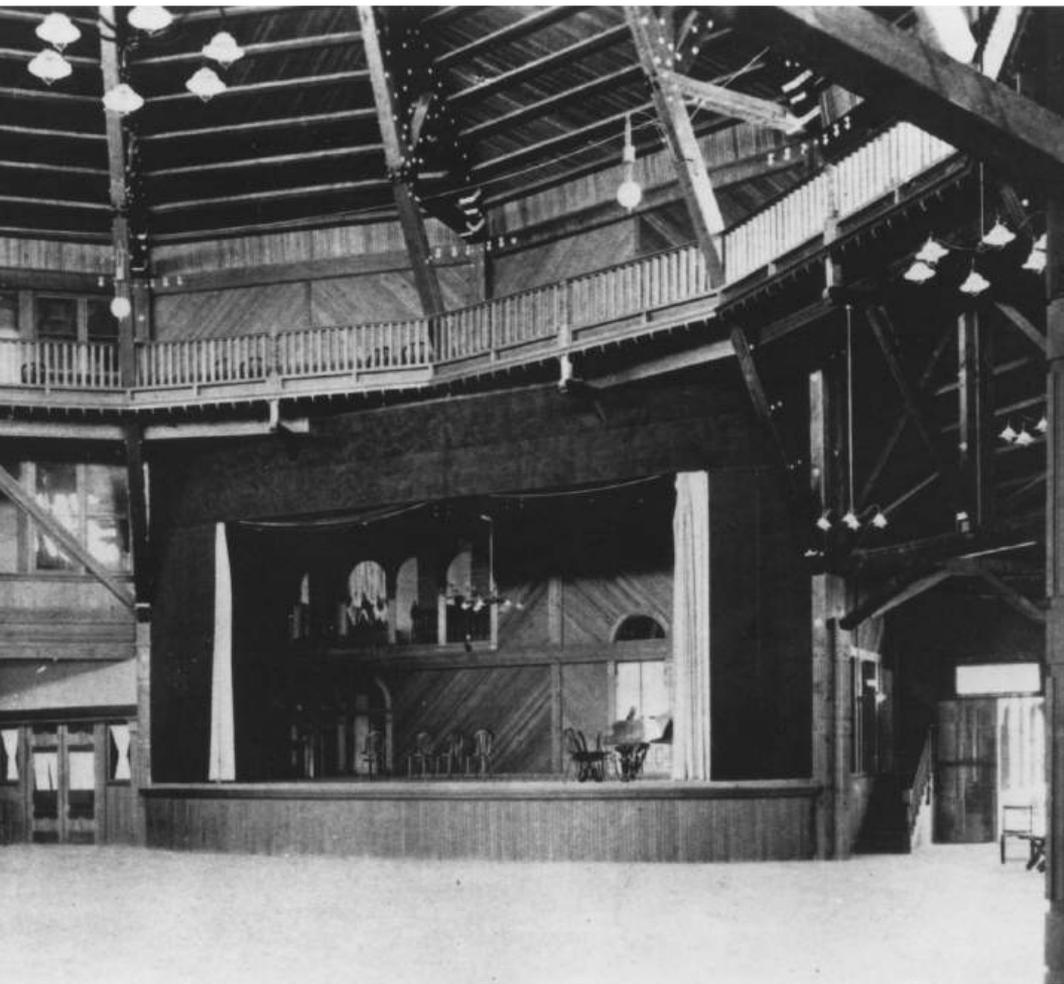
The ballroom as it originally appeared c. 1900s before modifications.

By 1931, convention demand had outpaced the Ballroom’s size, and “extensive alterations were done, including an extension of 15’ on three sides.” By the mid-20th century, remodeling decisions dictated a smaller interior space with the ceiling lowered.

In 2024, the Ballroom underwent a thoughtful refresh, which included the removal of some non-historic elements, updated wall coverings and carpeting, and the removal of a non-historic back-of-house area to expand the floor space. The historic stage was also carefully restored.

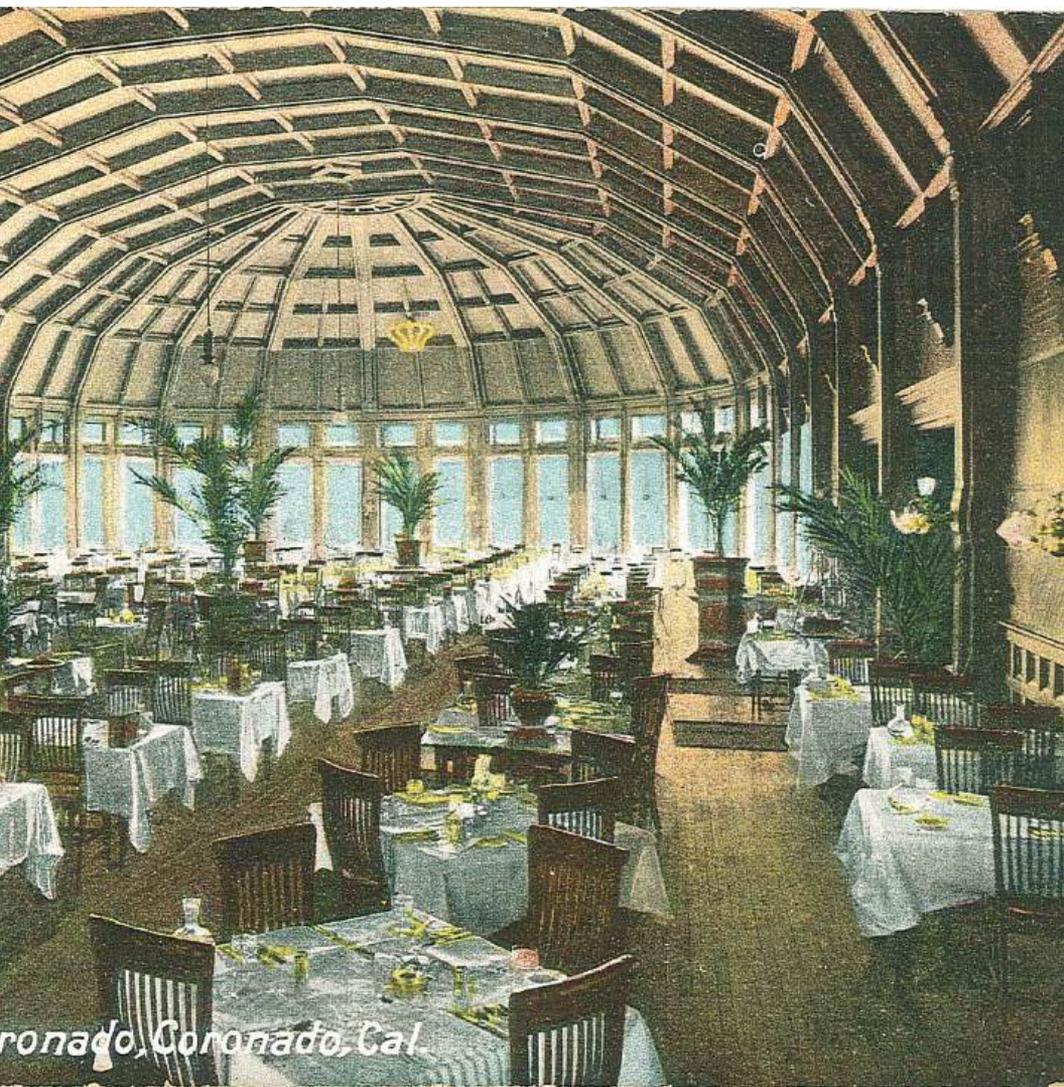
Postcard image, c. 1890

Once The Del's main dining room and the setting for grand celebrations hosted for presidents and royalty, the Crown Room has been lovingly restored. This restoration involved refinishing the original wood, uncovering and repairing the historic entry doors, upgrading the electrical systems, and installing new speakers, carpeting, and wall sconces.

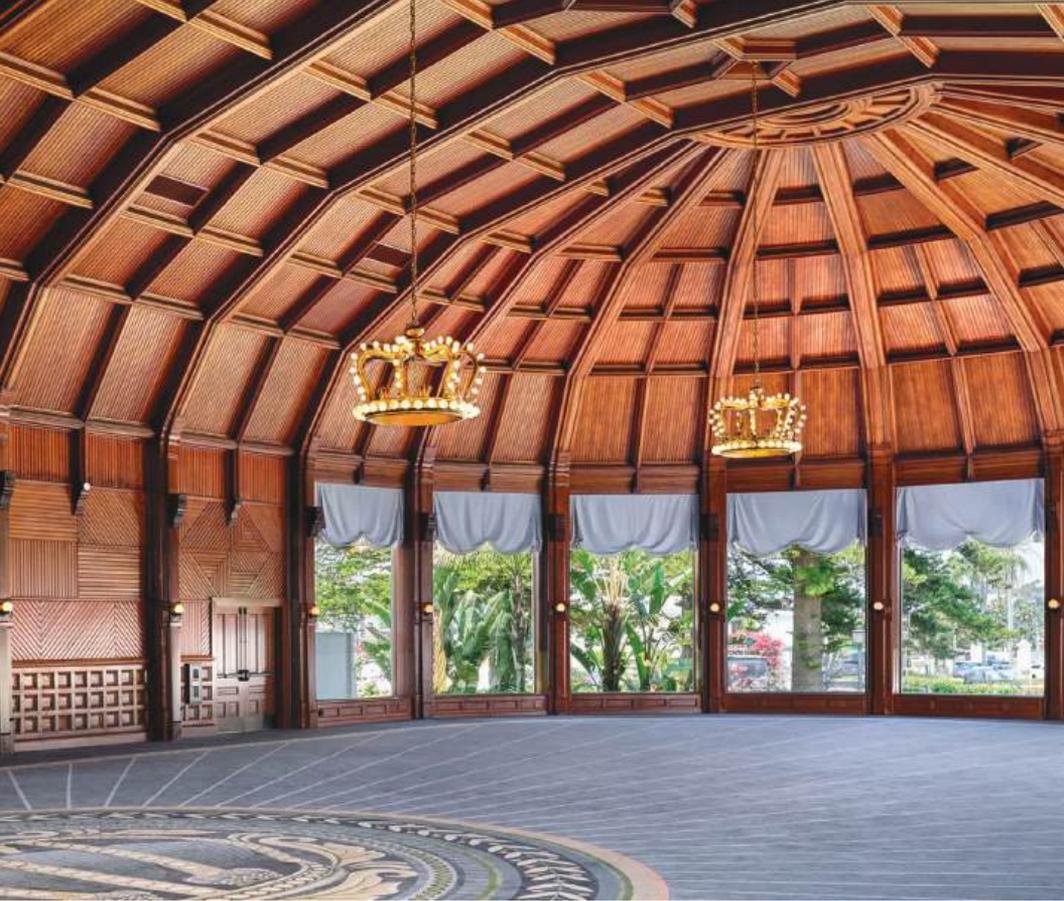
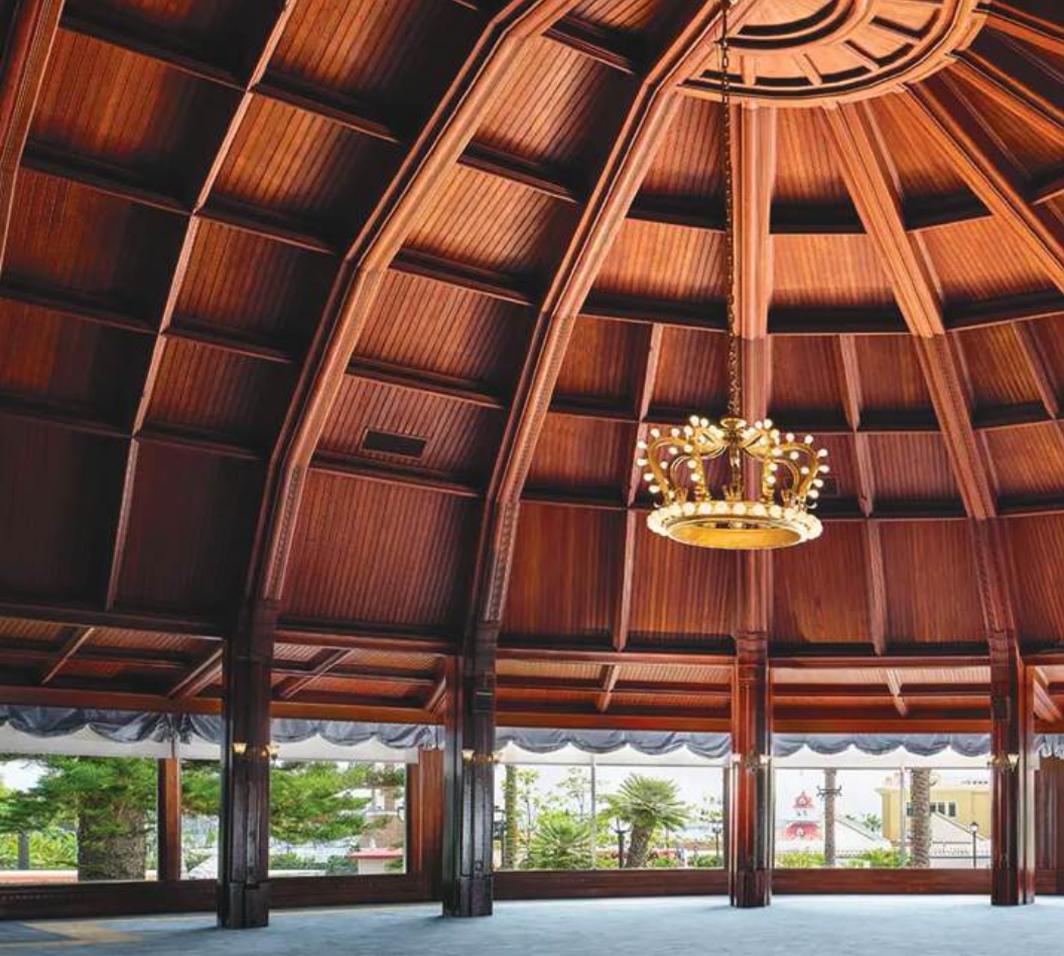
Before

In addition, the Crown Room's balcony was carefully restored, along with extensive rehabilitation of its historic wood finishes, which required stripping, repairing, and re-staining the surfaces to their original beauty. The iconic crown chandeliers, first installed around 1911, were also refurbished as part of the meticulous restoration.

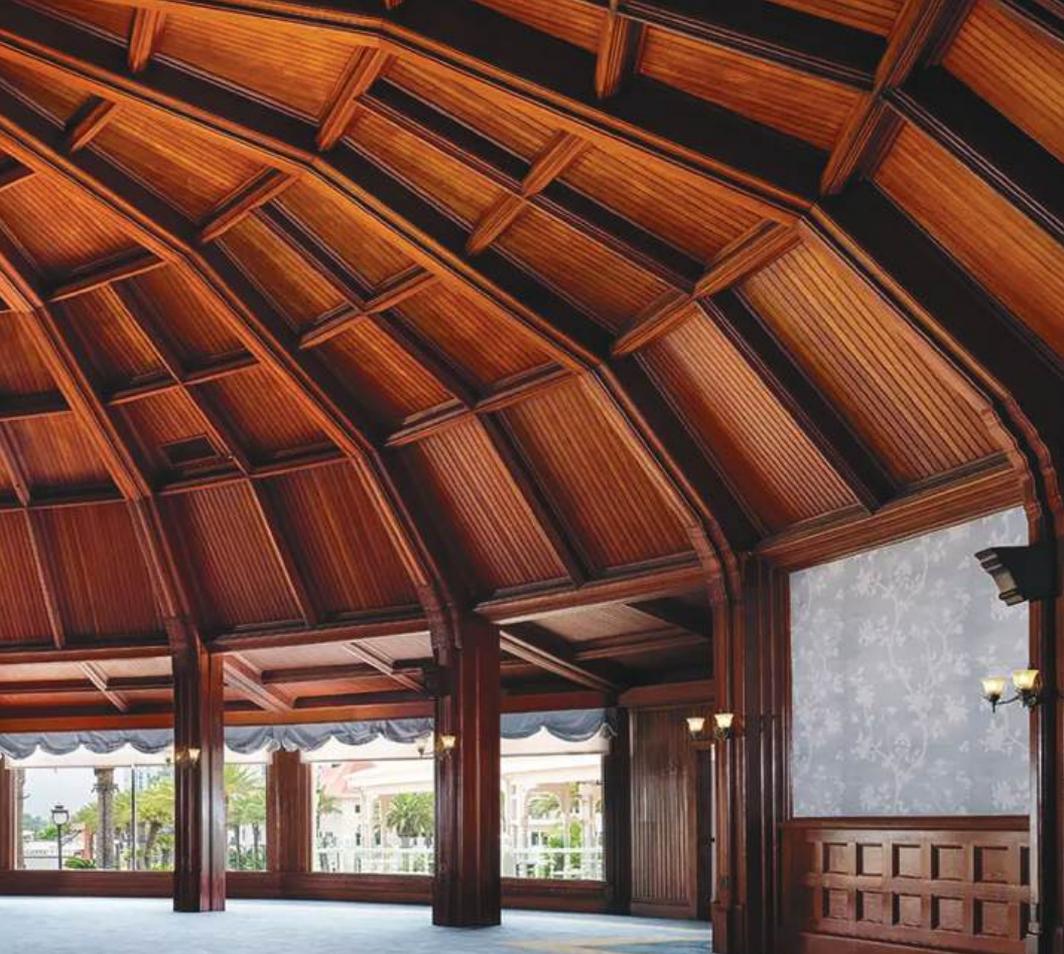
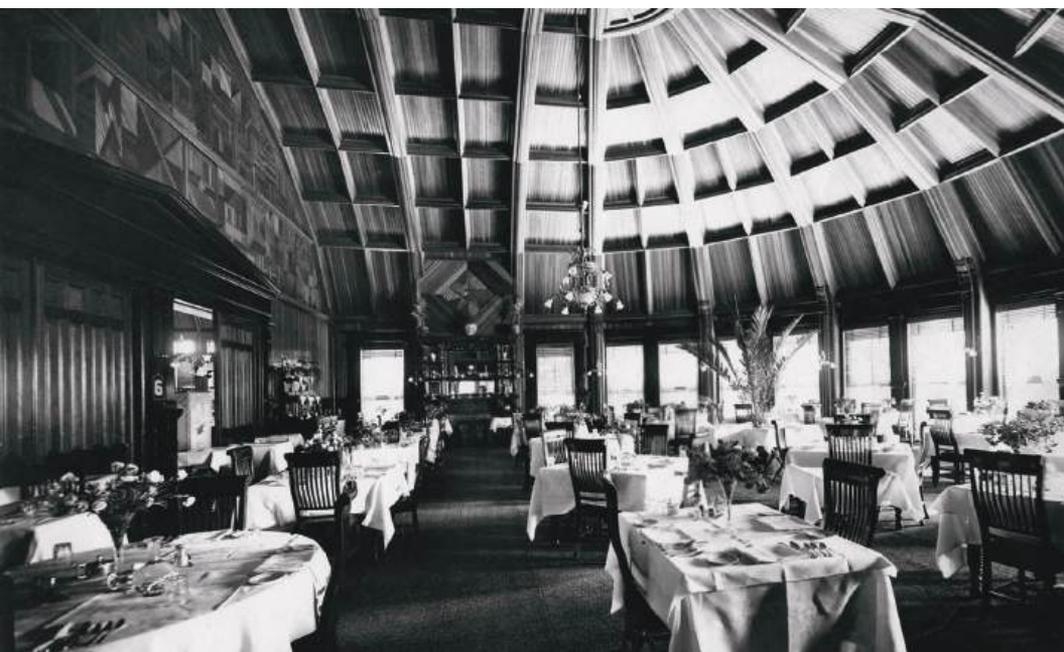
The adjacent Coronet Room, originally used for breakfast, is a more intimate version of the Crown Room, boasting its own stunning architectural features, including a vaulted wood ceiling, a single crown chandelier, and floor-to-ceiling windows. During the restoration, the Coronet Room's historical coffered wainscot was recreated, and its original wood doors were restored to their former grandeur.

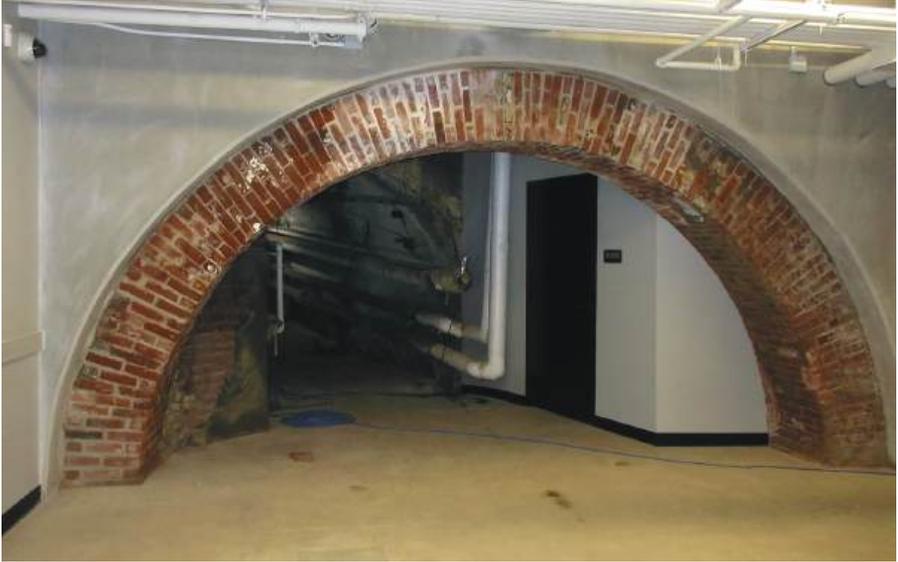
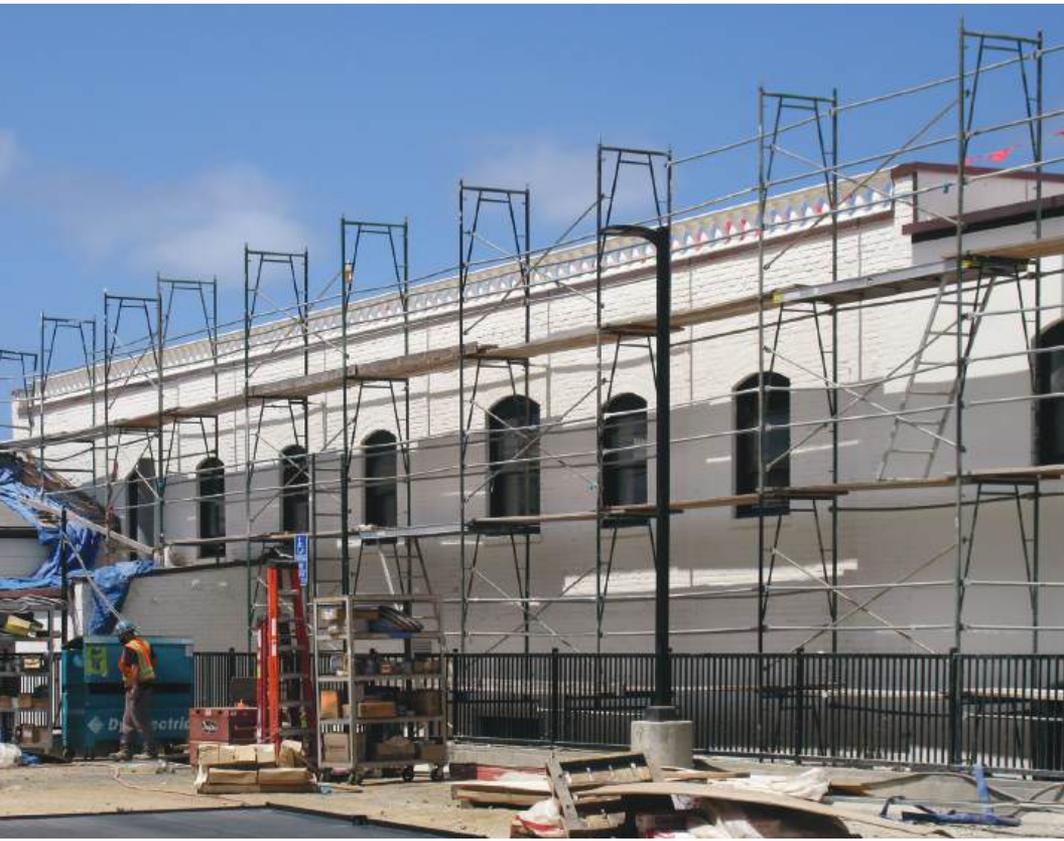
Above Service tunnel; *facing page top* During restoration; *bottom* Adaptive reuse of the interior

The electrical generating plant was powered by two Corliss steam engines, installed by Mather/Westinghouse, pioneers of the alternating current (AC) electrical system still in use today. In 1888, electricity was still a novelty, and The Del is considered one of the largest buildings in the country to have been electrified so early. Upon opening, the power plant was hailed by the *San Diego Union* as the “Largest installation of its type in the World” and once supplied electricity to the entire City of Coronado. Today, it provides offices and meeting rooms for staff training.
