History Uncovered

The Hotel del Coronado Restoration

A commemorative publication celebrating the restoration, rehabilitation, and preservation of the historic Hotel del Coronado.

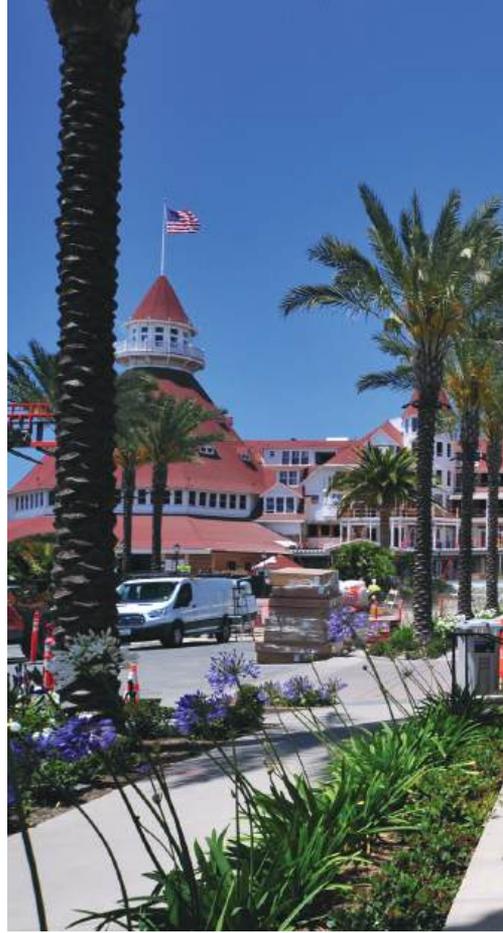
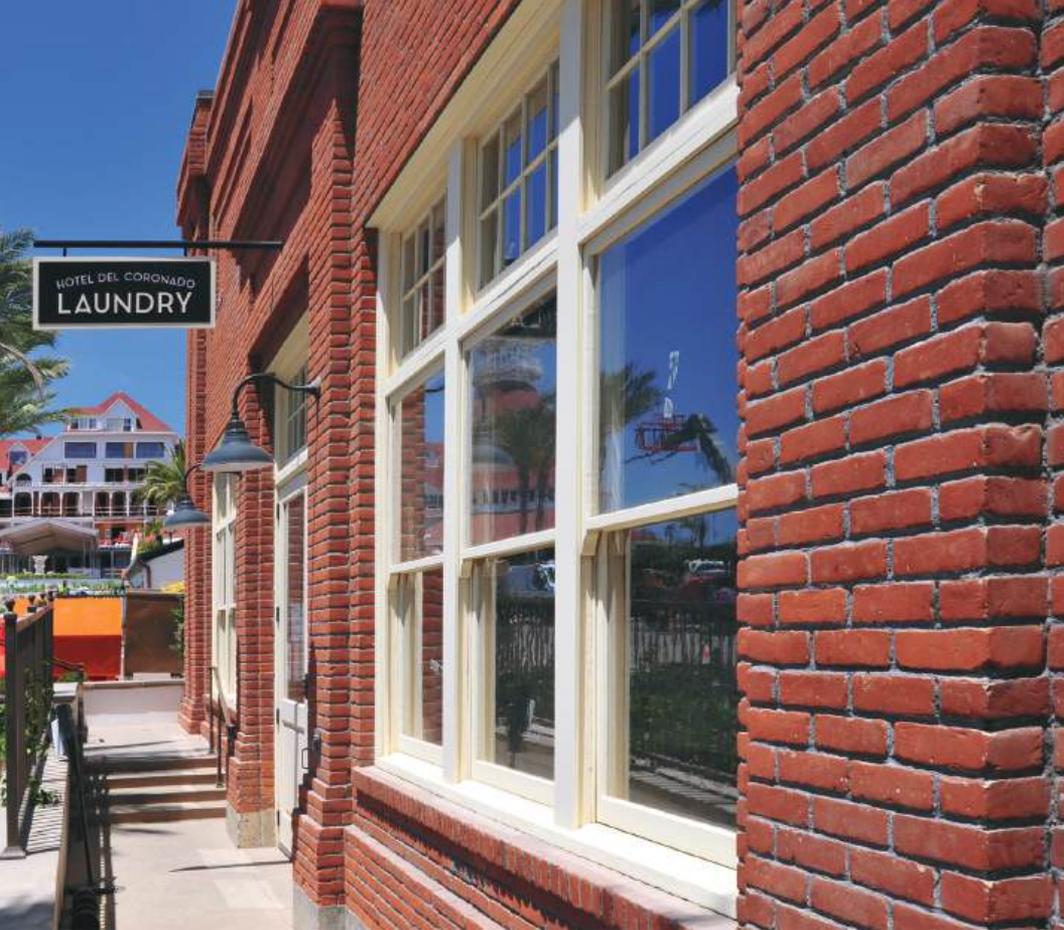
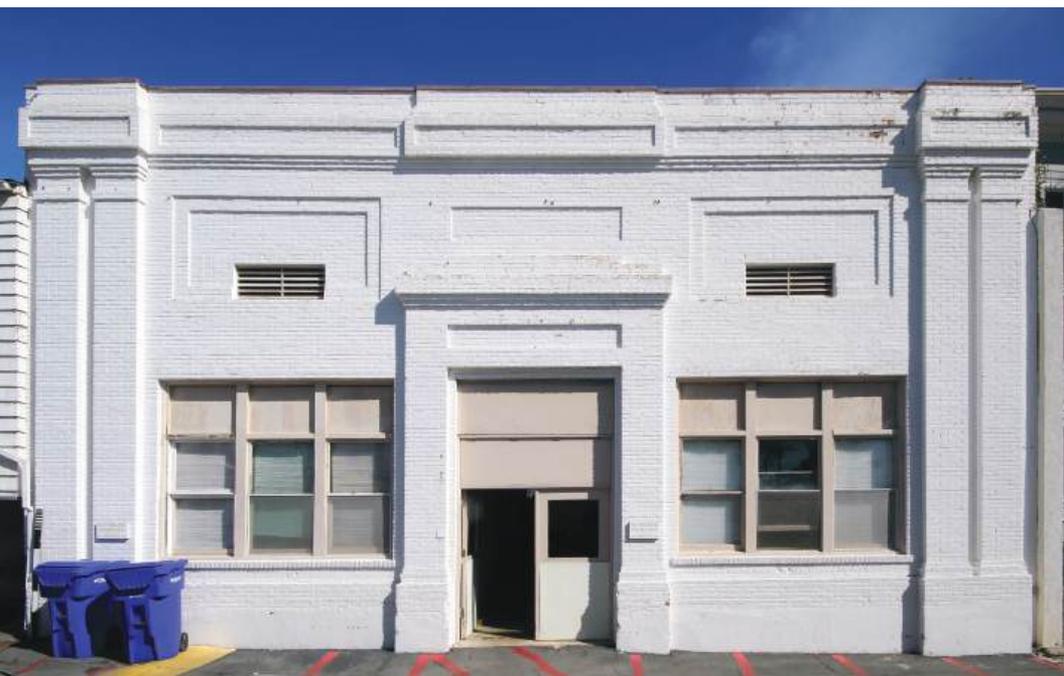
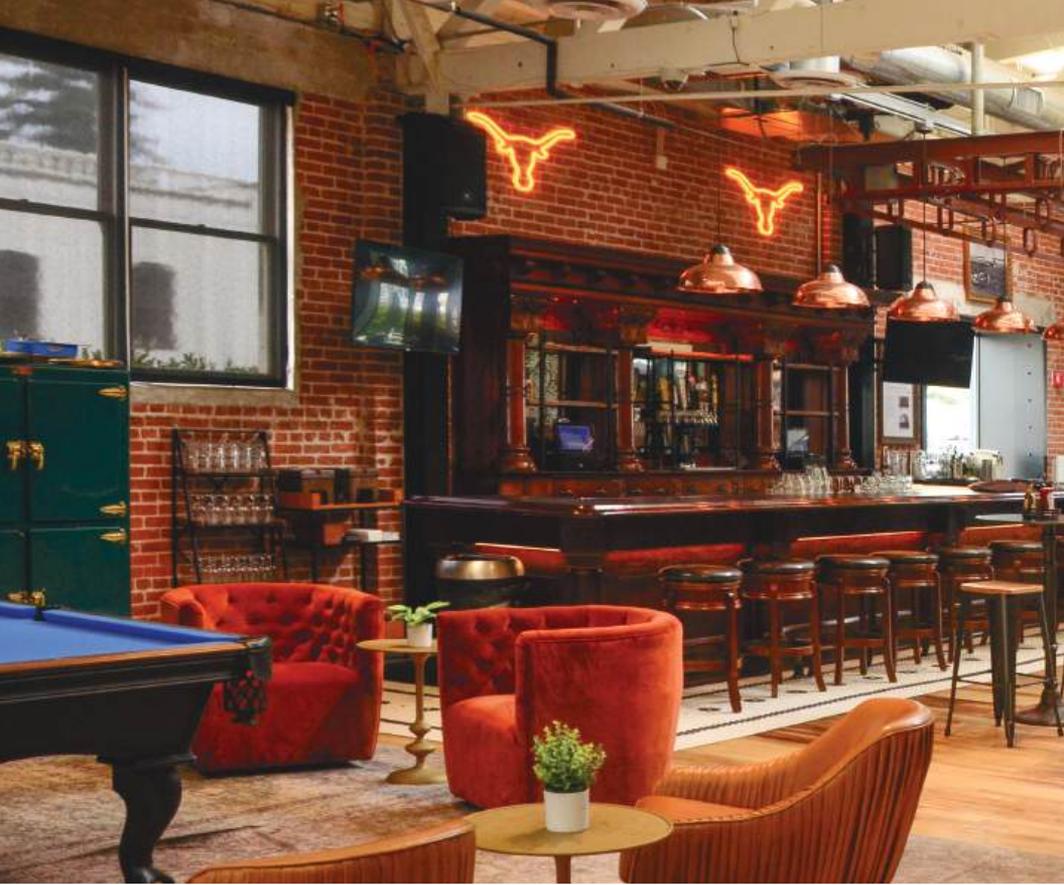
The interior renovation included light, steel-framed windows to fill large obsolete openings, while interior birch plywood paneling contrasts with the refurbished brick exterior walls. Two original interior rooms remain, and the historic overhead laundry conveying system was kept intact to honor the building's history while providing a unique conversation piece.

Painted white as seen in the before image below right, exterior restoration work included returning the brick to its original unpainted finish, repairing and reglazing old wood windows, and recreating the signature laundry sign.

All new features were designed to be obvious modern additions, so as not to detract or interfere with the historic components, and if ever removed, the building's historic integrity would not be compromised. The restored laundry building initially served as construction offices, but has been repurposed as the Laundry Pub, complete with a period antique bar.

Above The Laundry Pub; *right* Interior before view with laundering equipment in place. Note the red metal overhead laundry conveying system in both photos.

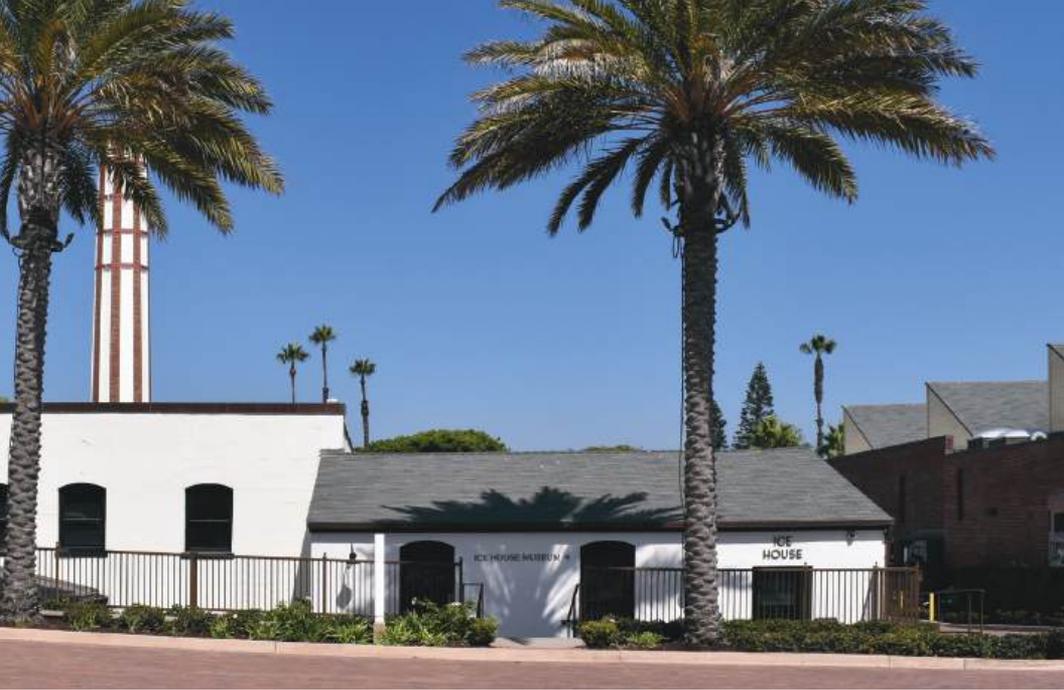
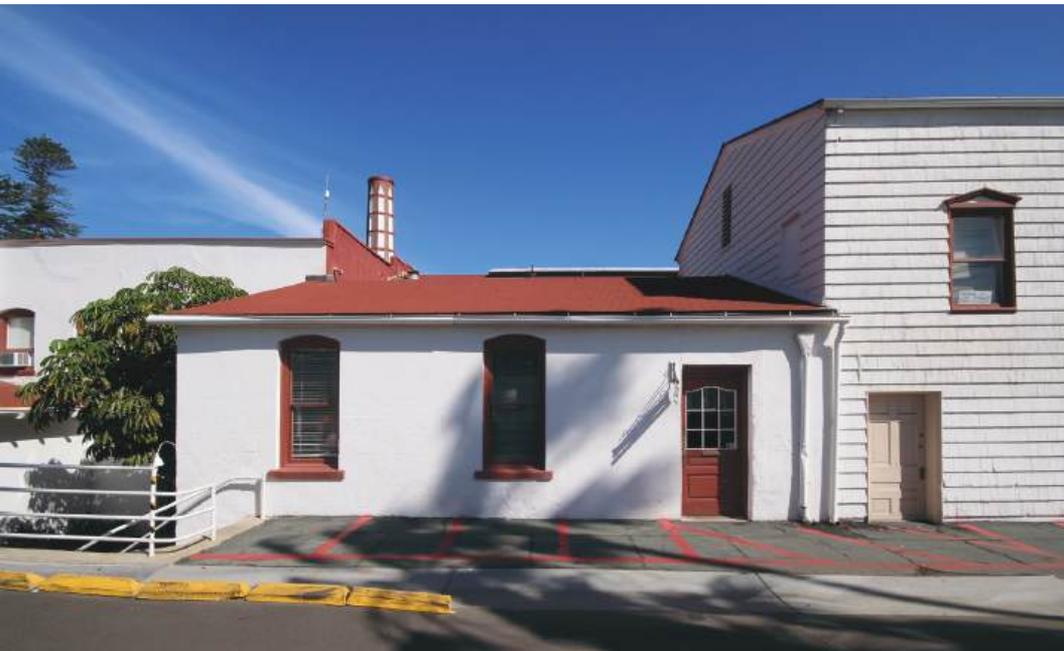
Top View of the power plant building on the left with the smoke stack in the distance, and the ice house on the right; *bottom* View of the ice house before restoration. The two-story building to the right was removed.
