**TWO FORKS IN THE ROAD:
TEST EXCAVATIONS OF THE RANCH HOUSE
AT WARNER'S RANCH
(WARNER – CARRILLO RANCH HOUSE)
AND SITE OF
JONATHAN T. WARNER'S HOUSE AND STORE**

VOLUME I: The Ranch House

JULY 2011

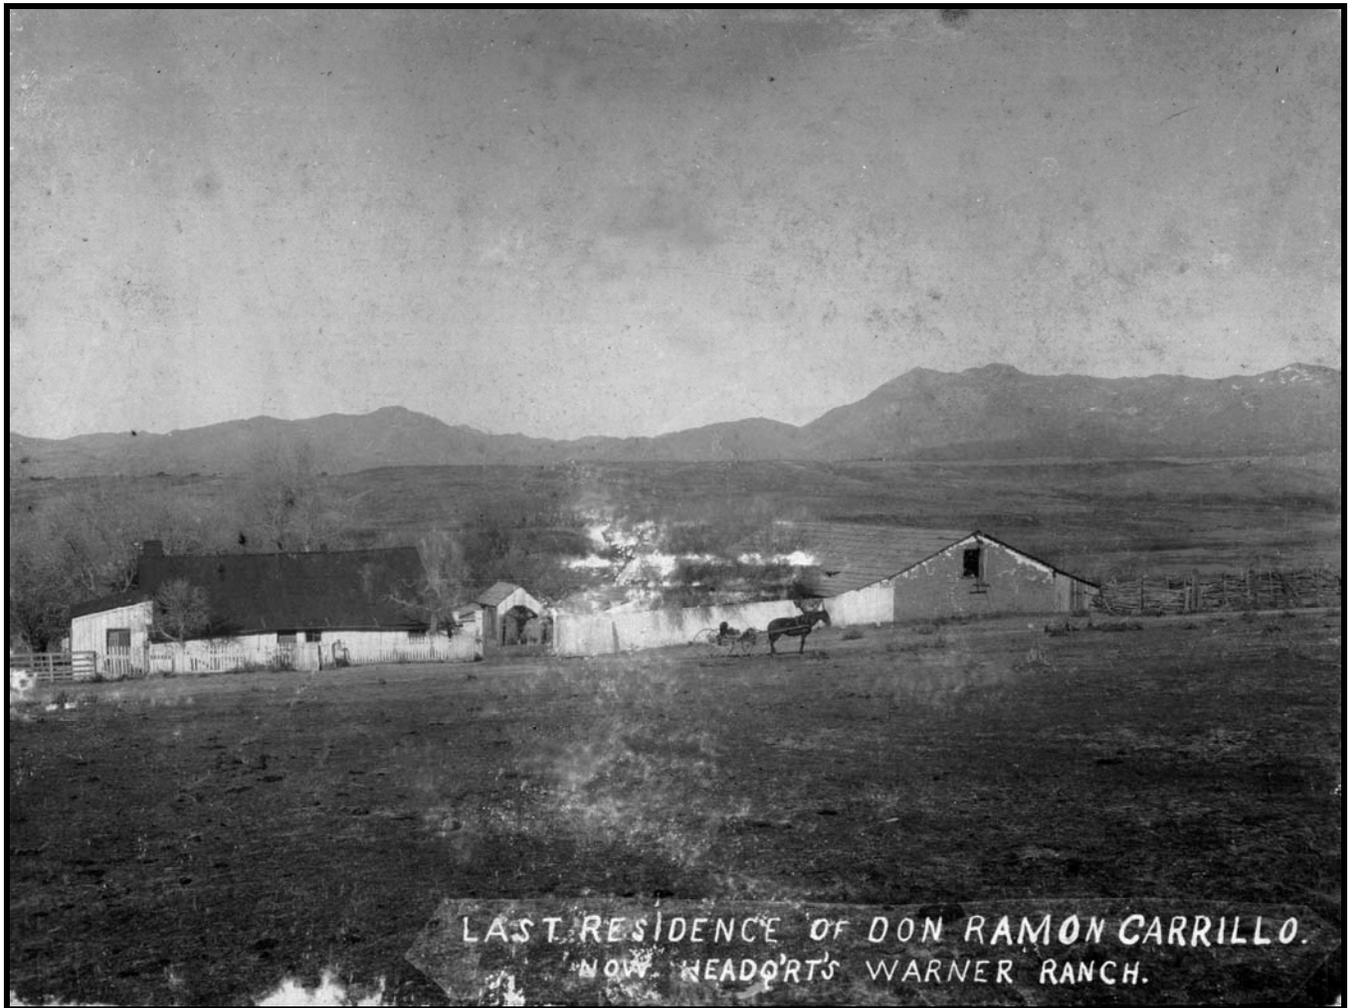
Figure 9: Ranch House at Warner's Ranch and Barn Complex in the early 1890s (Photograph courtesy San Diego County Parks).

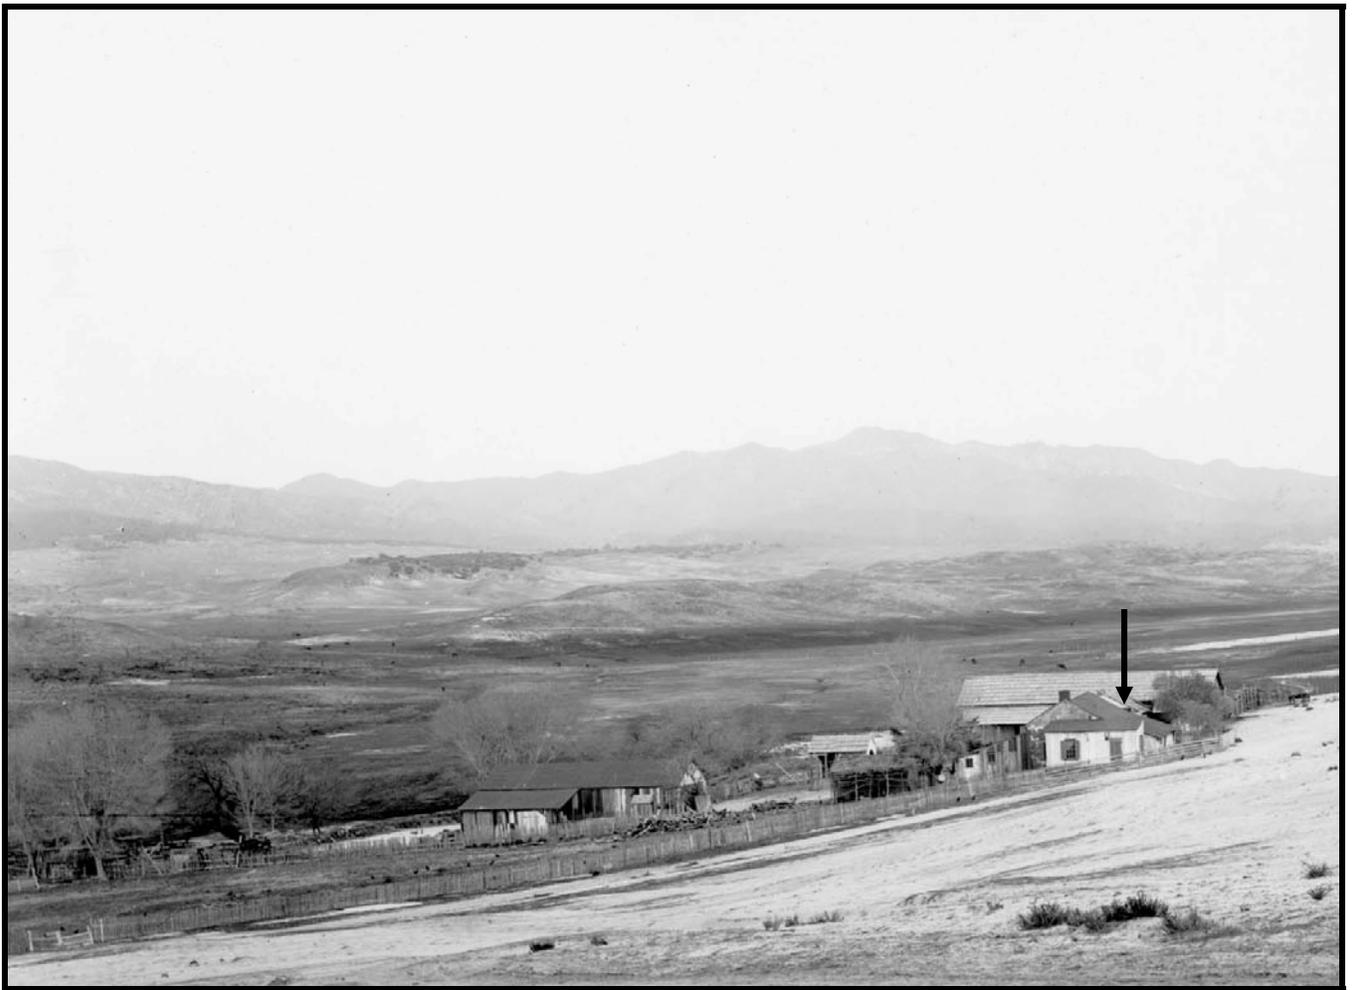
Figure 10: Ranch house and Barn Complex 1894. Note the buildings between the Ranch House and the Barn (Photograph courtesy San Diego History Center).

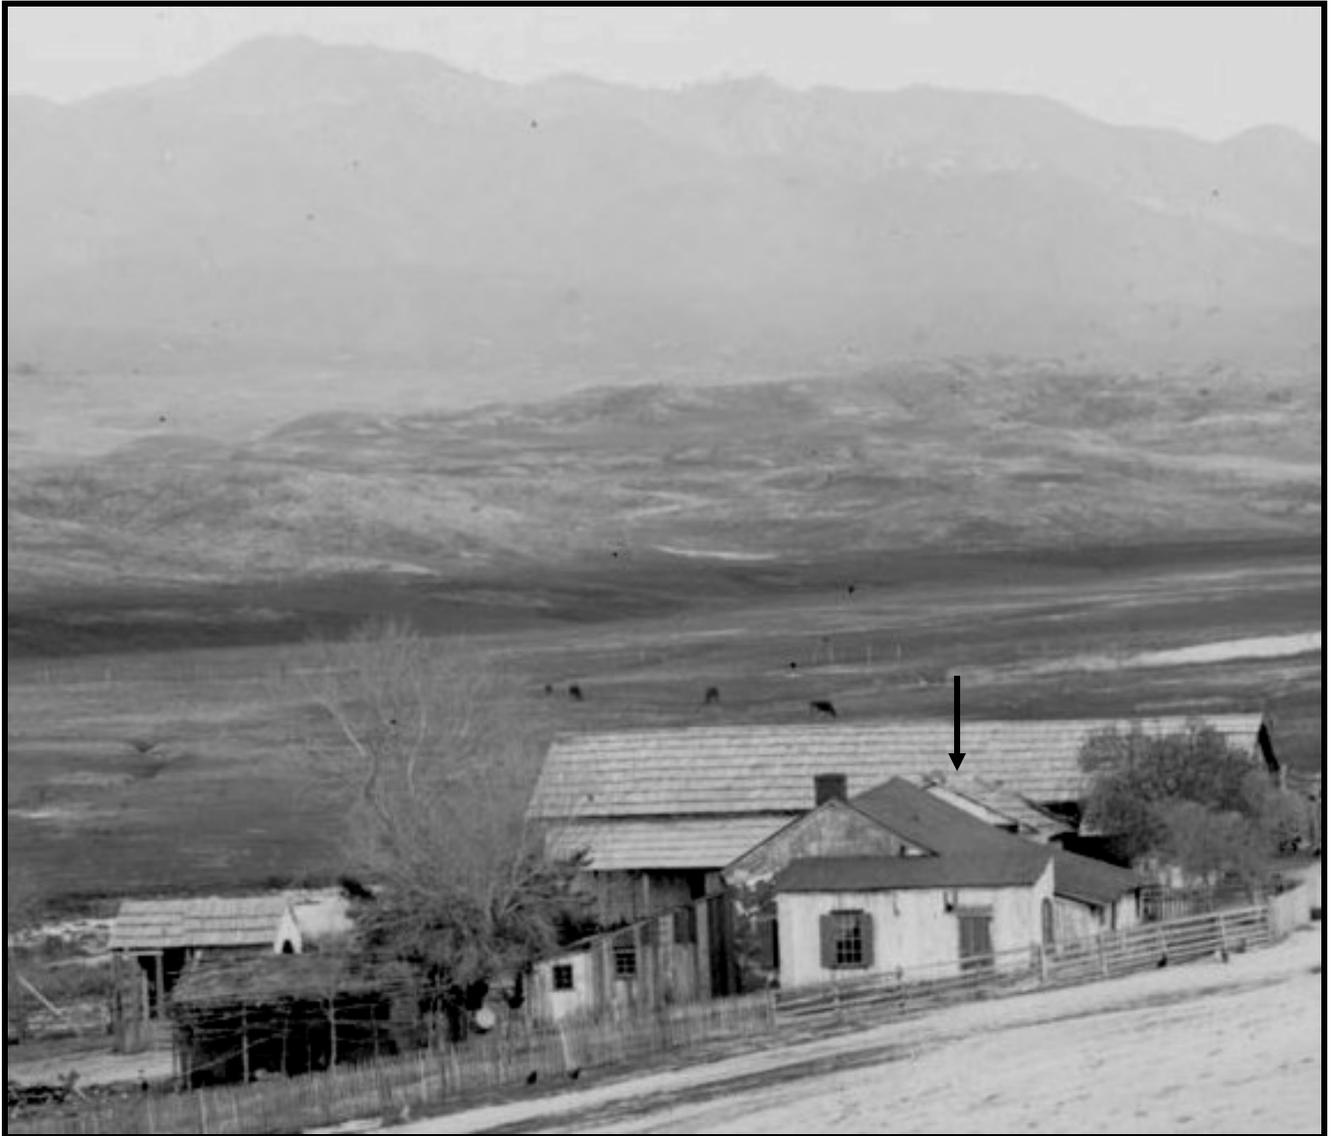
Figure 11: Ranch House and Barn Complex detail from the 1894 photograph in the previous figure. Note the roof line of the large building between the Ranch House and the Barn (Photograph courtesy San Historical Society).

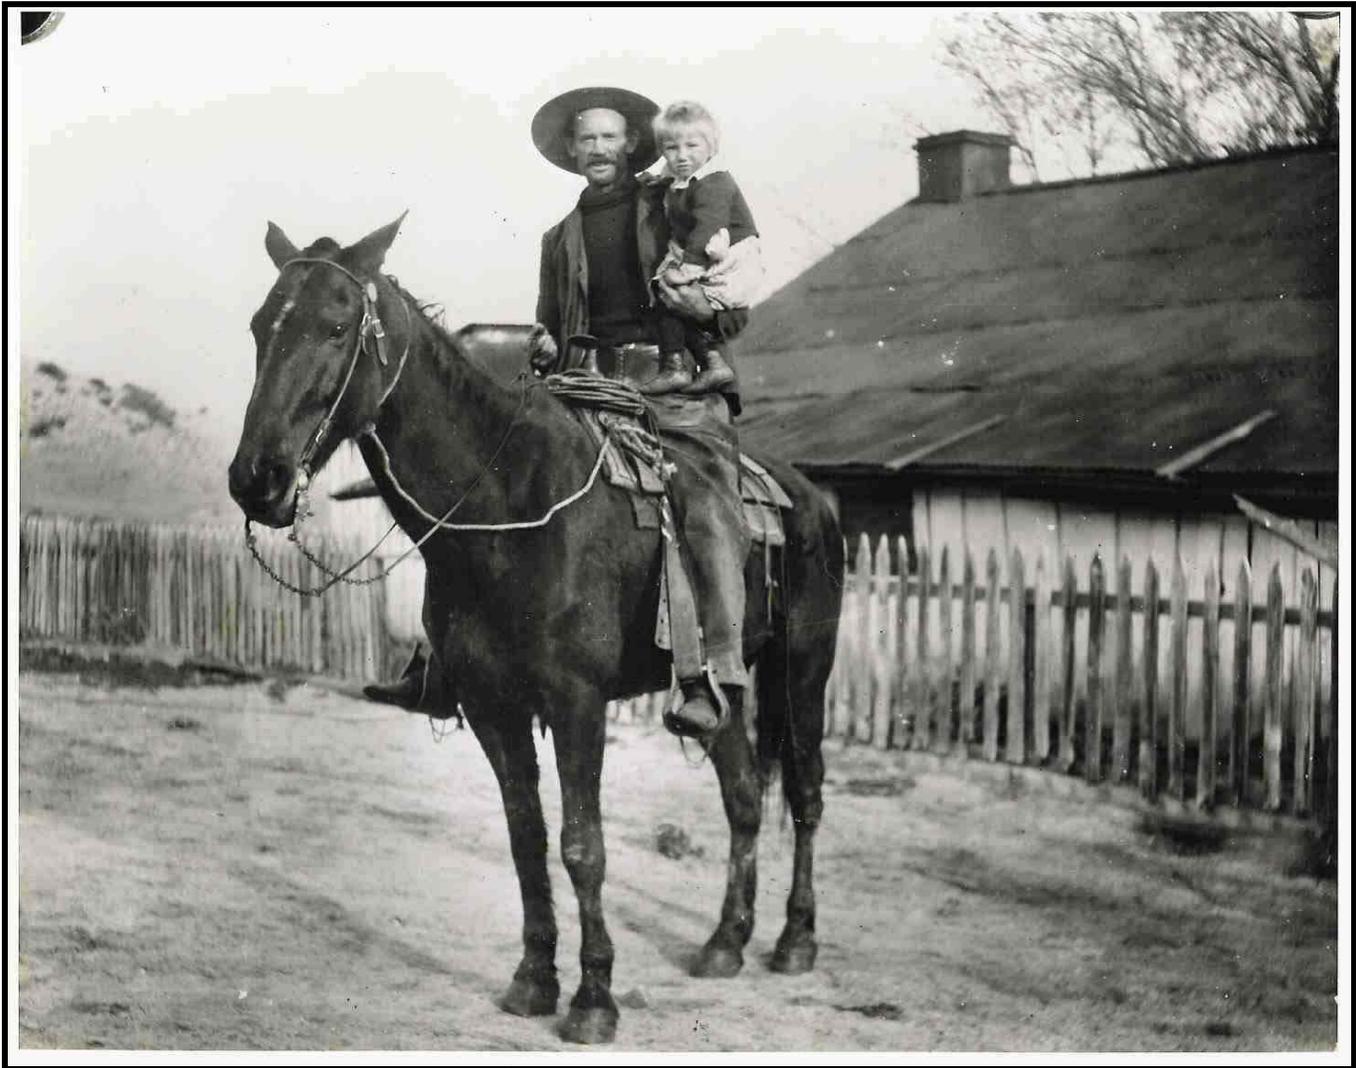
Figure 12: Sam Taylor and son in front of south side of the Ranch House in 1904. Note the picket fence, wood board and batten siding, and corrugated sheet metal roof (Courtesy San Diego History Center).

In addition to the large barn, other out buildings included animal coops and storage sheds as well as a smaller wooden barn located on the north side of the structure. A split rail corral was located on the east side of the large barn and a combination rail and picket fence separated the south side of the compound from the road. By 1910 these had been replaced by a wire fence (Figures 12-13).

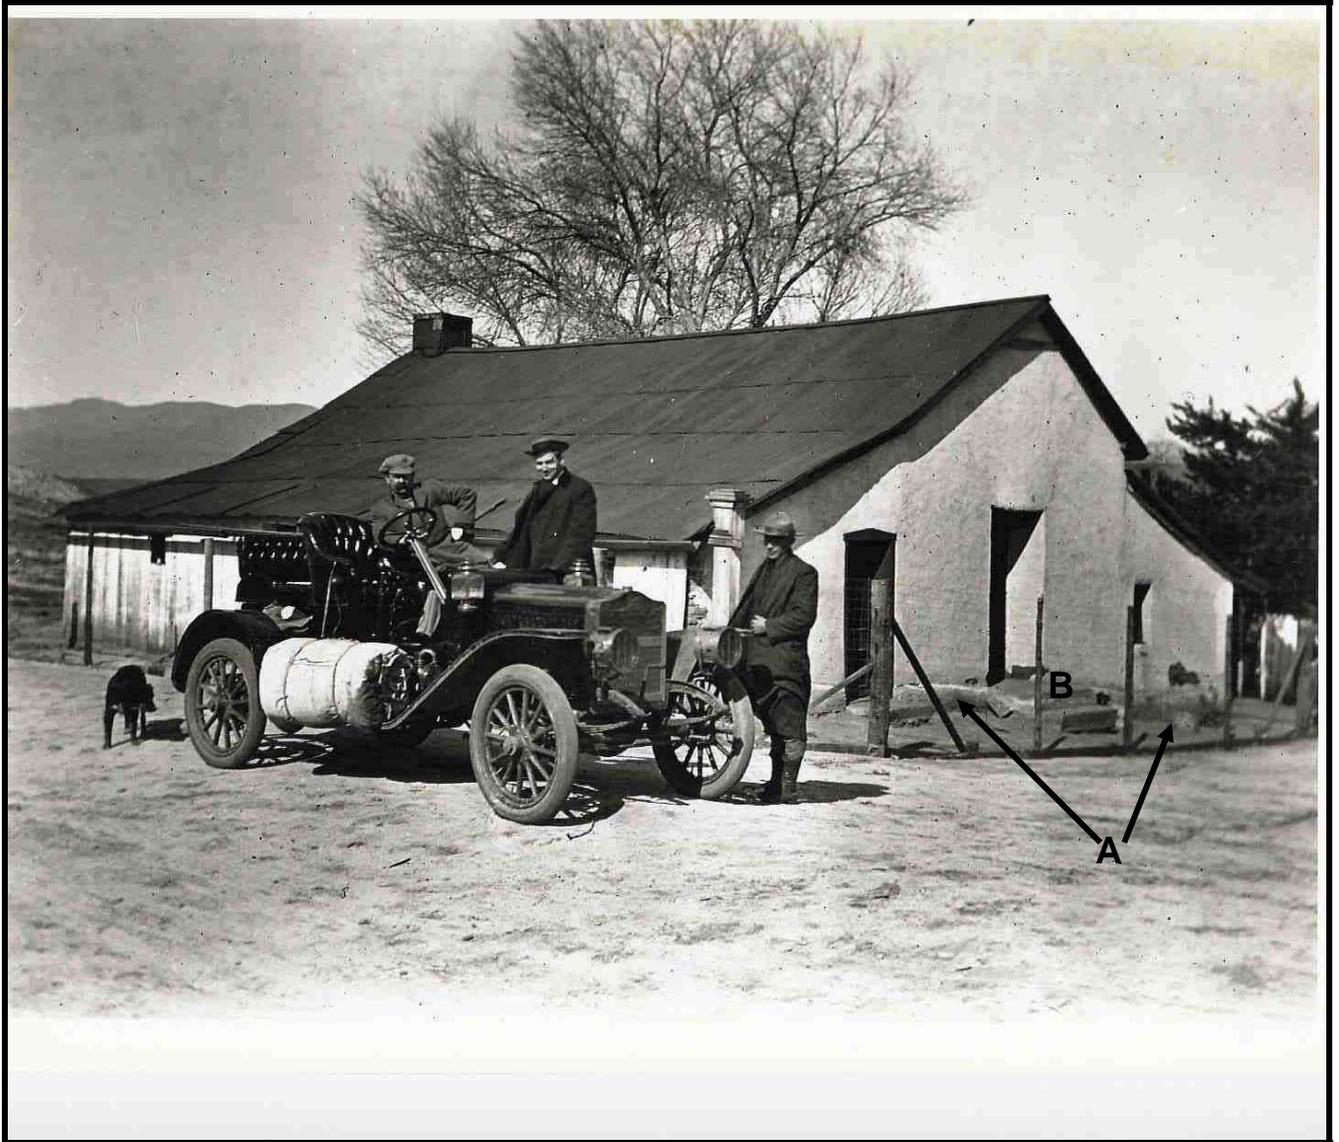
Figure 13: The Ranch House about 1910. The picket fence is gone. Note the board and batten siding on the south side behind the car, the sheet metal roof, the well maintained white wash exterior, the stone facing along the base of the east side (A) and the concrete mortared stone steps (B) (Courtesy San Diego History Center).

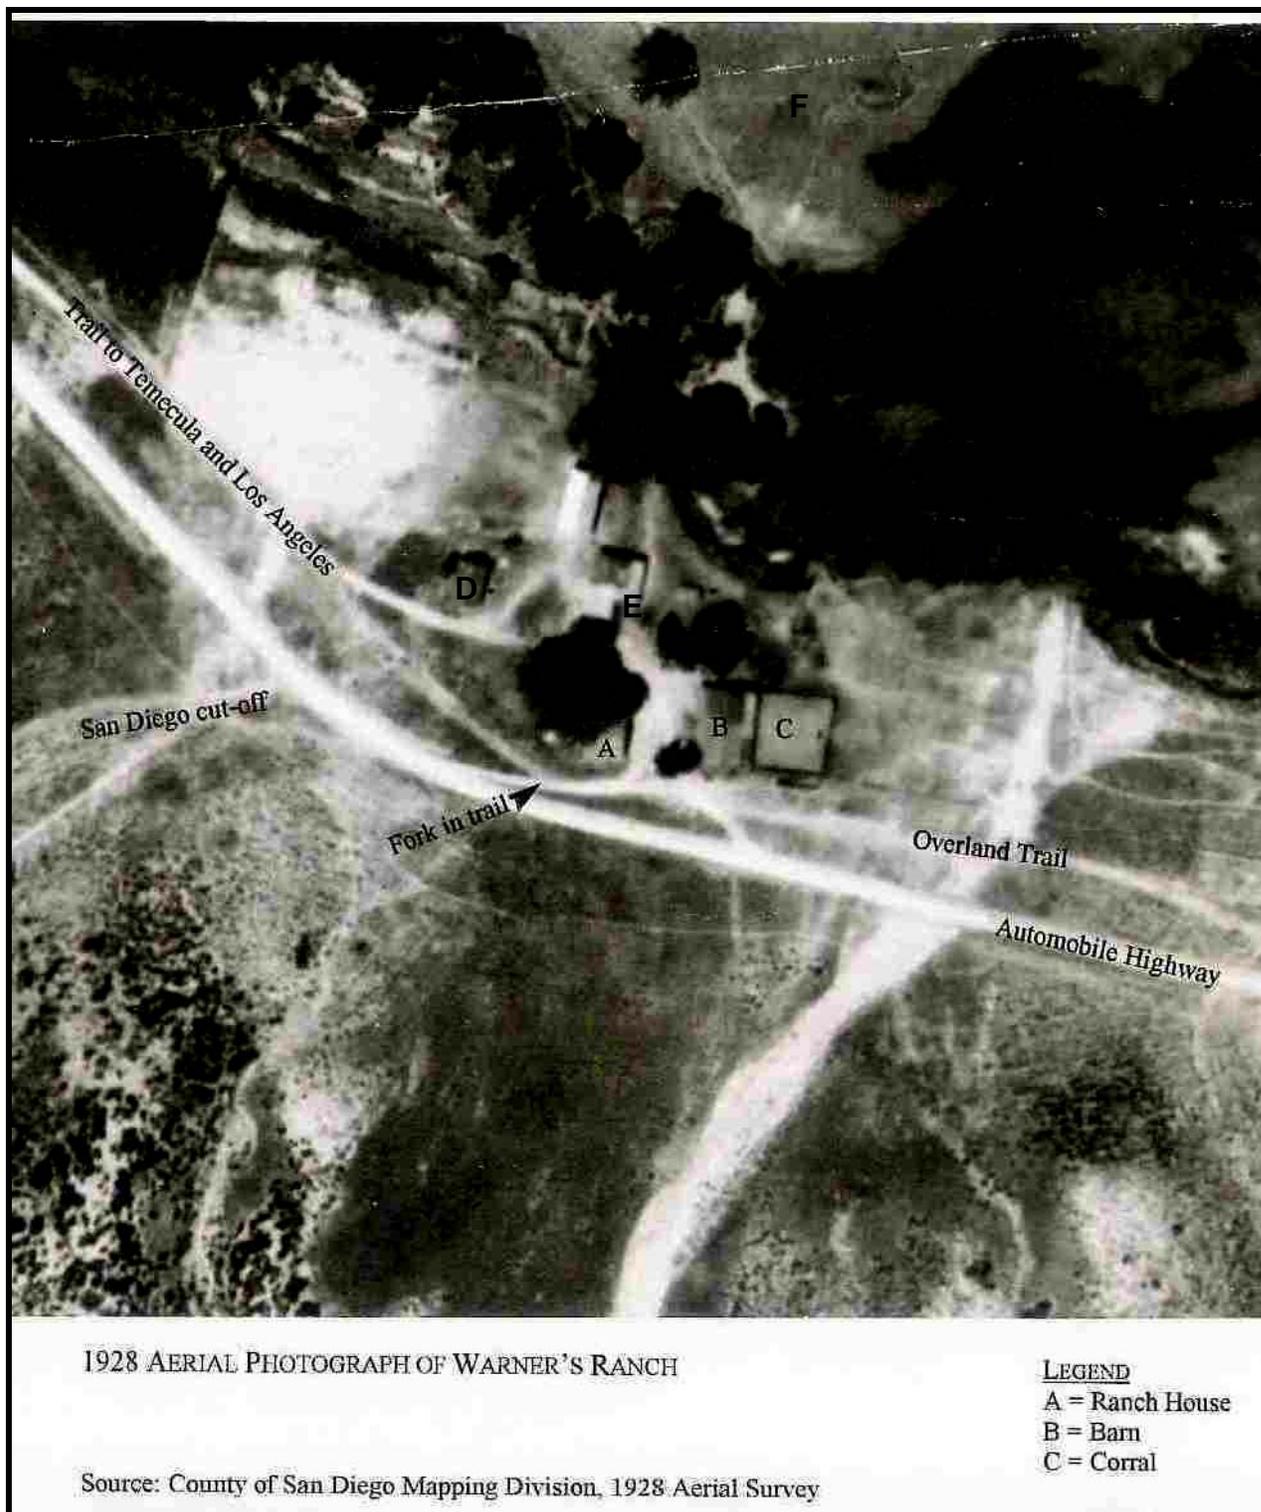
Figure 15: A 1928 aerial photograph of the Ranch House at Warner's Ranch showing the Ranch House (A), Barn (B), Corral (C), Guest House (D), Barns north of the Ranch House (E), and site of Warner's 1849 – 1851 house and store on the north side of Buena Vista Creek (F). The old overland trail along the south side of Buena Vista Valley with the fork in the road and cut-off to San Diego can still be seen.

house had been built to the northwest of the original Warner's Ranch Ranch House. Outbuildings included the large peg timbered barn, corrals, and two additional hay barns to the north of the adobe (Aerial Photograph 1928) (Figure 15). Around 1929 a previously existing hay barn that can be seen in the 1928 aerial photograph to the northeast of the guest house was replaced with a new wood framed barn (Candelaria 1996).

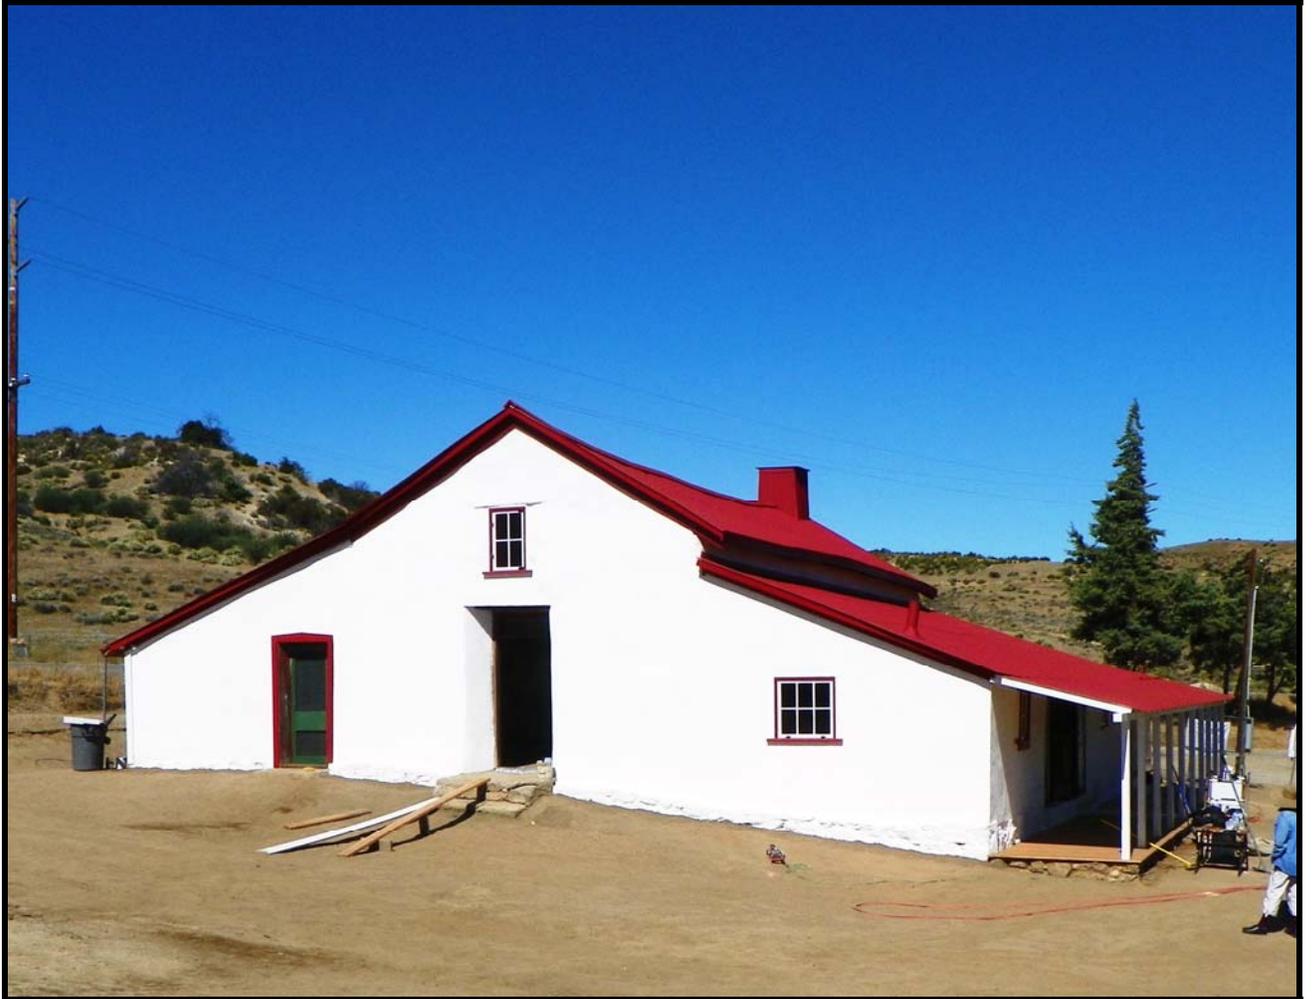
Figure 19: In July 2011, restoration work was completed along the east side of the Ranch House.

Severe weather resulted in continued decline of the building's architectural fabric and by the summer of 2006 SOHO had relisted it on its most endangered list, noting, "It is once again in great danger of loss" (*Reflections* 2006, 2009). In the meantime, fund raising efforts by Vista Irrigation District and San Diego County Parks continued. In August 2010 the Irrigation District Board voted unanimously to spend \$190,000 on the building's restoration allowing them to secure a \$306,000 California Cultural and Historical Endowment grant for the project. Once the building was restored the district planned to partner with Save Our Heritage Organization, to maintain and run the Ranch House as a living history museum (*North County Times* 8-22-2010; *Ramona Home – Julian Journal* 3-1-2011). Contractor Mark Sauer commented that the building would need to be "restored inside out." It had a tremendous amount of fatigue. Many of the walls were damaged or completely gone (*San Diego Union* 3-25-2011). Work began in the fall of 2010 and was completed by early summer 2011 (Figure 19).

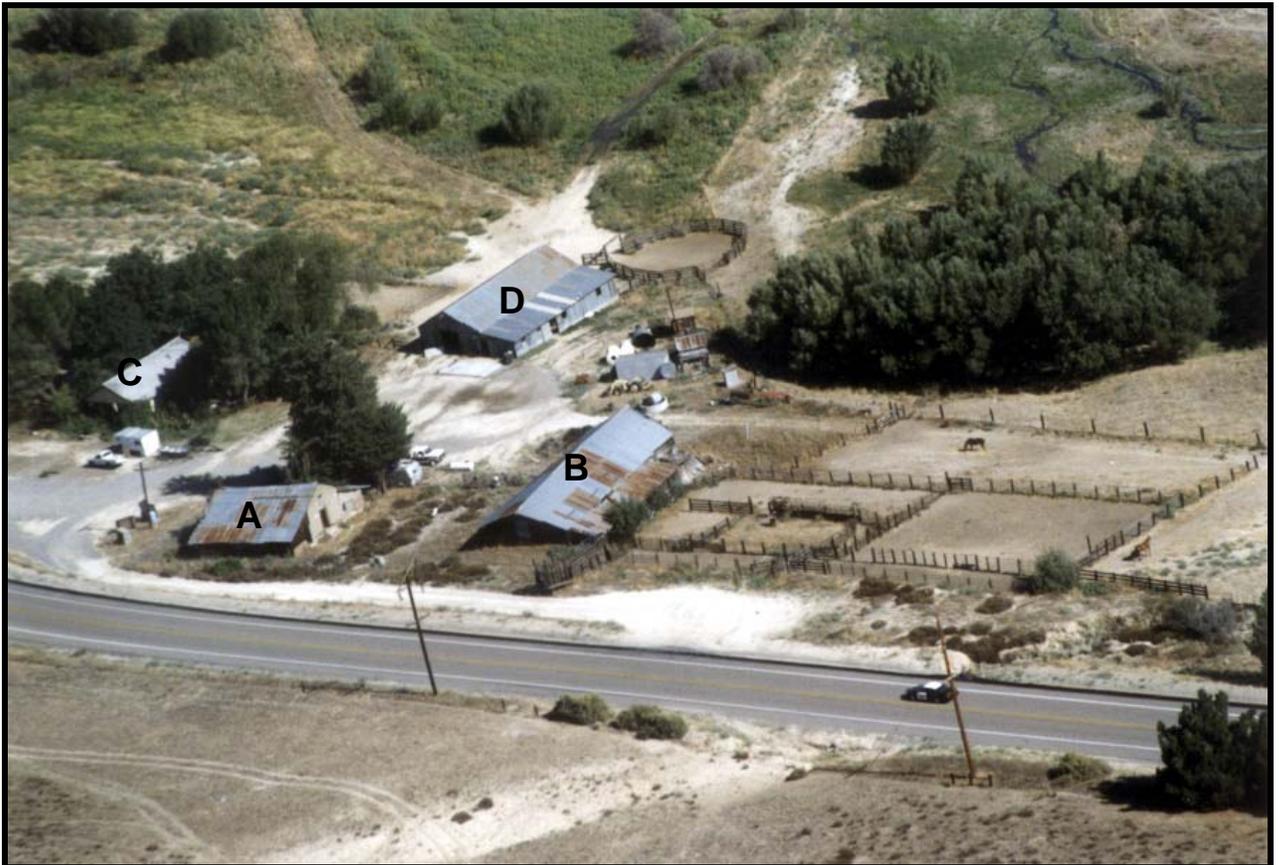
Figure 25: This aerial photograph, taken in 2000, shows the general setting and orientation of the Warner Ranch Ranch House and Barn. The Ranch House (A) sits to the west of the Barn (B), just north of San Felipe Road (S2). The 1920s caretaker's house (C) and a contemporary barn (D) appear in the upper left of the photograph.

The Ranch House at Warner's Ranch is situated at the base of a low rolling hill in the Buena Vista Valley. It is on the edge of the drainage for Buena Vista Creek, which is located about a hundred yards north of the building. On the east side of the adobe is a yard defined by the Ranch House on the west and a large square set timbered barn approximately 40 feet to the east. The barn dates from the mid to late 19th century, but its actual construction dates are not known. The site is a working ranch and corrals are located on the east side of the barn. Additional corrals and a modern sheet metal covered barn are situated a little over 100 feet to the north of the Ranch House. Around 50 yards to the west is the wood framed dwelling of the current ranch caretakers' built in the 1920s (Figure 25).

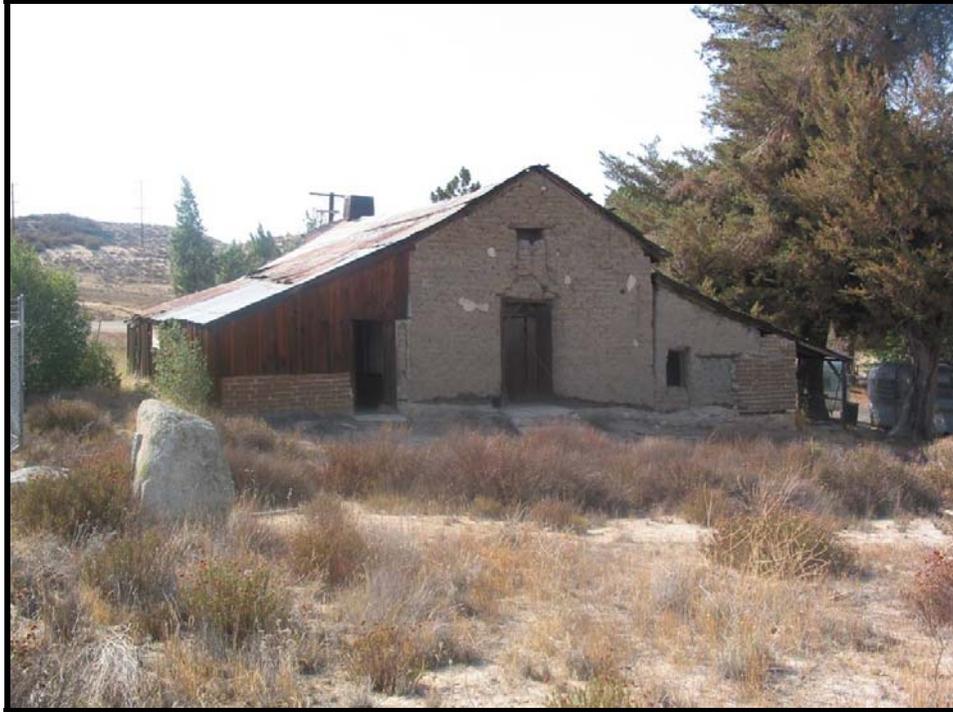
Figure 26: The east façade vividly illustrates the three different sections of the structure. The original two-room adobe can be seen in the center with the adobe addition to the north (right) and the wood/adobe addition to the south (left).

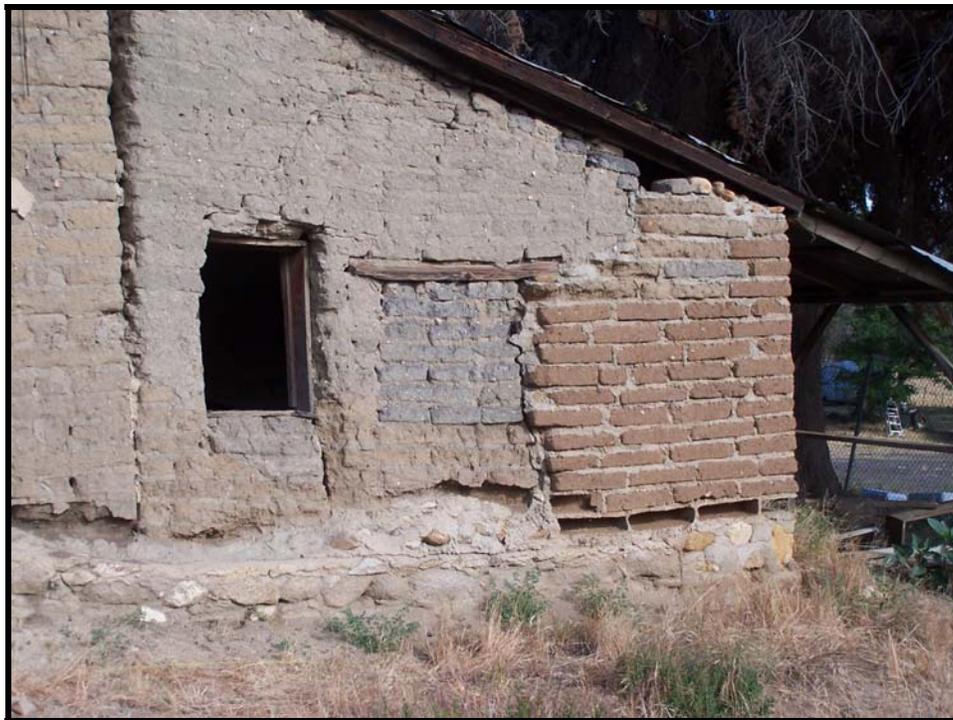
Figure 27: Multiple phases of construction can be seen in the east wall of the North Wing. Note how the wall is pulling away from the Central Wing on the left, suggesting a later period of construction.

All walls were made of adobe block with stone foundations. However, several features in the building give testimony to a long, multi phased, and complicated structural evolution. On the east end of the building the walls of the Southern and Northern Wings were pulling away from the Central Wing indicating that the center two room section was built first and the north and south portions added to it as separate construction episodes. In the east wall of the North Wing at least 5 different building episodes could be documented in the various layers of adobe block (Figures 26 & 27). This wall was removed in 2004 as part of a stabilization program for the Ranch House. Along the south and west sides of the South Wing, the original adobe walls were either removed or badly eroded during the late 19th or early 20th centuries and replaced with a crude wooden frame covered with board and batten siding. During the late 19th century two wood framed room

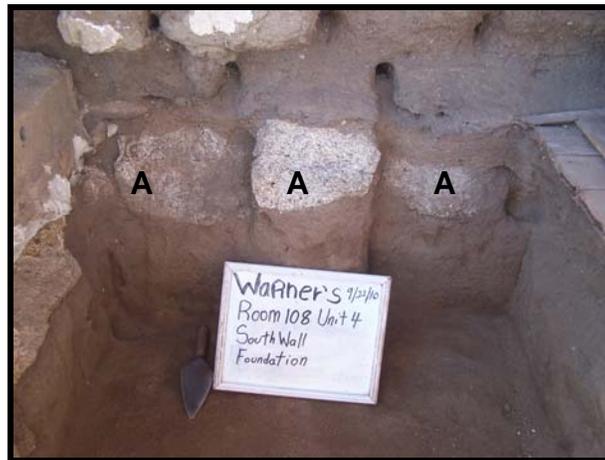
Figure 28: Angular granite fieldstones in the north wall footing of Room 101 (A), as seen in the south wall of Unit 10-4 Room 108. These are typical of the angular granite stone used throughout most of the foundation of the Central Wing.

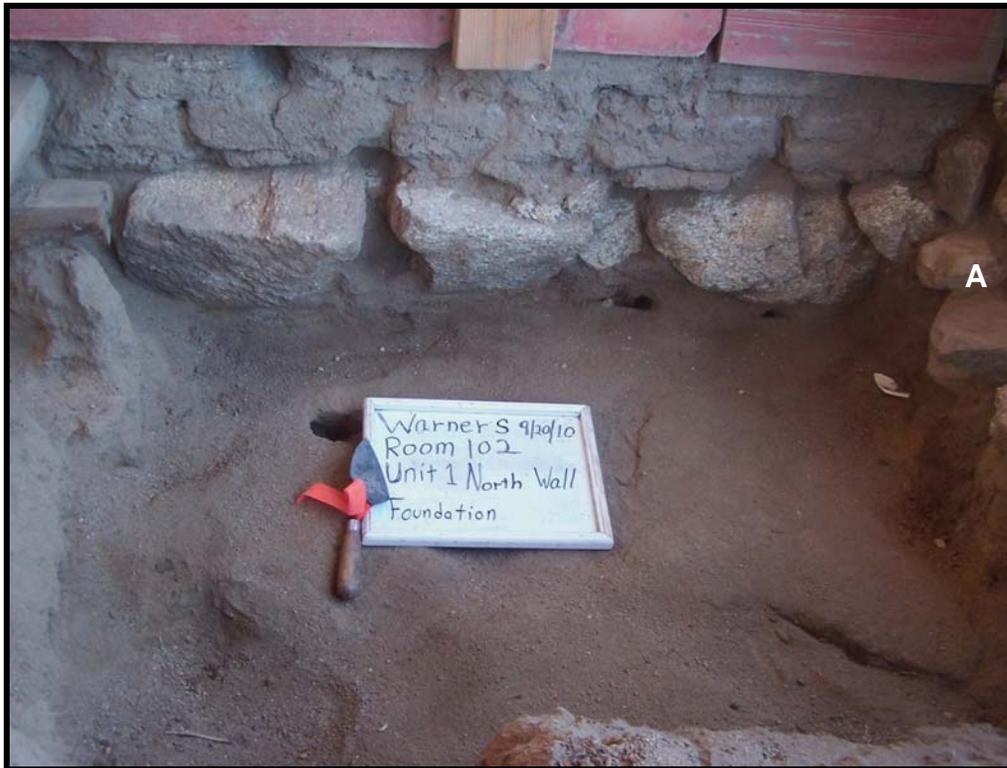
Figure 29: Photograph and profile drawing of the south wall foundation of Room 101 as seen in the north wall of Unit 10-1 in Room 102. Cobbles on the right side of the photo (A) are the east wall foundation of Room 102.

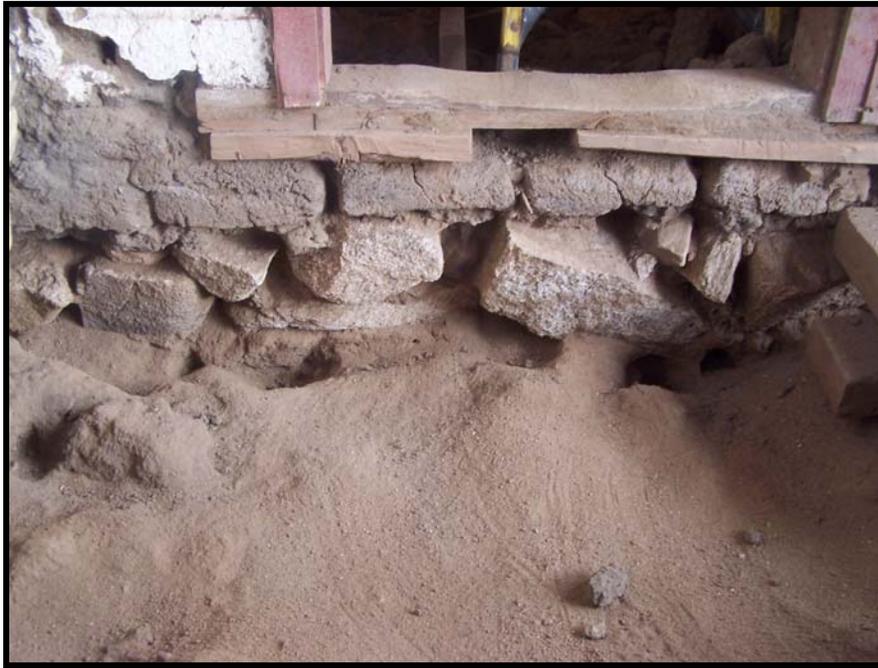
Figure 30: Photograph and profile drawing of the south wall foundation of Room 101 as seen in the north wall of Unit 10-2 in Room 102.

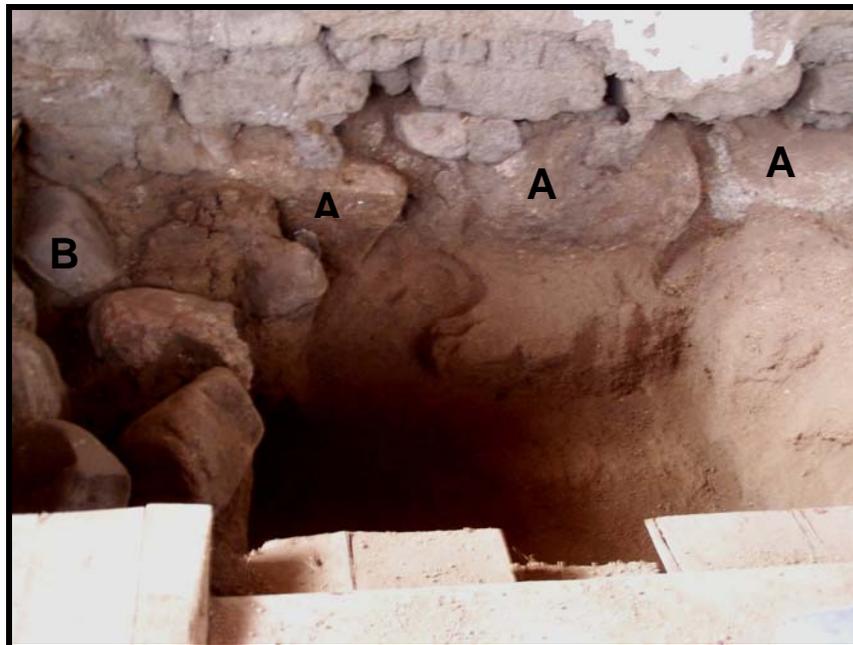
Figure 32: North wall foundation of Room 105 (A) as seen in the south wall of Unit 10-5, Room 107. The cobbles on the left (B) are the foundation to the interior dividing wall between Rooms 107 and 108. They are laid directly against the north wall foundation stones.

The second anomaly is the difference in depth of the foundation for the north and south walls. The tops of the foundation for the south wall are around 12 to 14 inches below the level of the existing floor in Room 105. The north wall foundation was substantially lower to accommodate the northwest trending slope of the site. At its east end, at the northeast corner of Room 108 in Unit 10-4, the top of the footing was about 22 inches below the level of the floor of Room 105. At Unit 10-5 in Room 107, the foundation stones were around 25 inches below the Room 105 floor level. The lowest point was at the northwest corner of Room 105 in Unit 10-6. The tops of the foundation stones at this point are approximately 28 inches below the wooden floor, or around 14 inches lower than the north wall footing. Essentially the foundation stones were placed in a trench with their tops at or near original ground surface, resulting in the lowered elevation of the north wall footing. More rows of adobe blocks have been added to the north wall foundation between the footing and the interior floor level to accommodate the differences in elevation between the north and south wall foundations.

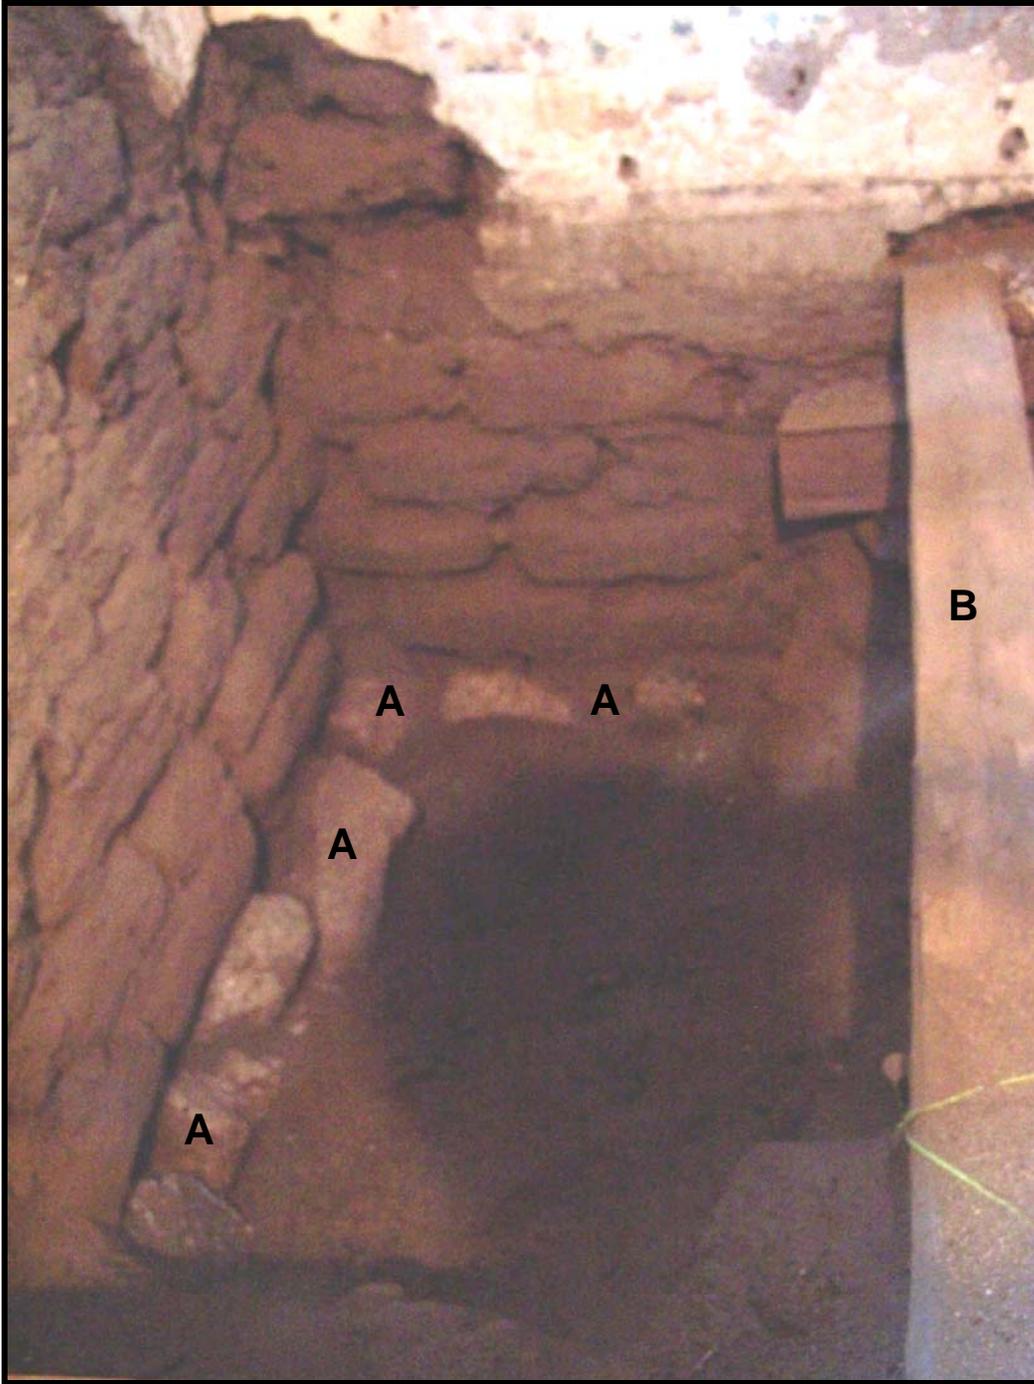
Figure 33: Angular granite field stone foundation (A) in Unit 10-6 at the northwest corner of Room 105. The wooden floor sleeper is in the upper right (B). At this point the foundation is around 14 inches lower than in the rest of the Central Wing.

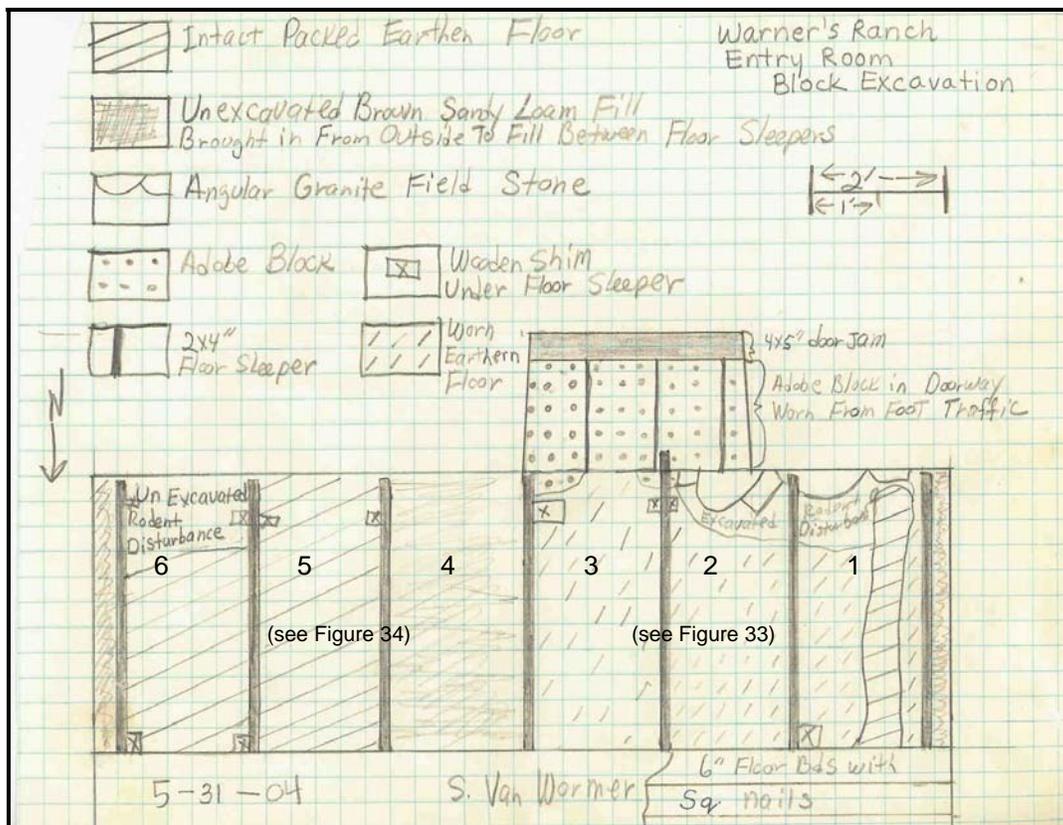
Figure 34: Plan view of Entry Room (101) block excavation prior to excavation of the corner units. Except for Section 4, which was not excavated, only the loose sandy loam fill between the sleepers has been removed. The cobbles at the west end of the south wall were exposed by rodent burrowing.

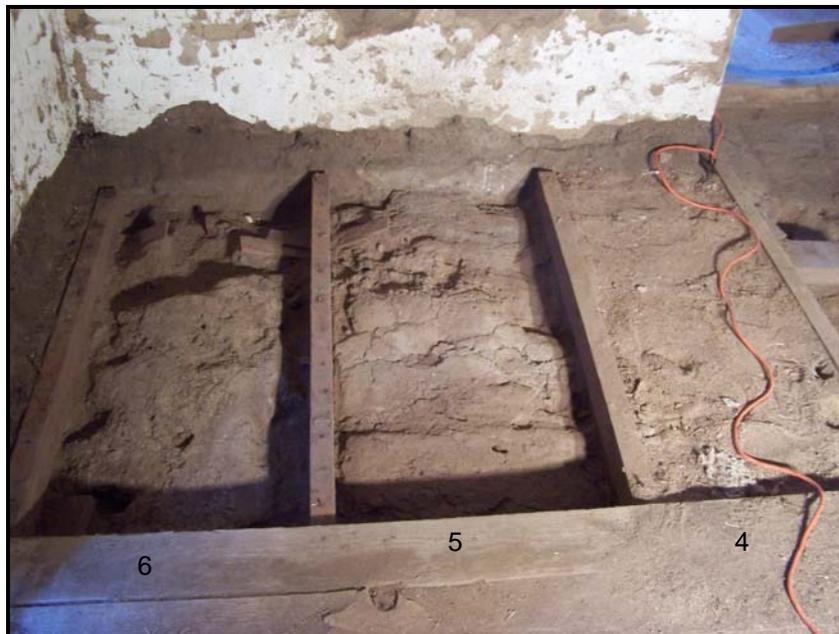
Figure 36: Sections 4, 5, and 6 of the Entry Room (101) block excavation showing the upper packed earthen floor surface that was exposed after the loose fill between the sleepers was removed. The fill has not been taken out in Section 4.

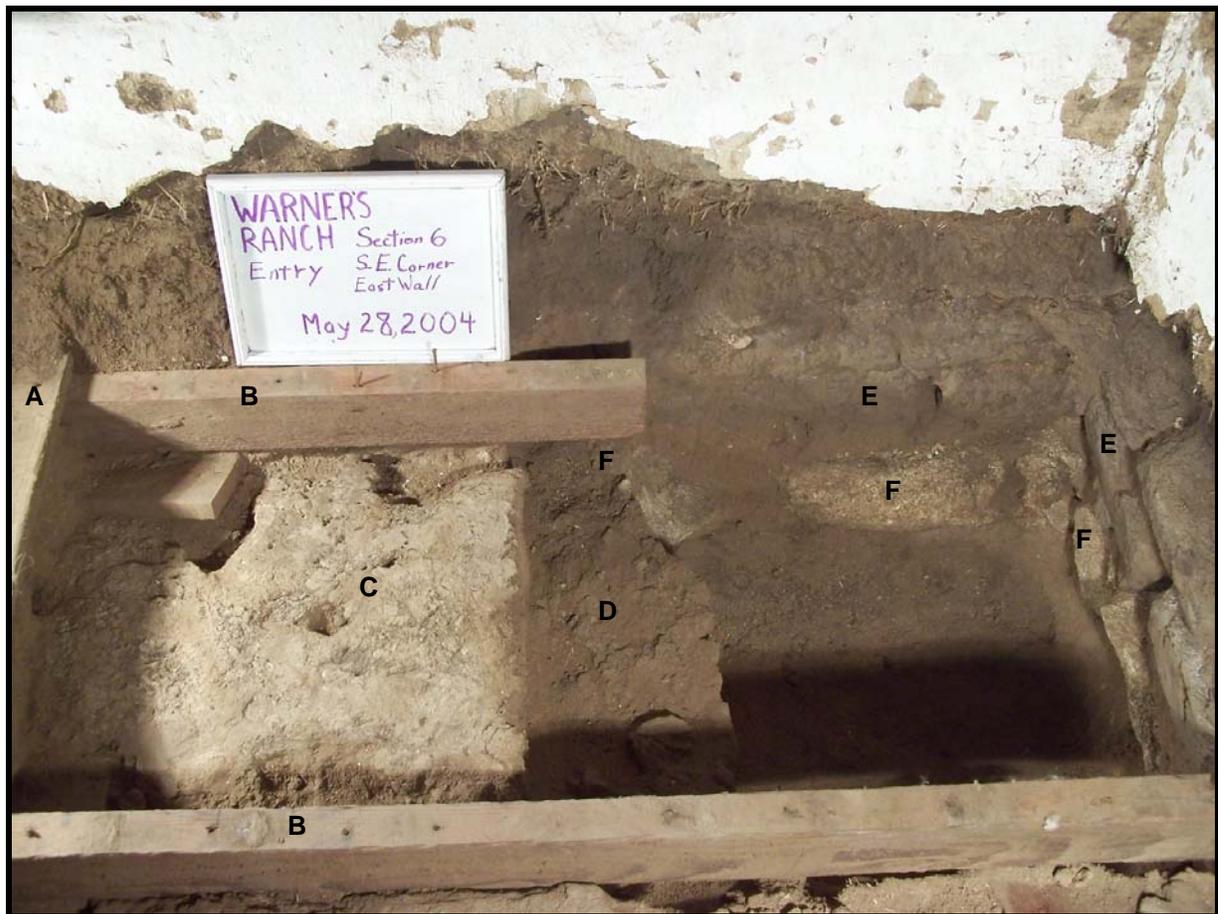
Figure 38: Entry Room (101) block excavation Section 6 following excavation of the northeast corner, looking east. A portion of the far sleeper has been cut off to allow excavation access. Note (A) the present wooden floor board, (B) sleepers, (C) upper earthen floor, (D) lower earthen floor, (E) adobe blocks at the base of the wall, and (F) a single course of field stones underlying the wall.

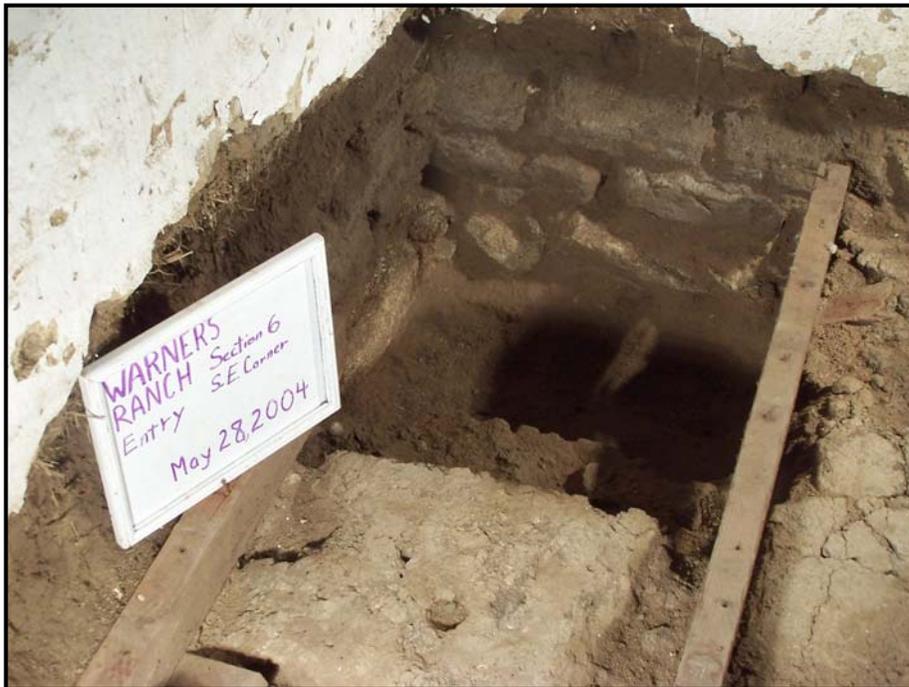
Figure 40: South side wall of excavated unit in Entry Room (101) block excavation Section 6. Note how the sleeper is resting in a shallow trench in the upper earthen floor.

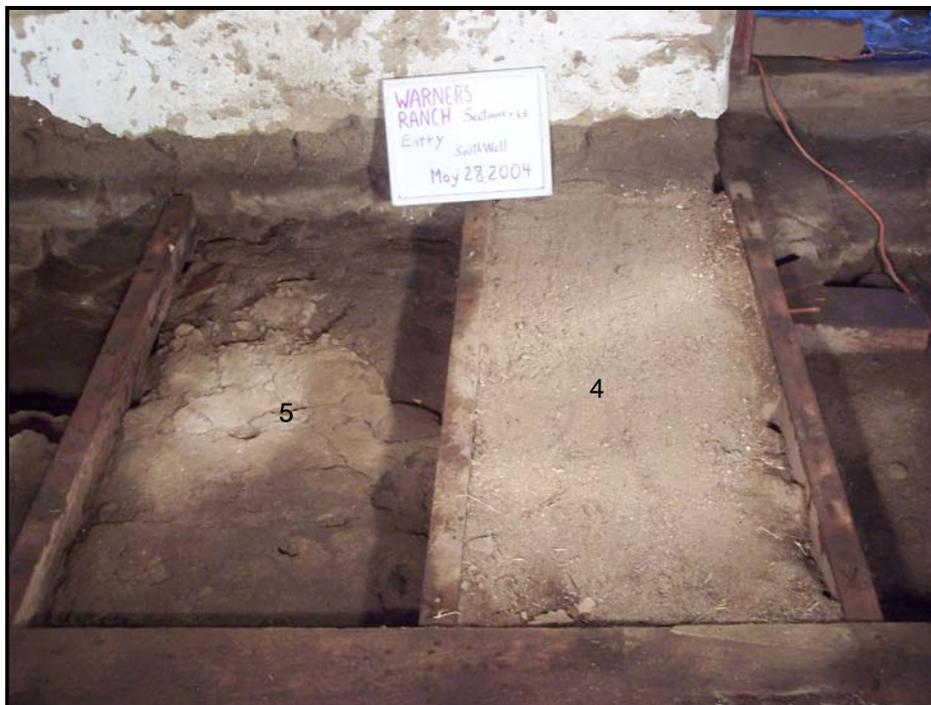
Figure 41: Entry Room (101) block excavation Sections 4 and 5. The upper earthen floor was left intact in Section 5 and the loose fill was left in place in Section 4.
