**TWO FORKS IN THE ROAD:
TEST EXCAVATIONS OF THE RANCH HOUSE
AT WARNER'S RANCH
(WARNER – CARRILLO RANCH HOUSE)
AND SITE OF
JONATHAN T. WARNER'S HOUSE AND STORE**

VOLUME I: The Ranch House

JULY 2011

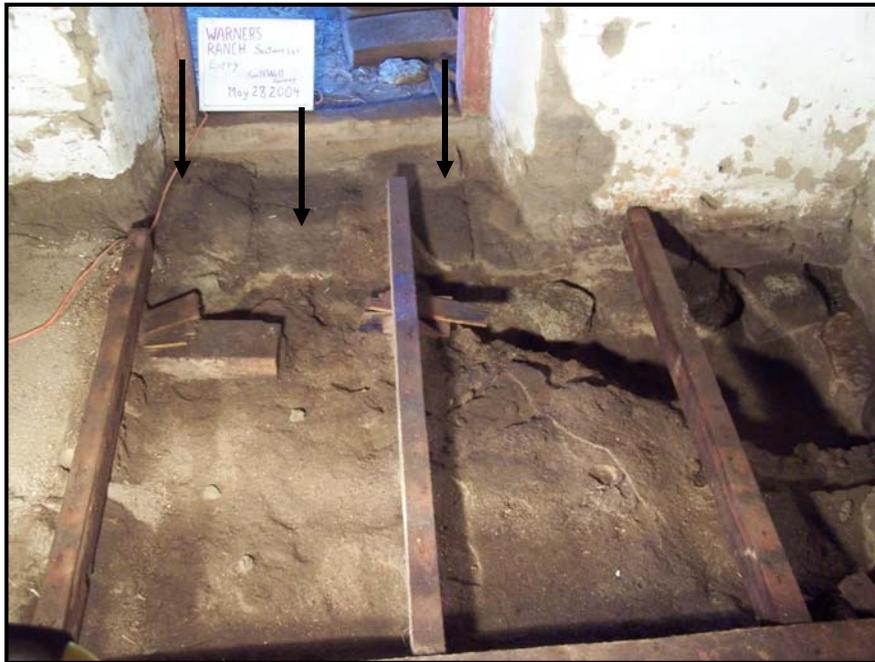
Figure 42: Entry Room (101) Block excavation Sections 2 and 3. The badly worn lower earthen floor and blocks in the door way can clearly be seen.

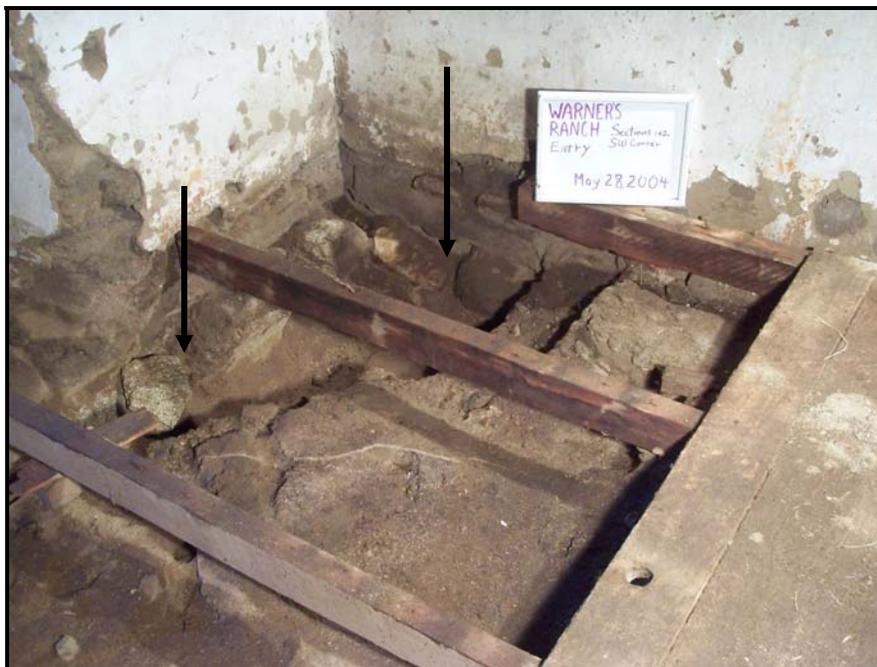
Figure 43: Overview of the excavation unit in the southwest corner of Entry Room (101) block excavation Section 6. Note the single course of large irregular shaped granite field stones in the foundations of both the south and west walls.

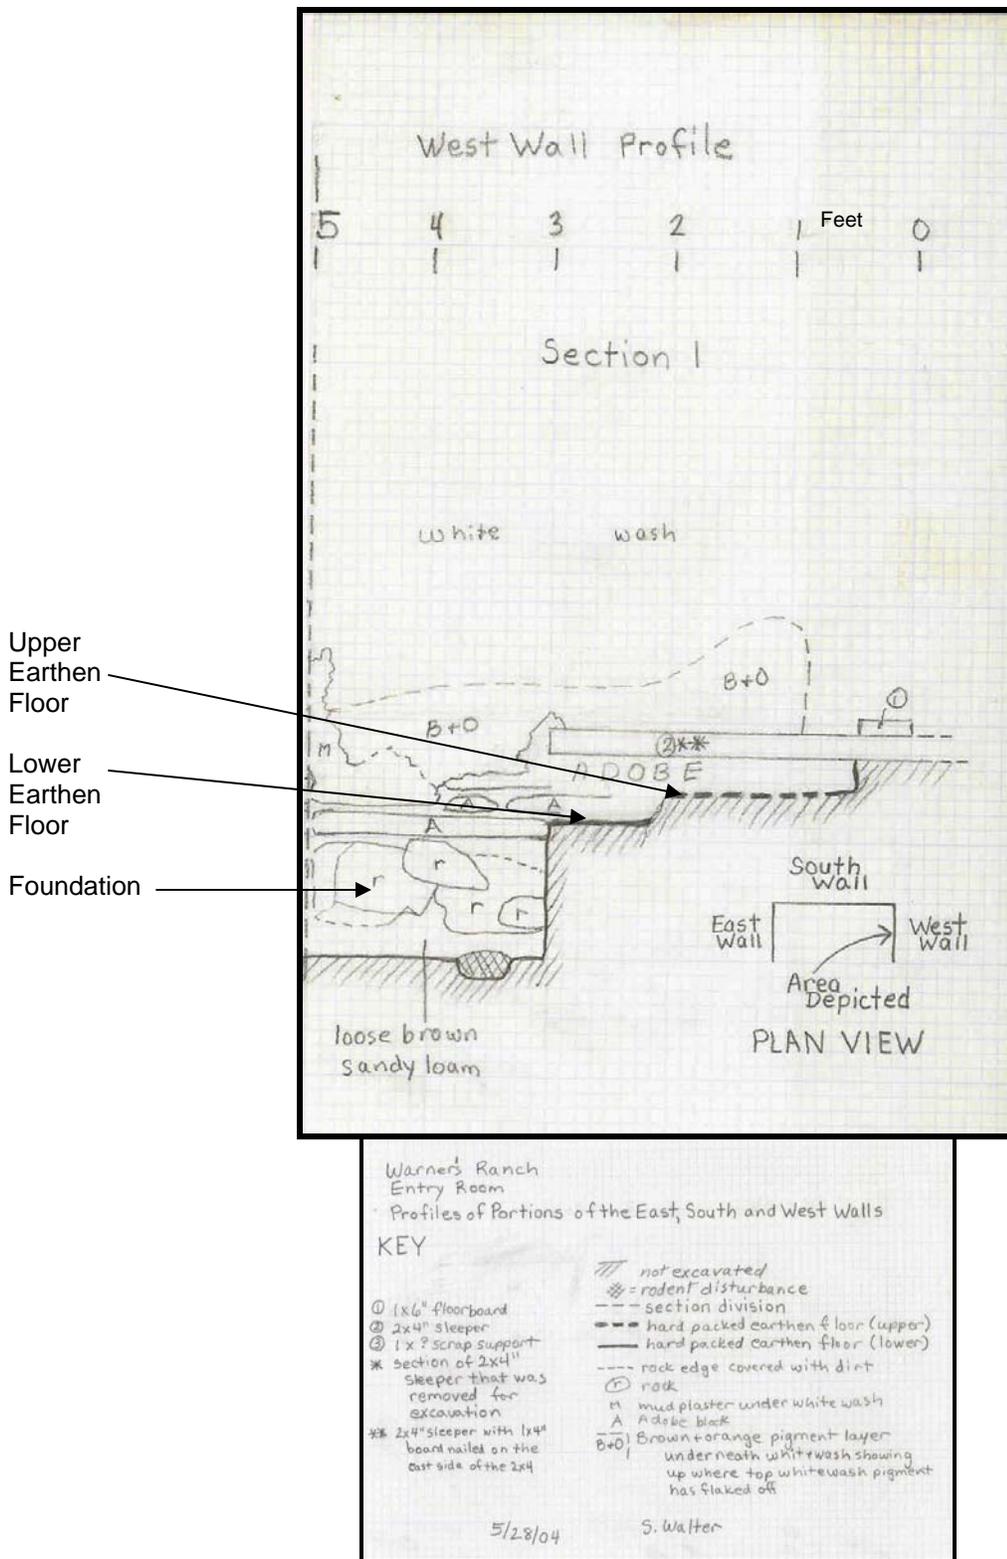
Figure 44: West wall profile of Entry Room (101) block excavation Section 1 following excavation of the unit in the southwest corner. Most of the same features can be noted as in the east wall profile of Section 6 in Figure 37.

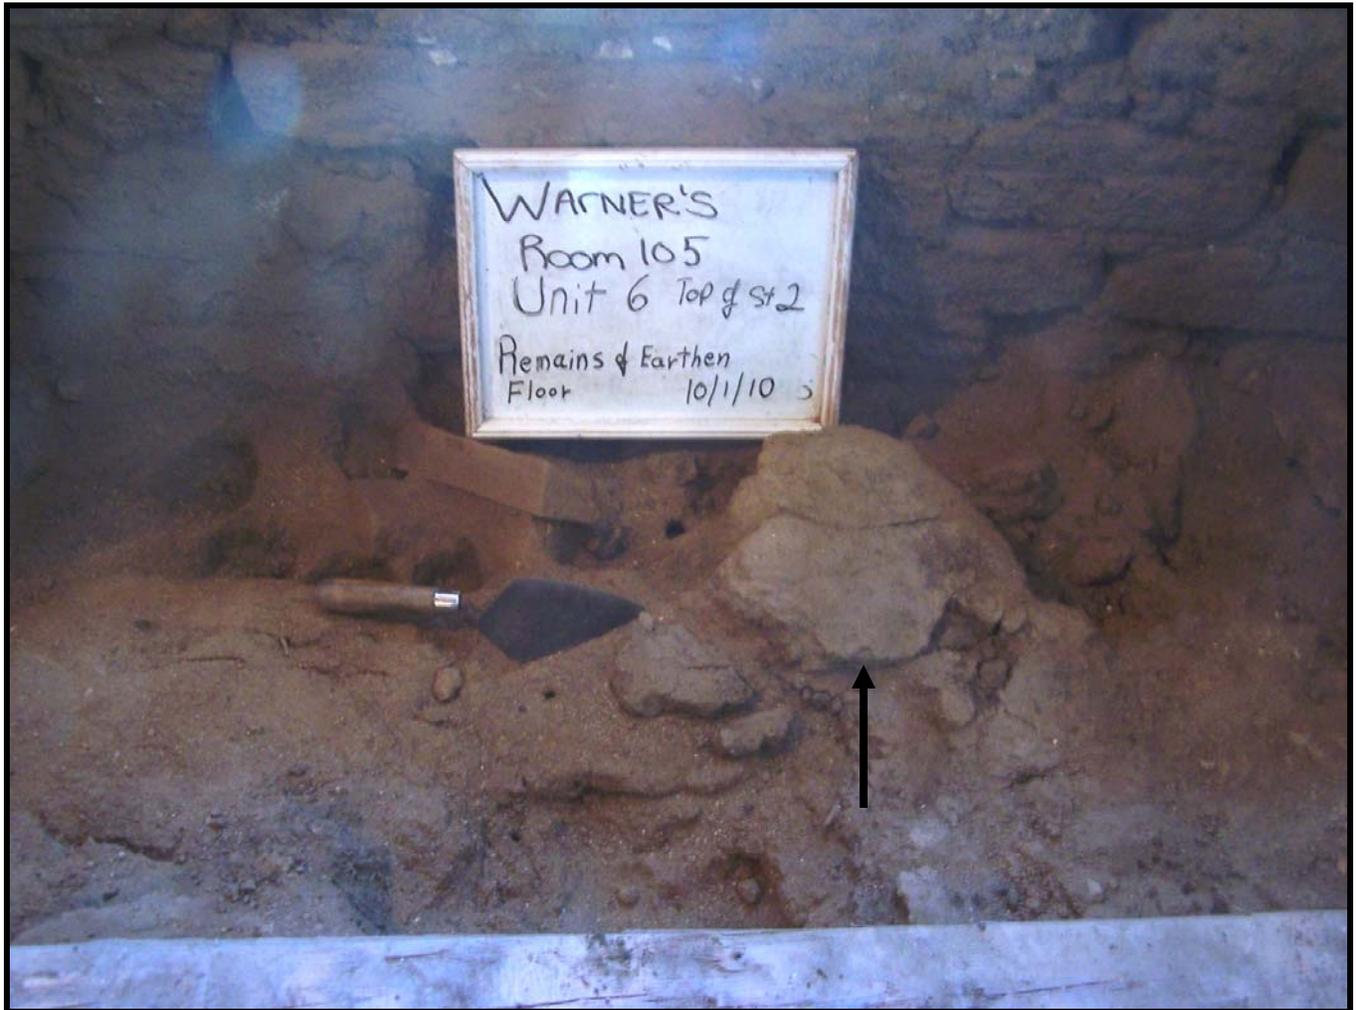
Figure 46: Small remnant of packed earthen floor in the highly rodent disturbed northwest corner of Room 105.

Due to the highly churned state of the soil from the rodent activity almost none of the previous earthen floors or other stratigraphy remained intact. The only evidence that this room had a packed earthen floor prior to construction of the wooden floors was a small remnant of an old earthen surface encountered in the north end of the unit approximately 9 inches below the existing wooden floor. This irregular shaped piece measured approximately 10 by 14 inches by 1 inch thick (Figure 46).

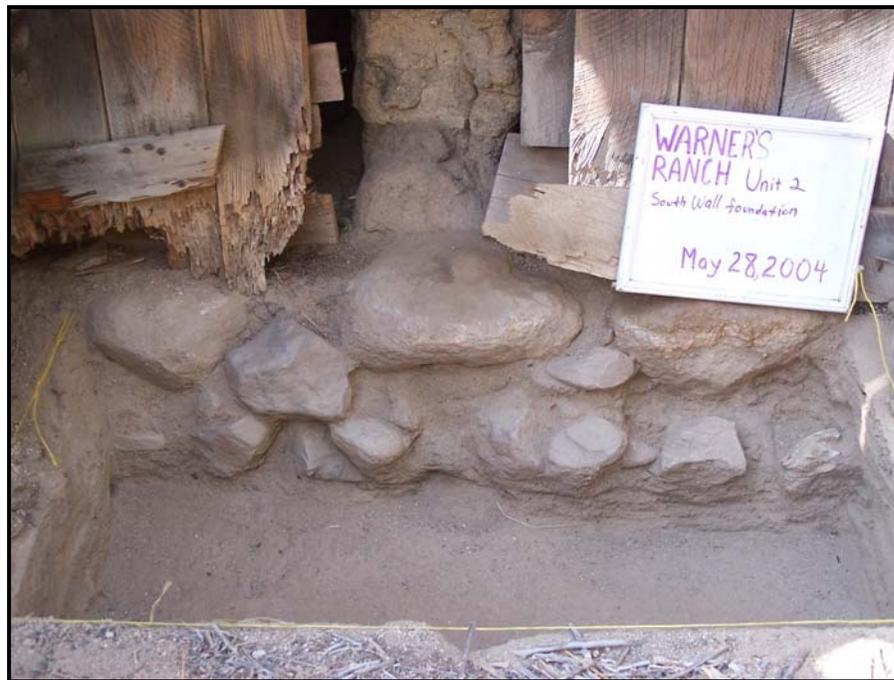
Figure 50: Cobble foundation and the end of the western interior dividing wall in Unit 04-2.

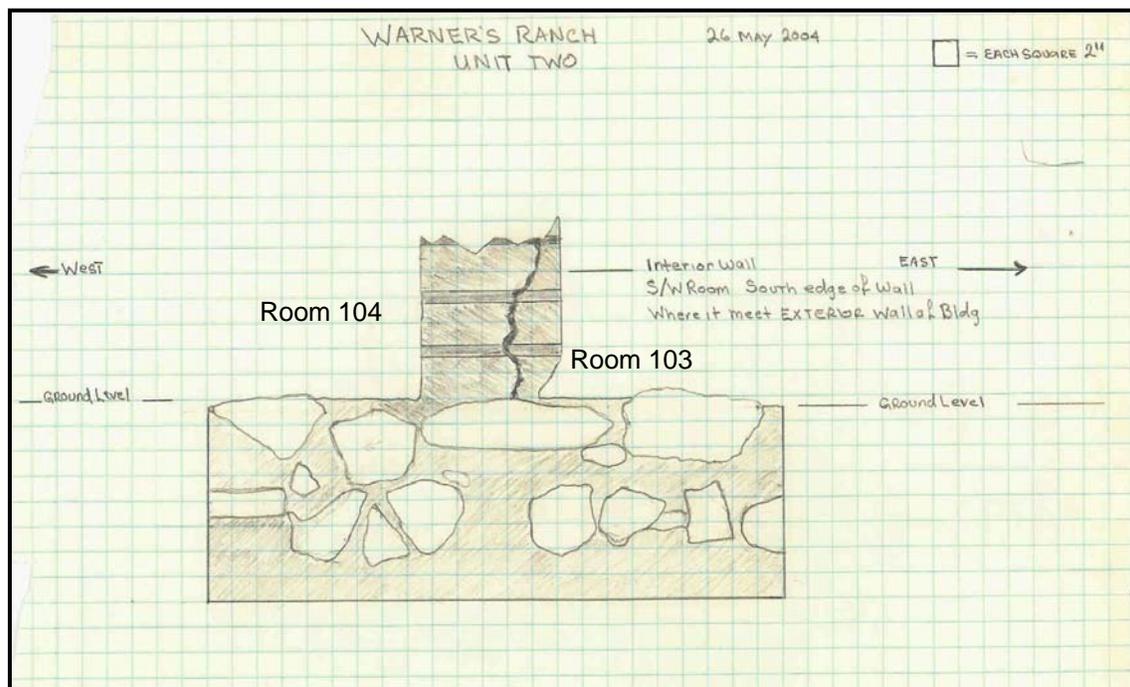
Figure 51: Profile drawing of the cobble foundation and the end of the western interior dividing wall in Unit 04-2.

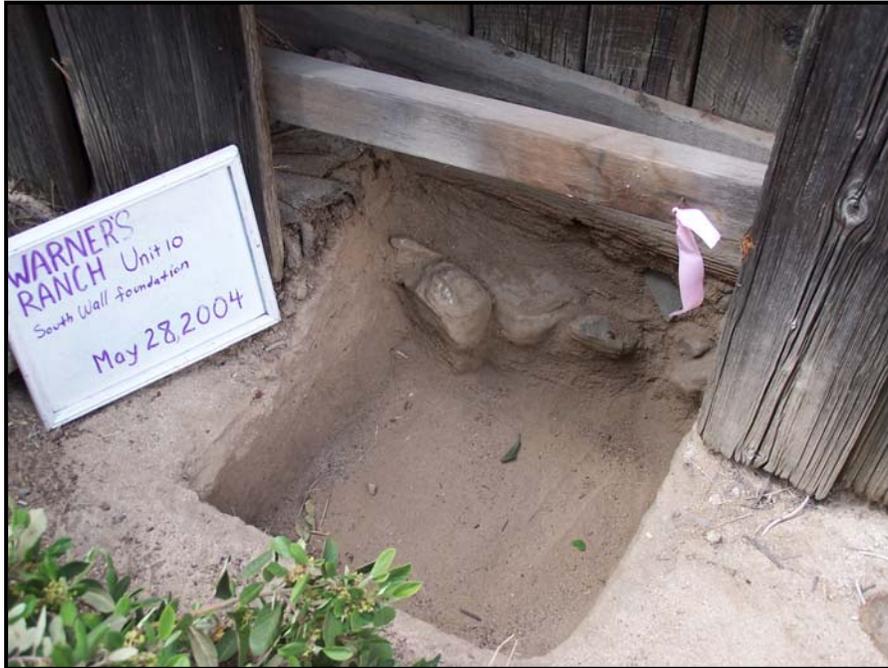
Figure 52: Disturbed foundation in Unit 04-10.

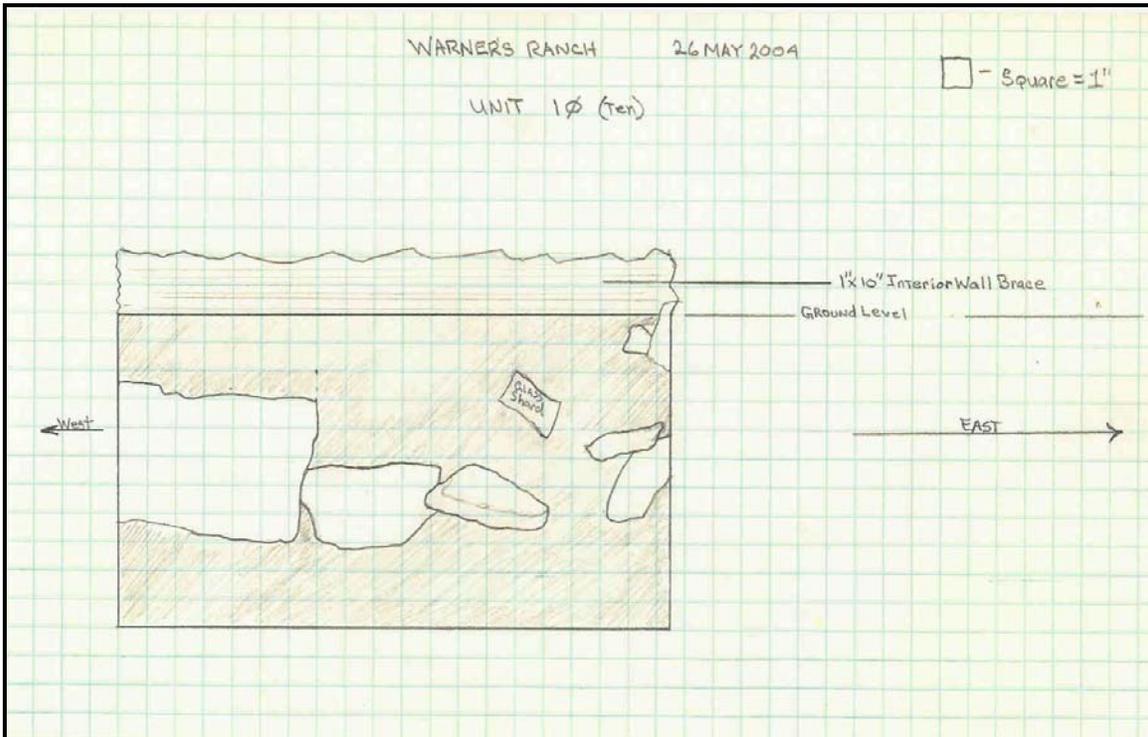
Figure 53: Profile drawing of the north sidewall of Unit 04-10. Only the bottom course of foundation stones remains intact.

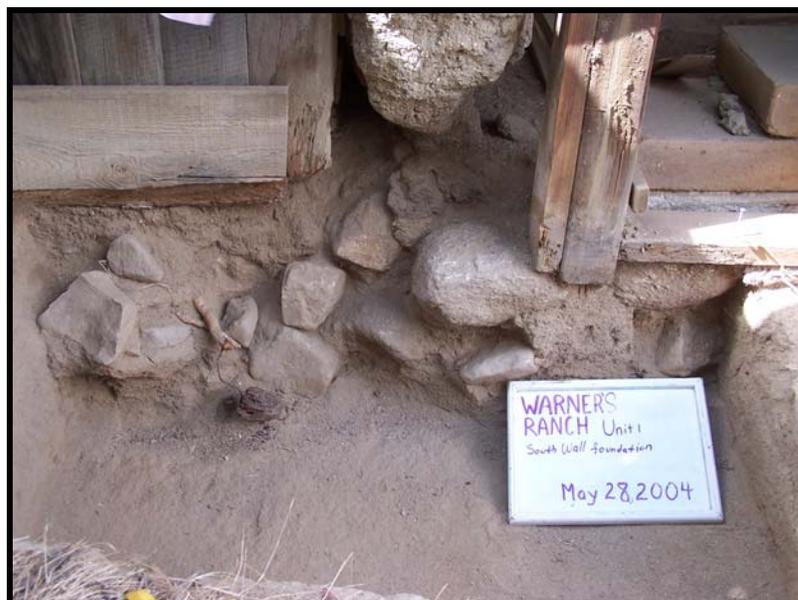
Figure 54: Cobble foundation in Unit 04-1. The west half (left) is badly disturbed while the eastern portion remains intact.

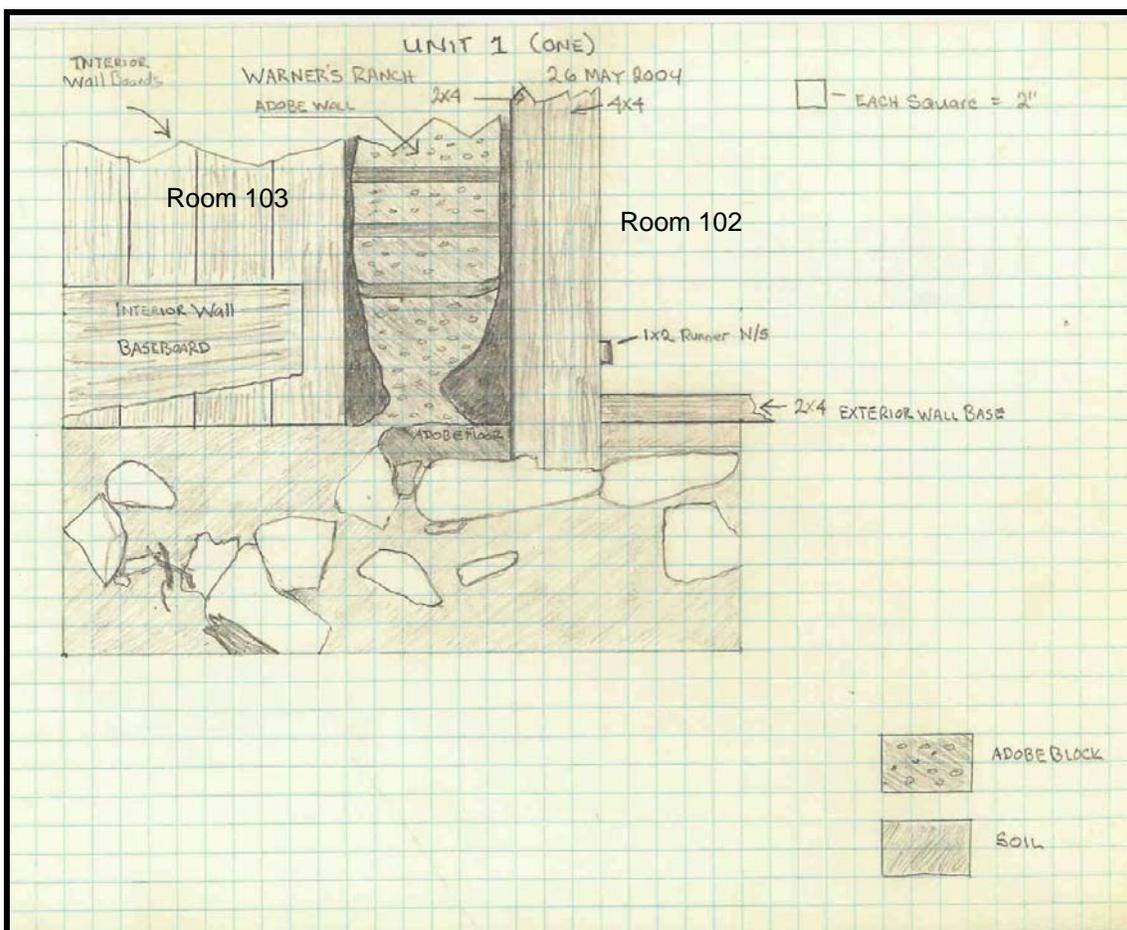
Figure 55: Profile drawing of the north sidewall of Unit 04-1, showing the end of the eastern interior dividing wall and partially disturbed foundation.

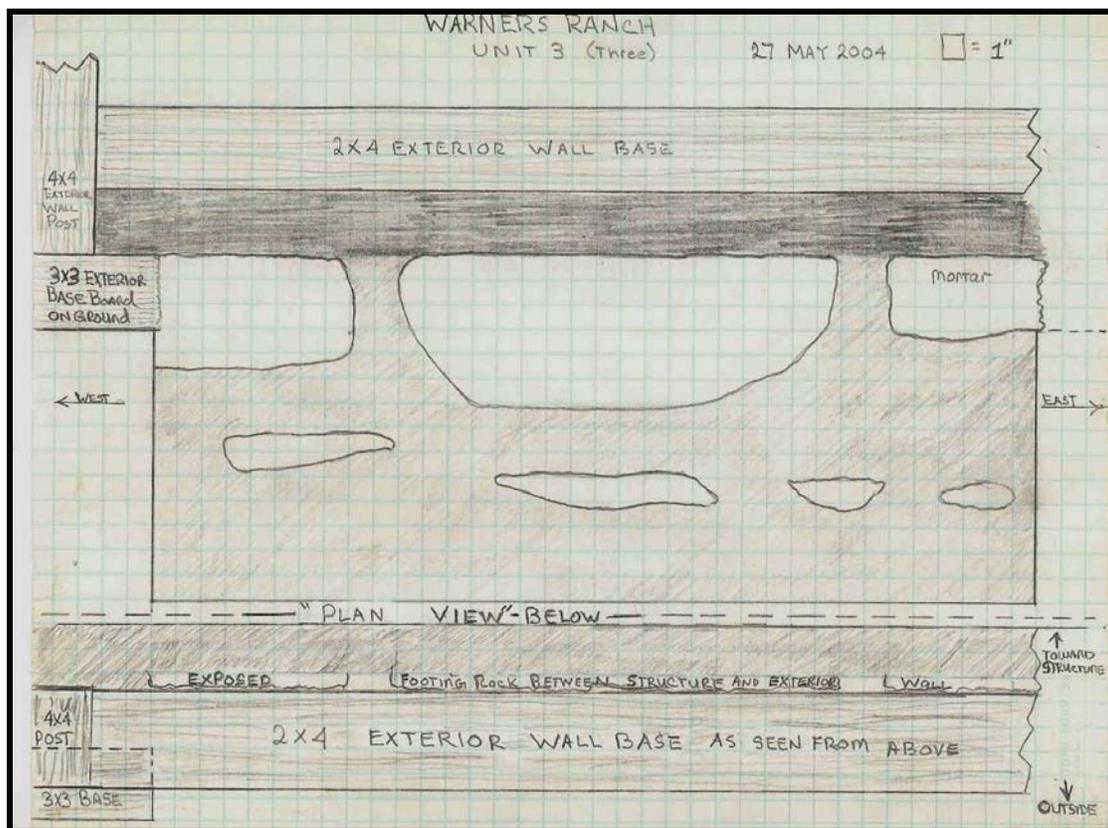
Figure 57: North side wall profile and partial plan view of Unit 04-3, placed beneath the south wall of Room 102, showing undisturbed foundation stones.

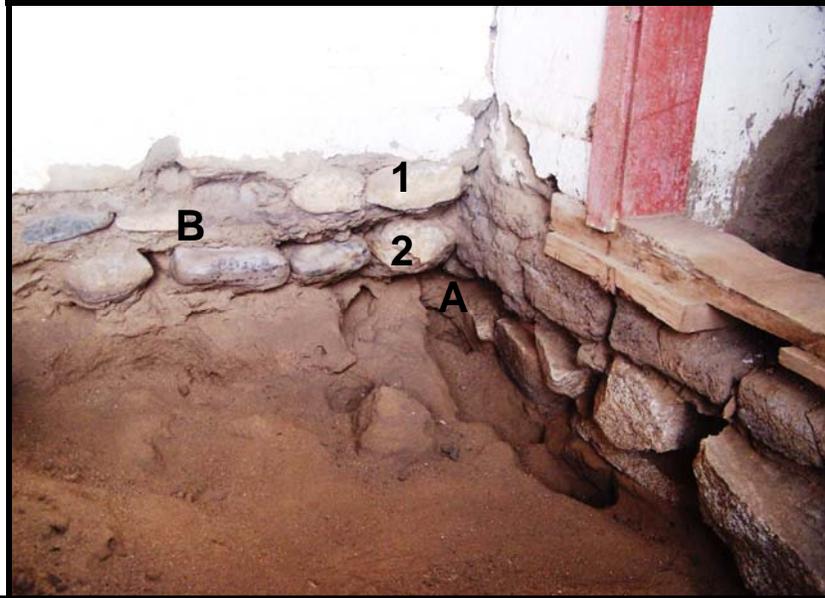
Figure 58: Photograph and profile of the east wall foundation of Room 103, as seen in the west wall of Unit 10-2, Room 102, showing the relationship between the angular granite field stone footing of the Central Wing (A) and the higher placed, multi-course foundation of the interior dividing wall(B). Points 1 and 2 represent the same cobbles in the photo and profile.

The sections of the Room 103 wall foundations exposed in Unit 10-2 and 10-3 consisted of two courses of medium sized water worn cobbles measuring from 6 to 10 inches in length and 2 to 4 inches in width. The two courses are not placed one on top of the other but are separated by approximately 2 to 6 inches of mud mortar and soil. The foundation is built against the adobe blocks in the south wall of Rooms 101 and 105, rather than against the granite field stone footing of that wall. The bottom courses of cobbles are at the same depth as the bottom course of block in the original building's (Rooms 101 & 105) south wall. Consequently the top of the irregular granite field stone footing for the south wall of Rooms 101 and 105 is about an inch below the alignment of the cobble foundation for Room 103 (Figures 58 & 59).

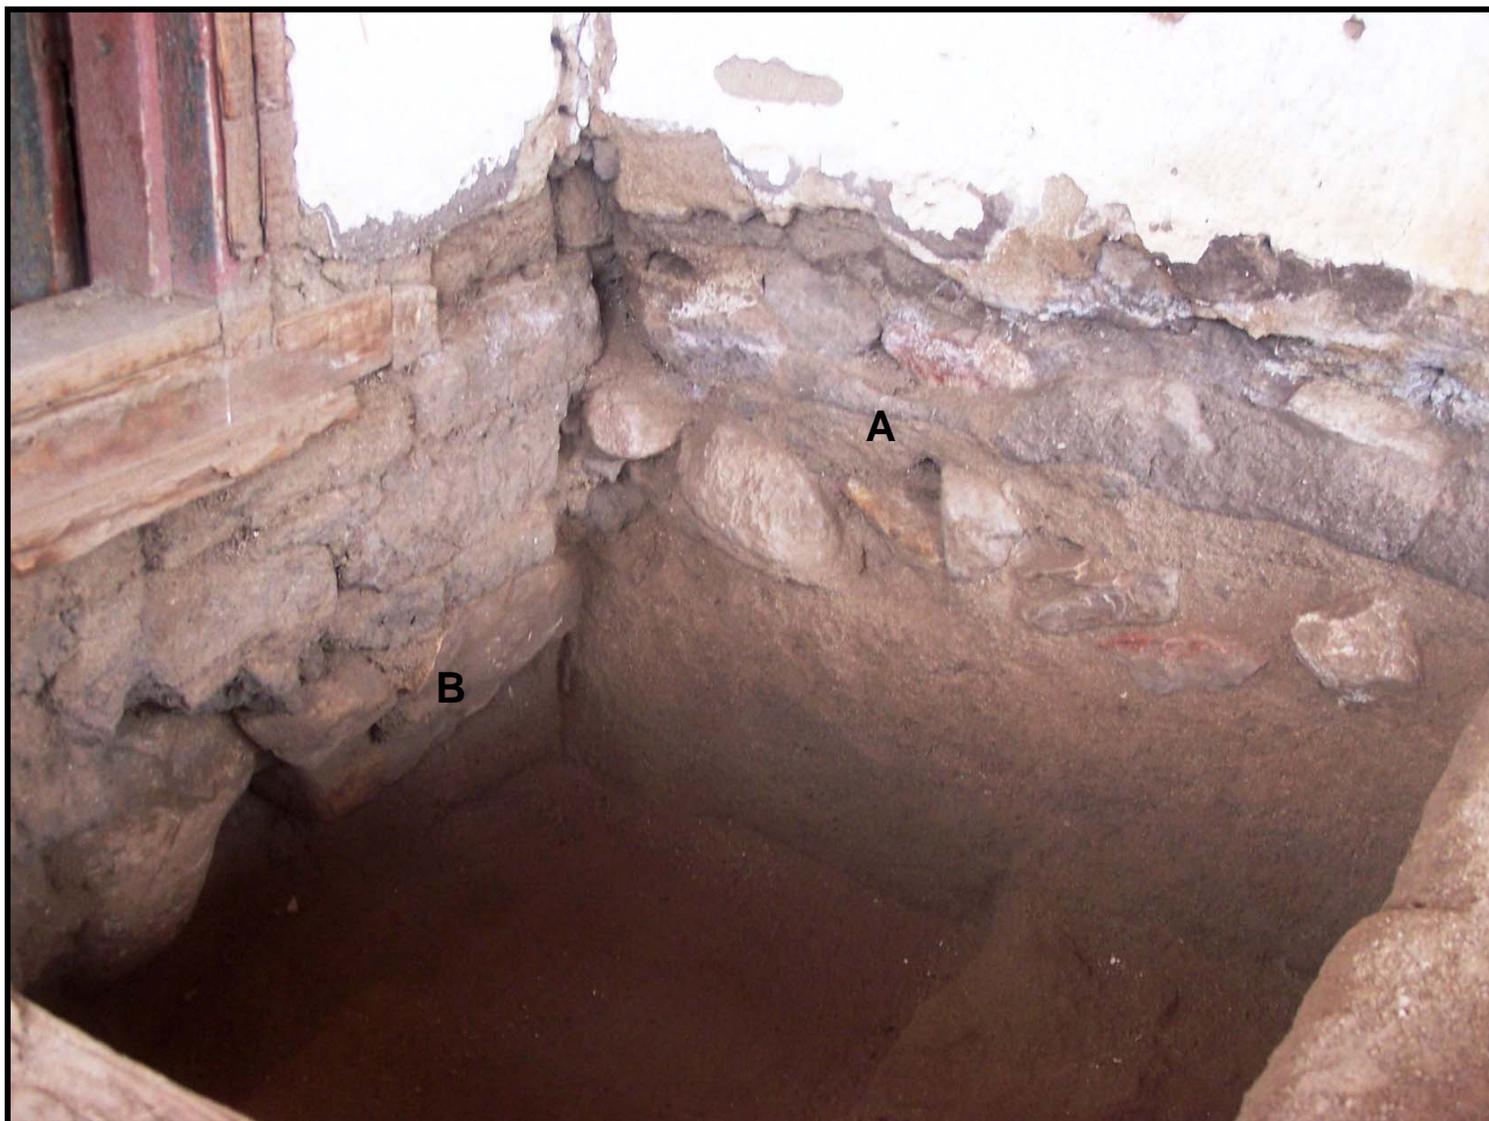
Figure 59: Unit 3, Room 104, showing the west wall foundation of Room 103 (A) and the relationship between the angular granite field stone footing of the Central Wing (B).

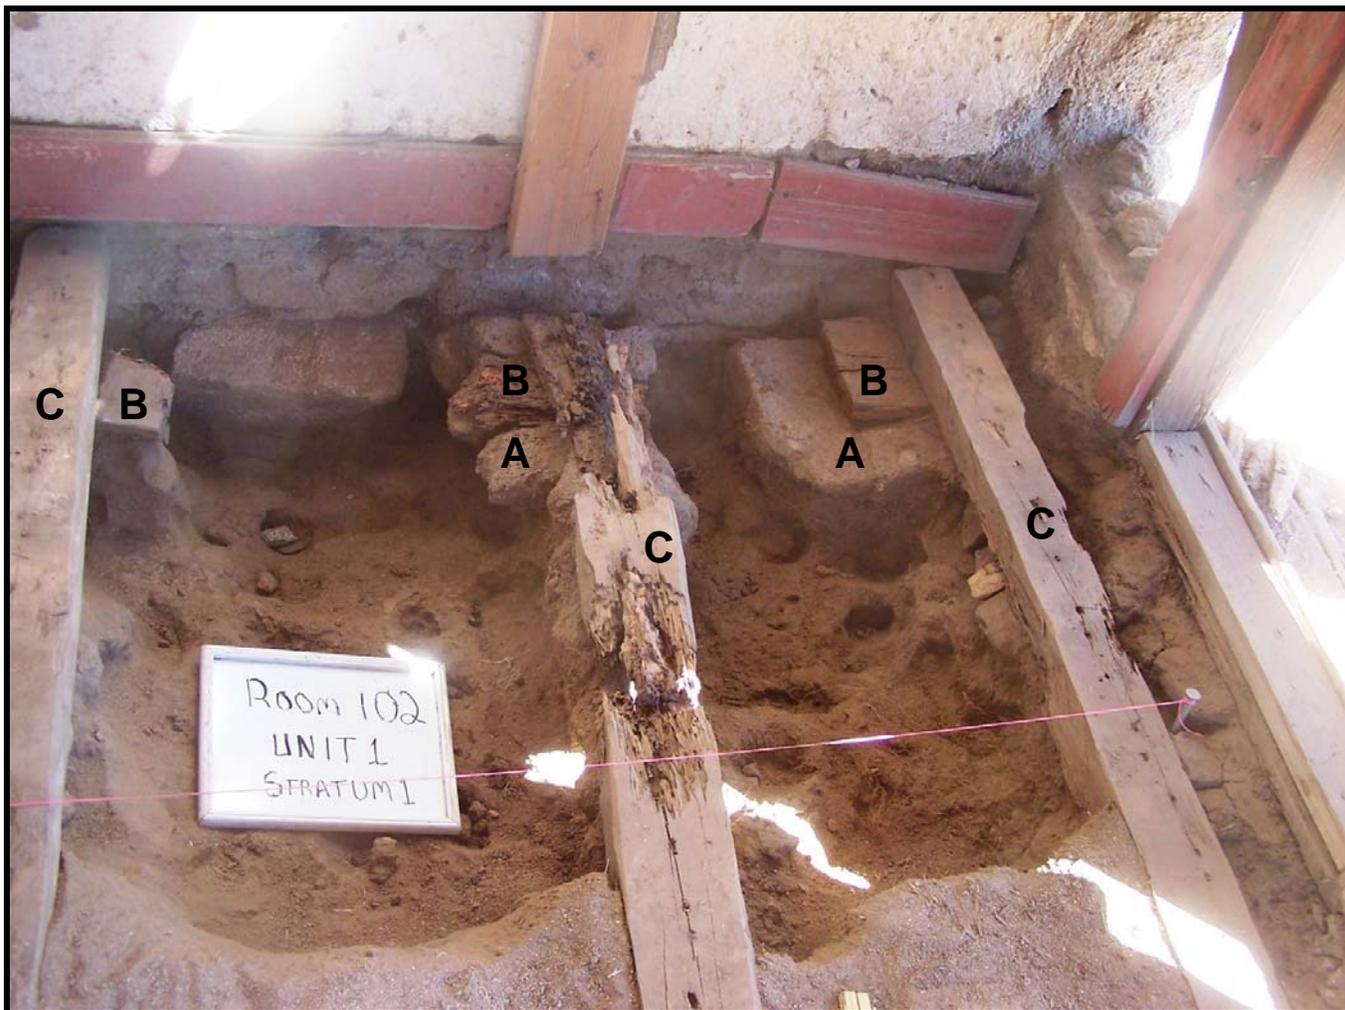
Figure 61: Unit 10-1 excavated to 12 inches below surface. Note the large number of rodent burrows and the adobe blocks (A) supporting wooden boards (B), set under the floor sleepers (C).

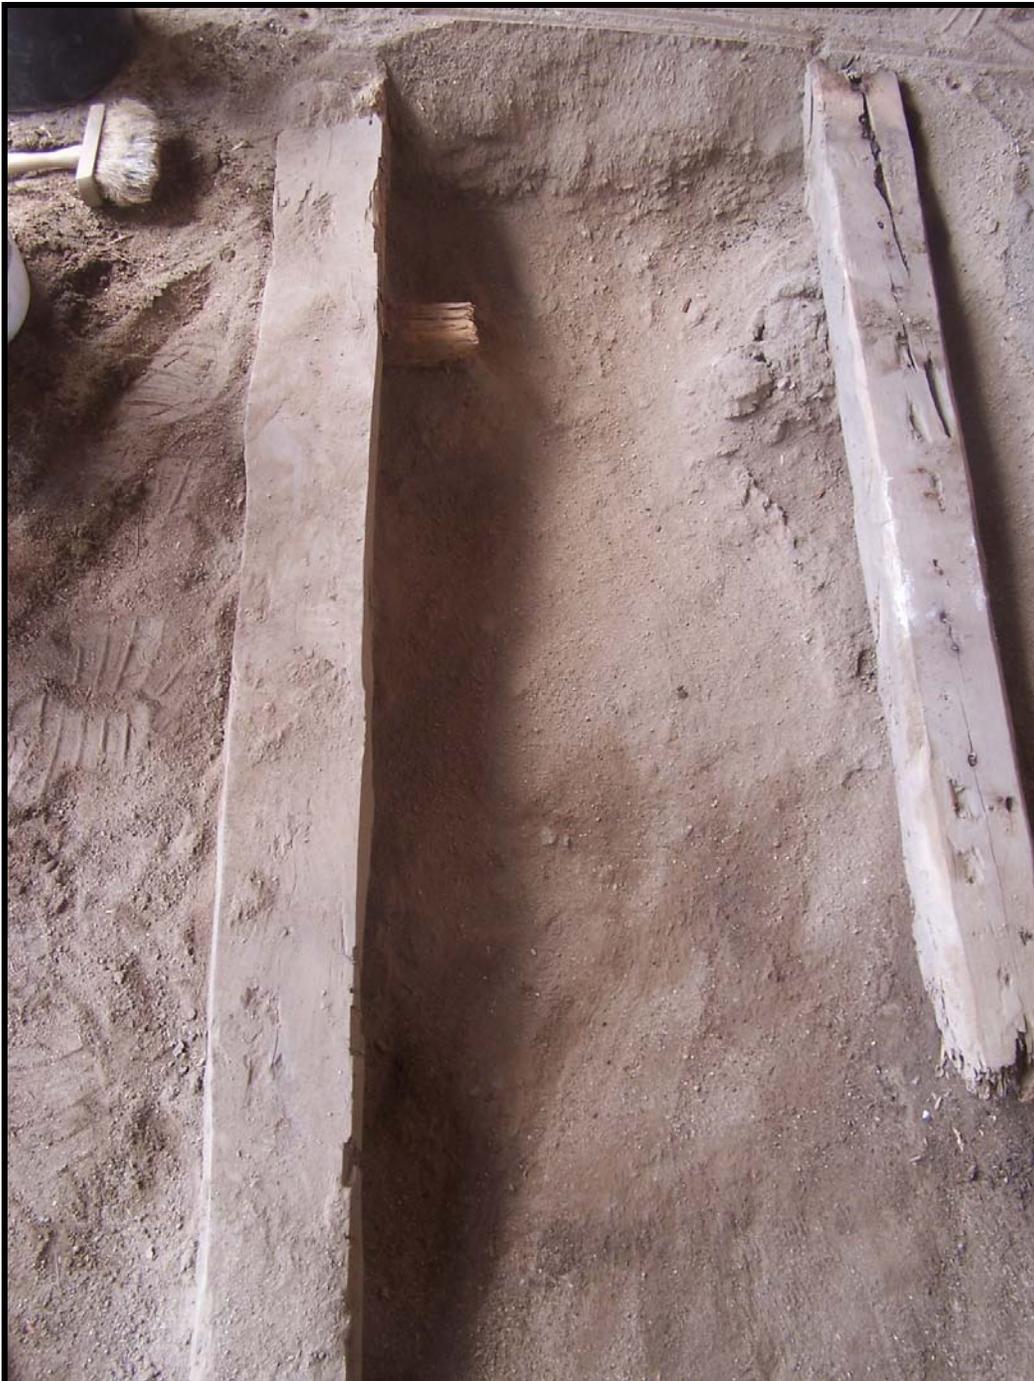
Figure 62: Irregular compact surface in Trench A, looking south.

Soil consisted of a loose brown sandy loam fill between the floor joists. This was removed as Stratum 1. In the units and the portion of the trench against the north wall the area was heavily disturbed by rodents and the stratigraphy ill defined. Here Stratum 1 was arbitrarily excavated to 12 inches below the surface. In the units the floor sleepers were found to be supported by 1 by 3 by 5 inch boards. In the northeast end of the room in Unit 10-1 two of these boards were supported by 12 inch square pieces of adobe block (Figure 61). In Trench A, approximately 3 feet south of the north wall, there was less impact from rodent burrowing and a moderately compacted surface was encountered below the loose joist fill at around 7 inches below the surface. Excavation of the trench was halted at the level of the packed surface. It appeared to be a former exterior ground surface and may have also served as a packed earthen floor for this room before the wooden floor was installed. Unlike the earthen floors in Room 101 that are of a denser packed clayey soil, this surface is simply the compacted brown sandy loam soil found through out the site (Figure 62).

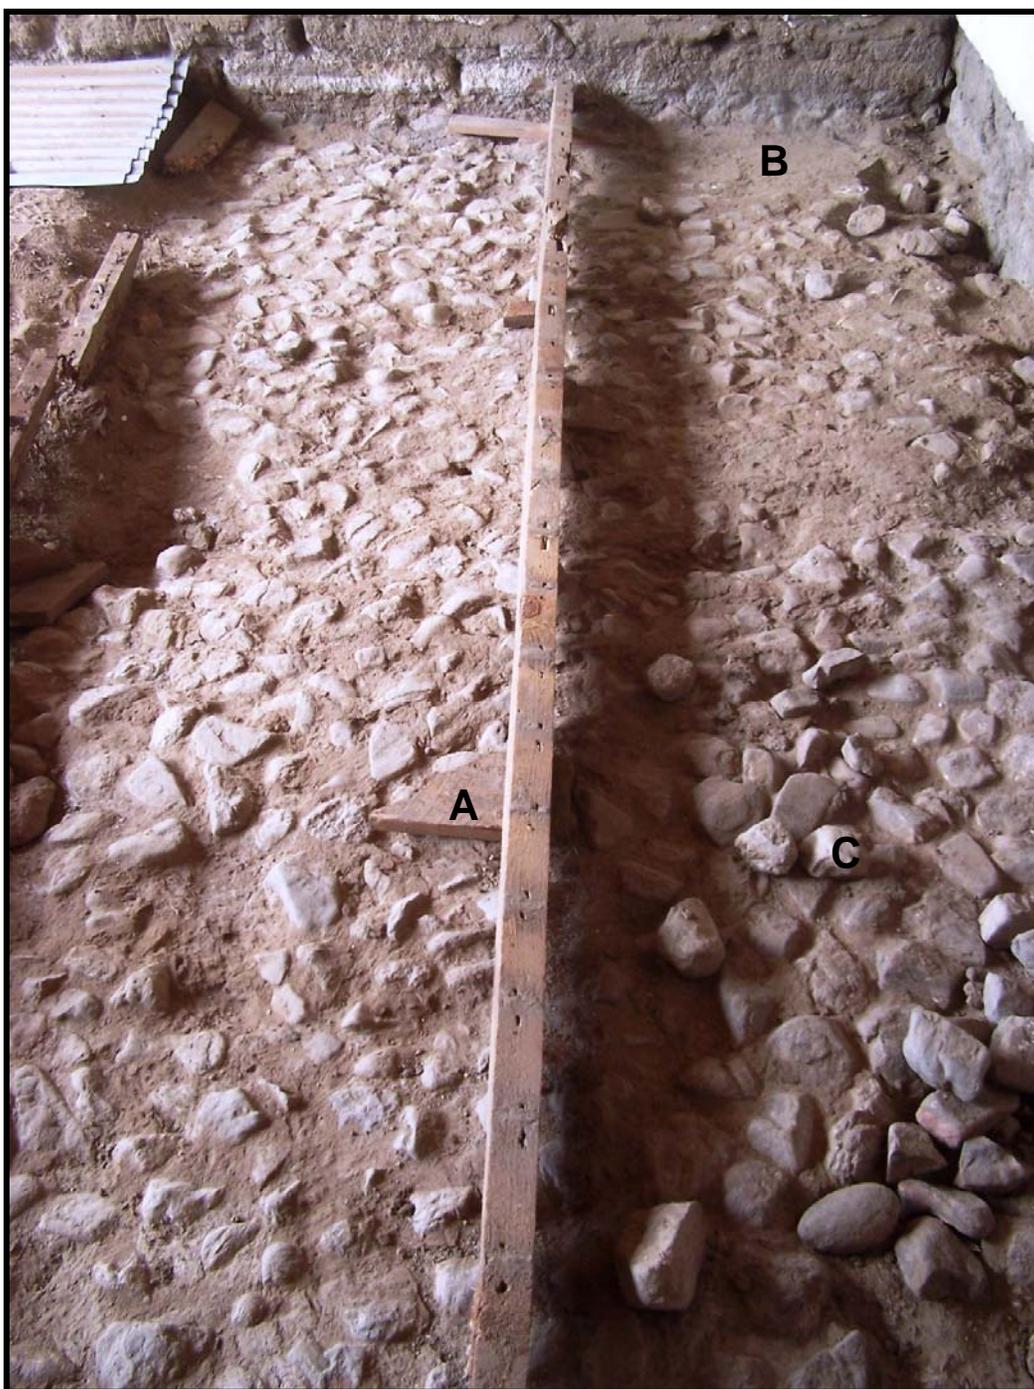
Figure 64: Densely packed cobble floor in the north half of Room 103, looking toward the west wall. The board (A) beneath the 2 by 4 inch sleeper will be referenced in the following two photographs. Note the intact surface where the mud grout still covers the cobbles in the northwest corner (B), and the loose cobbles in the right foreground (C).

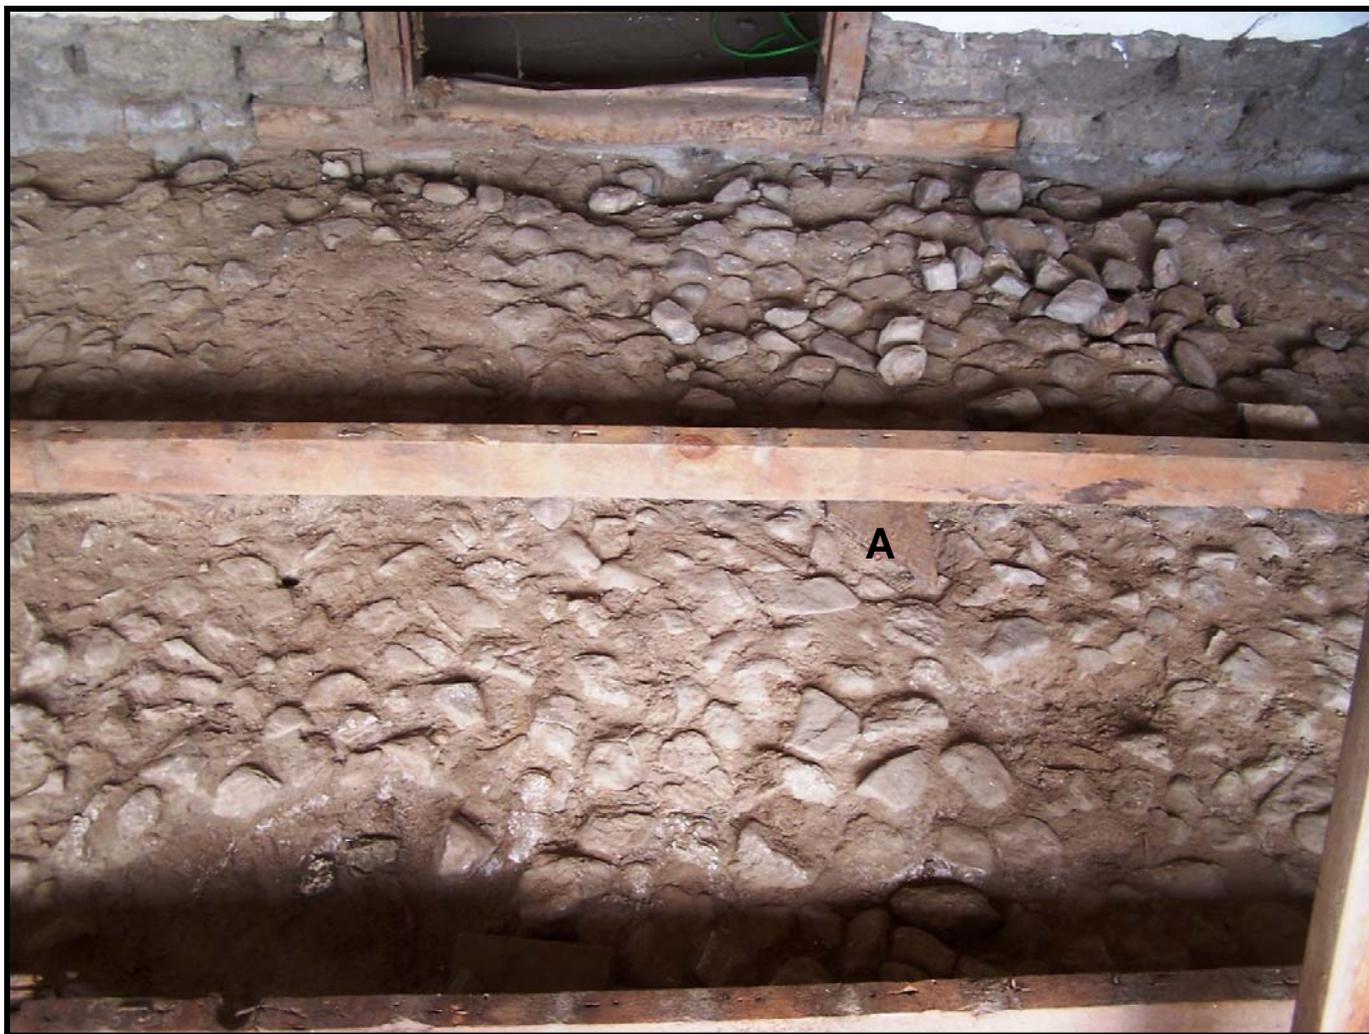
Figure 65: Center portion of the cobble floor uncovered in the north half of Room 103, looking toward the north wall. "A" marks the same reference point as in Figures 64 and 66.

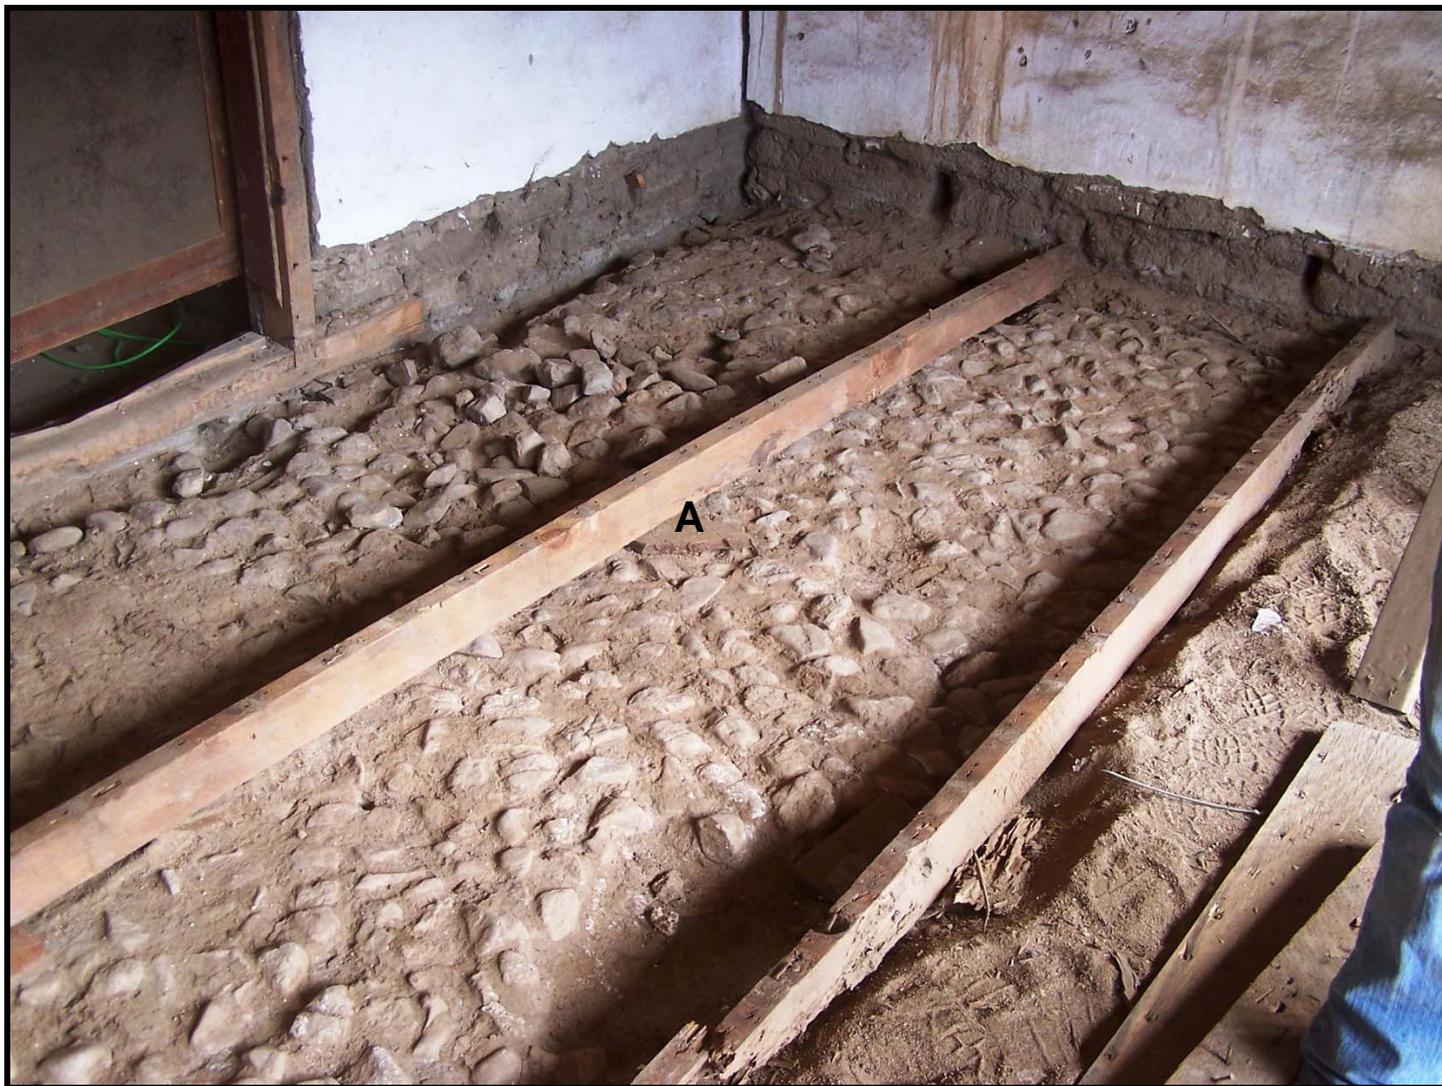
Figure 66: Another view of the cobble floor uncovered in Room 103, looking toward the northeast corner. "A" marks the same reference point as in Figures 64 and 65.

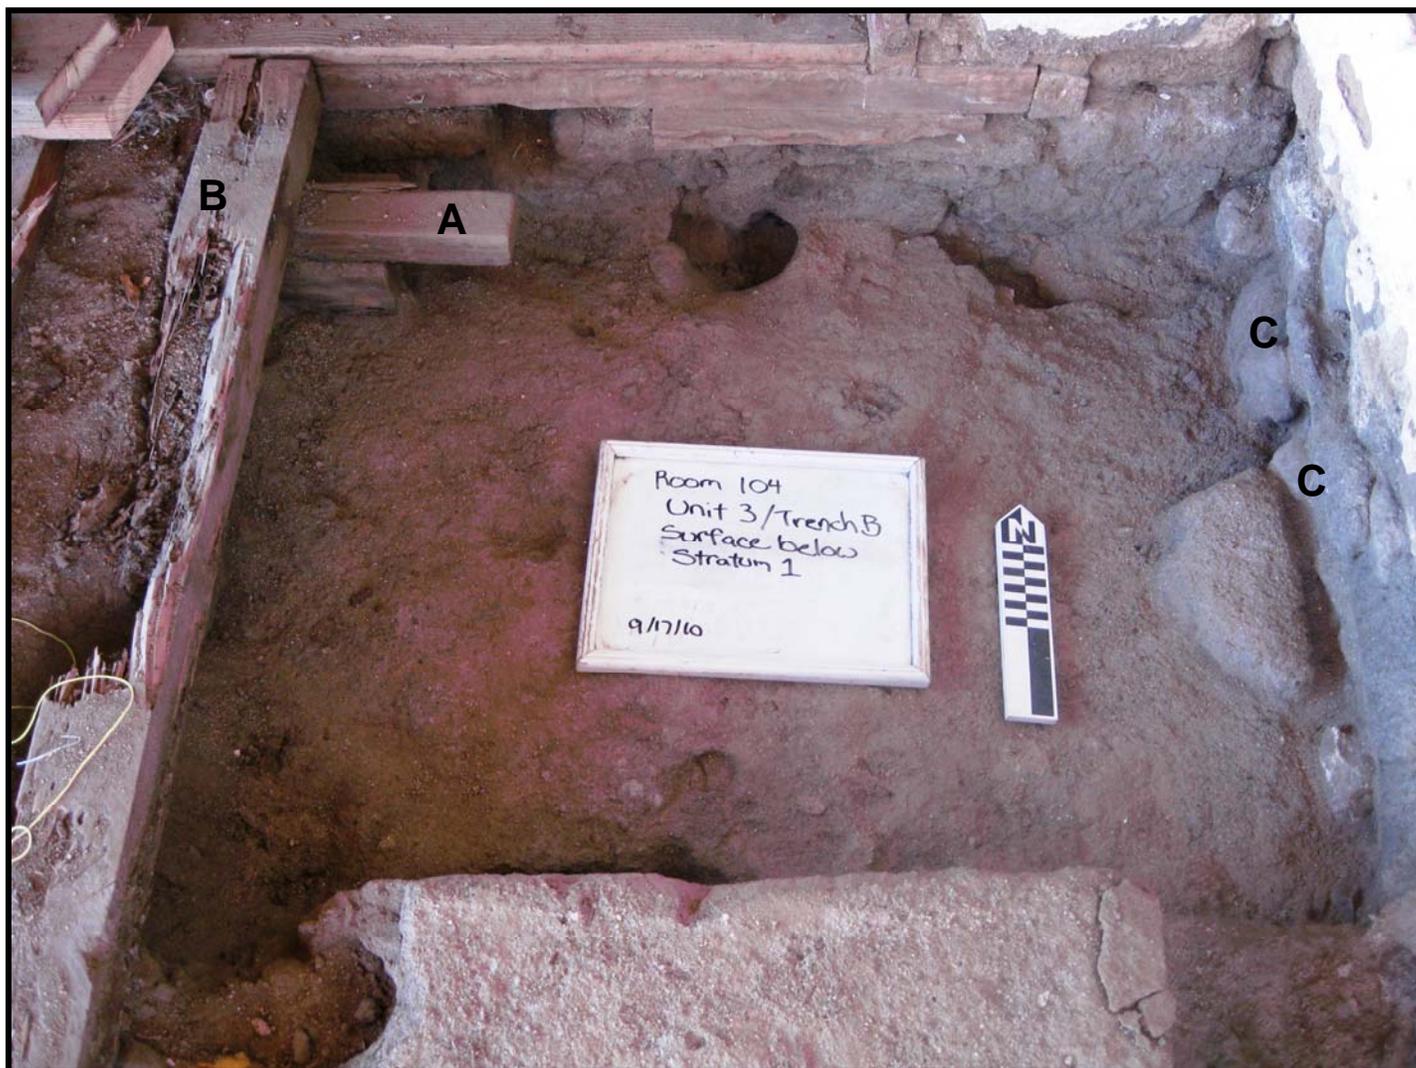
Figure 69: The compact surface uncovered in Room 104, Unit 3. Note the segments of 2 by 4 inch boards (A) supporting the floor sleeper (B) and the tops of the cobbles in the footing of the east wall extended into the compact surface (C), suggesting the use of a shallow trench at this point to accommodate the foundation cobbles.
