**TWO FORKS IN THE ROAD:
TEST EXCAVATIONS OF THE RANCH HOUSE
AT WARNER'S RANCH
(WARNER – CARRILLO RANCH HOUSE)
AND SITE OF
JONATHAN T. WARNER'S HOUSE AND STORE**

VOLUME I: The Ranch House

JULY 2011

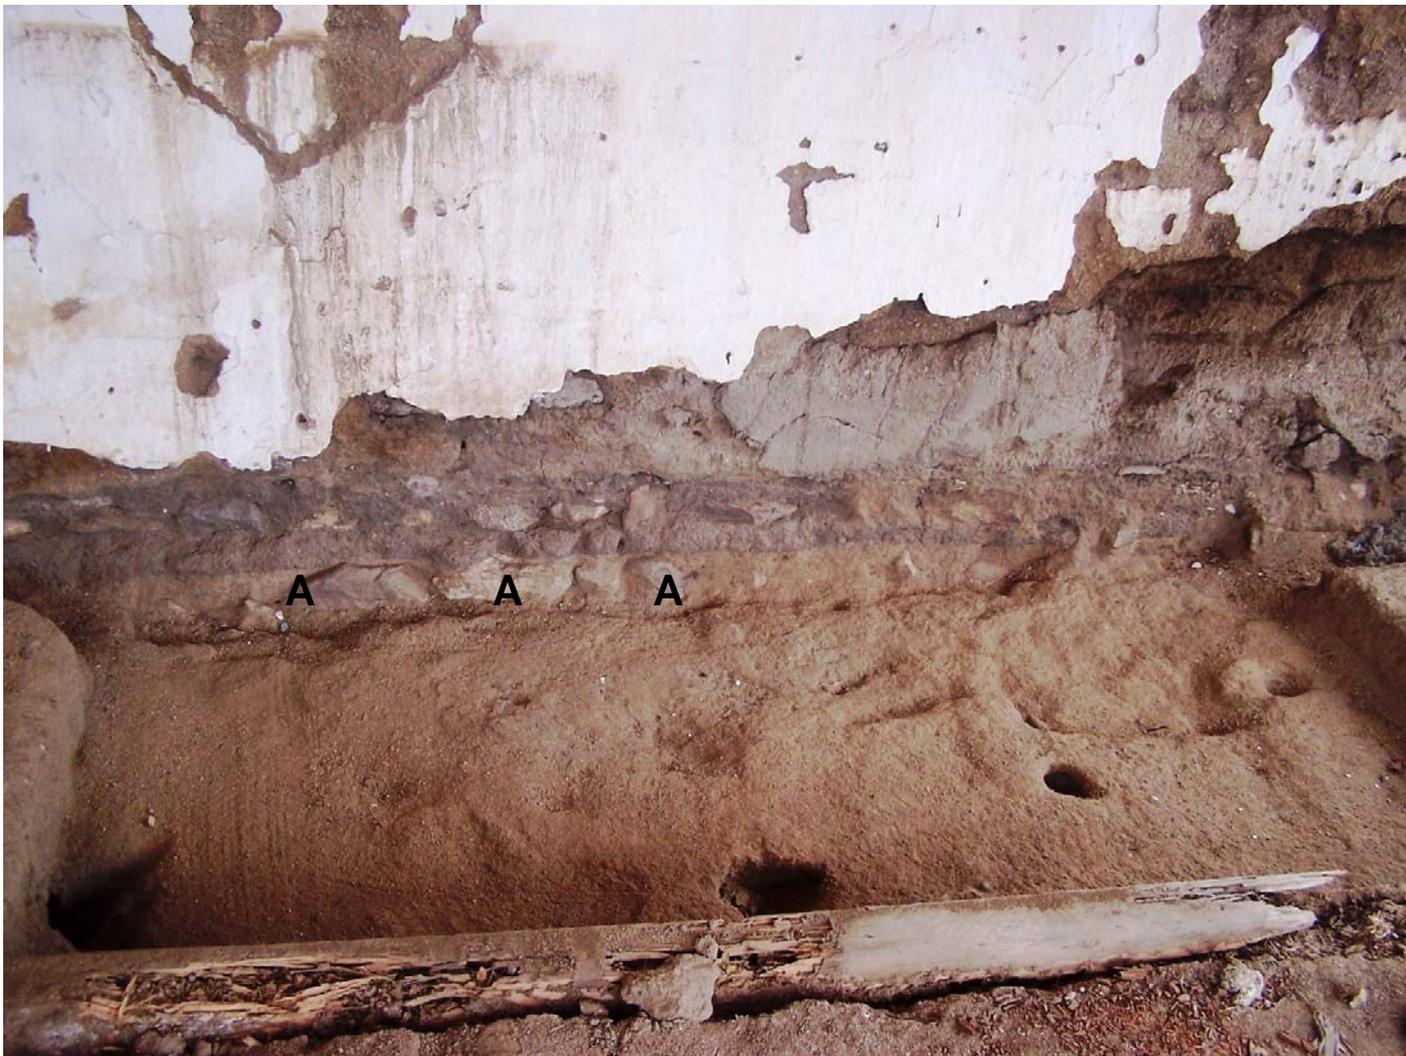
Figure 70: Compact surface uncovered in Trench B, Room 104, looking toward the east wall of the room. Note how the foundation cobbles (A) appear to have been laid upon this surface.

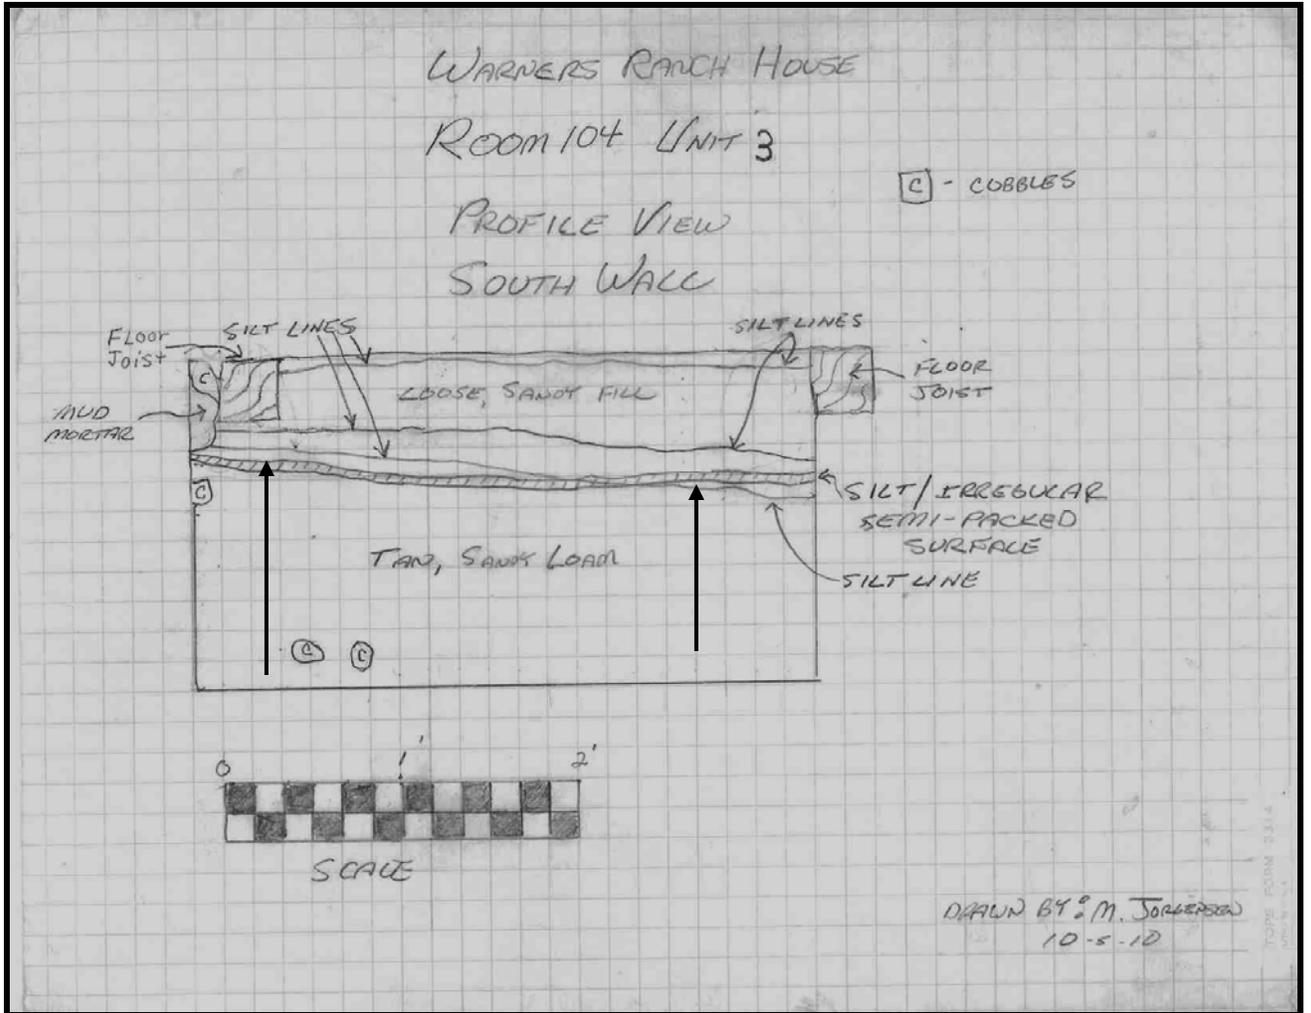
Figure 71: South side wall profile of Unit 3, Room 104, showing a cross section of the packed earthen surface.

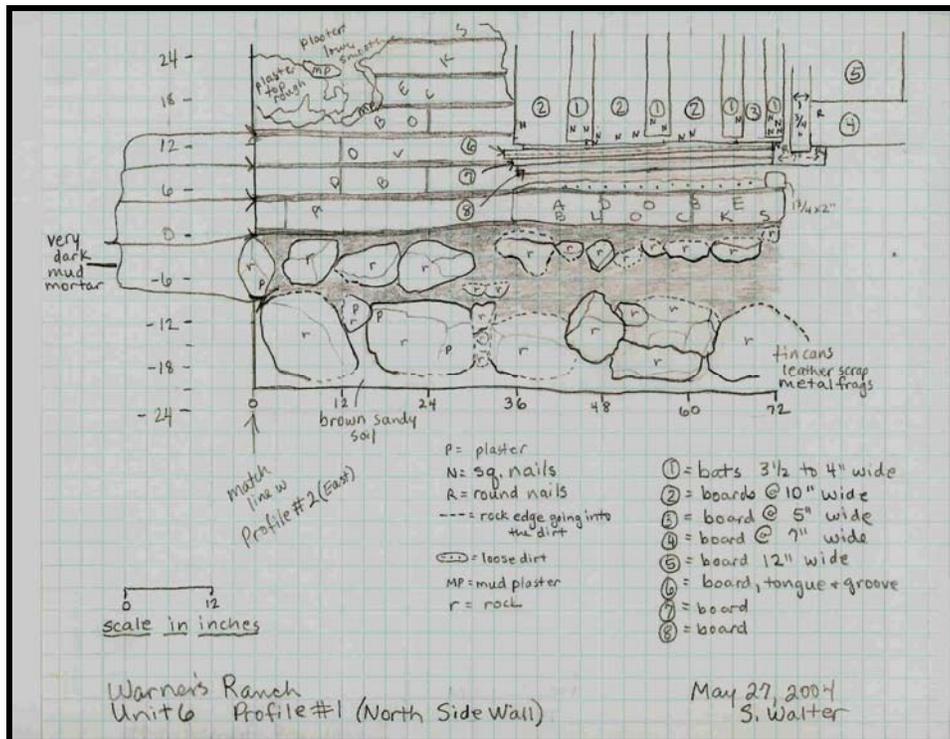
Figure 75: Unit 04-6 south sidewall profile sketch of the stone foundation and adobe block under the wooden infill on the north wall of Room 107.

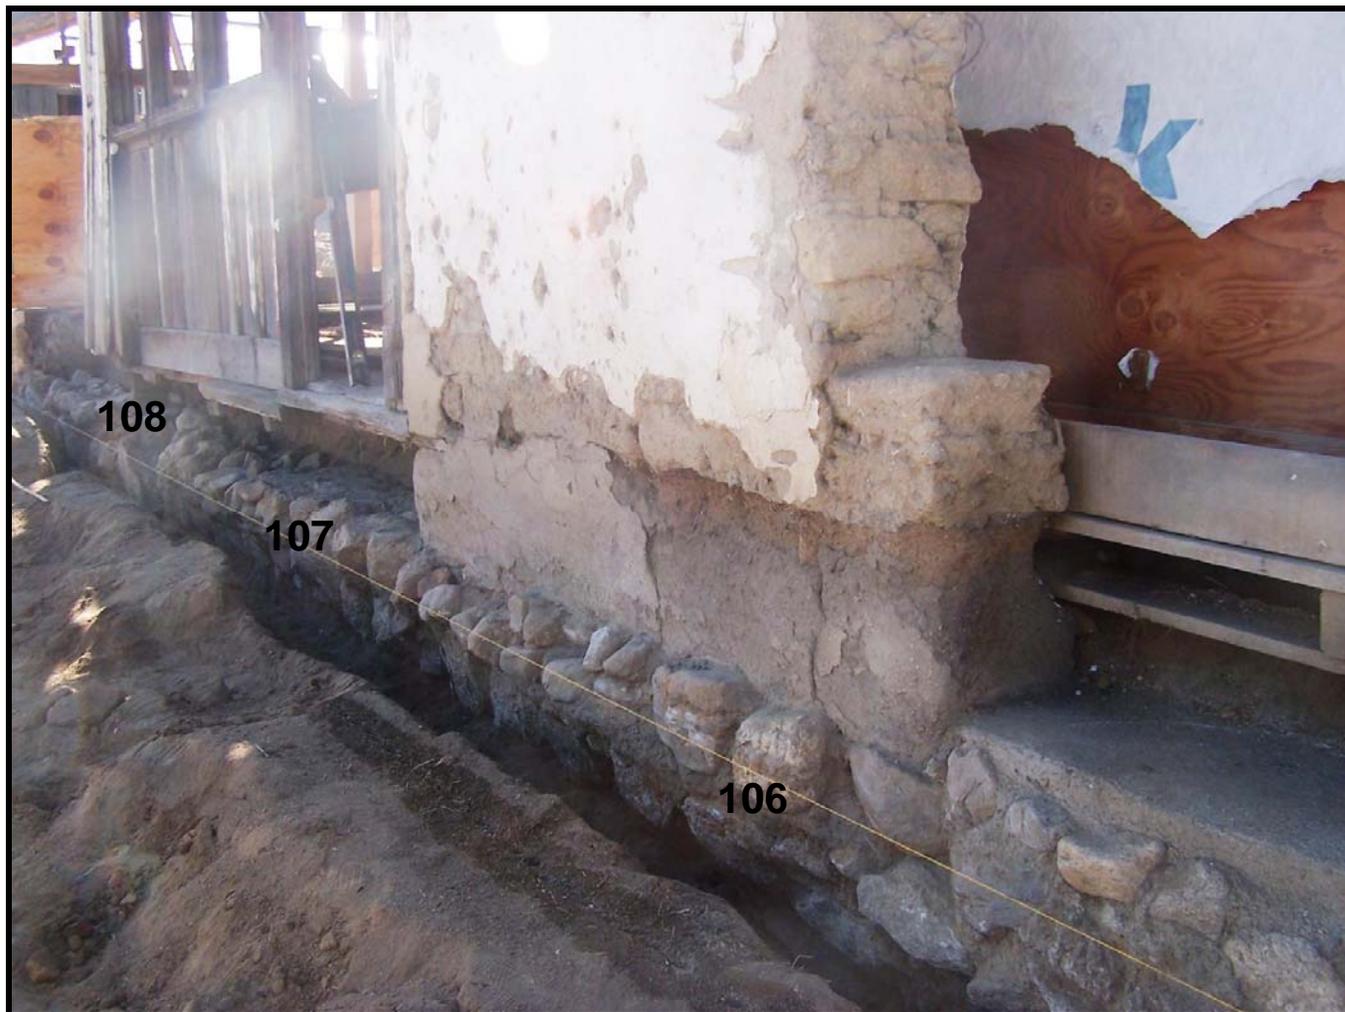
Figure 76: North wall foundation of the North Wing exposed in the restoration construction trench along the northern edges of Rooms 106, 107 and 108. The segment at lower right was capped with concrete during stabilization activities in 2004.

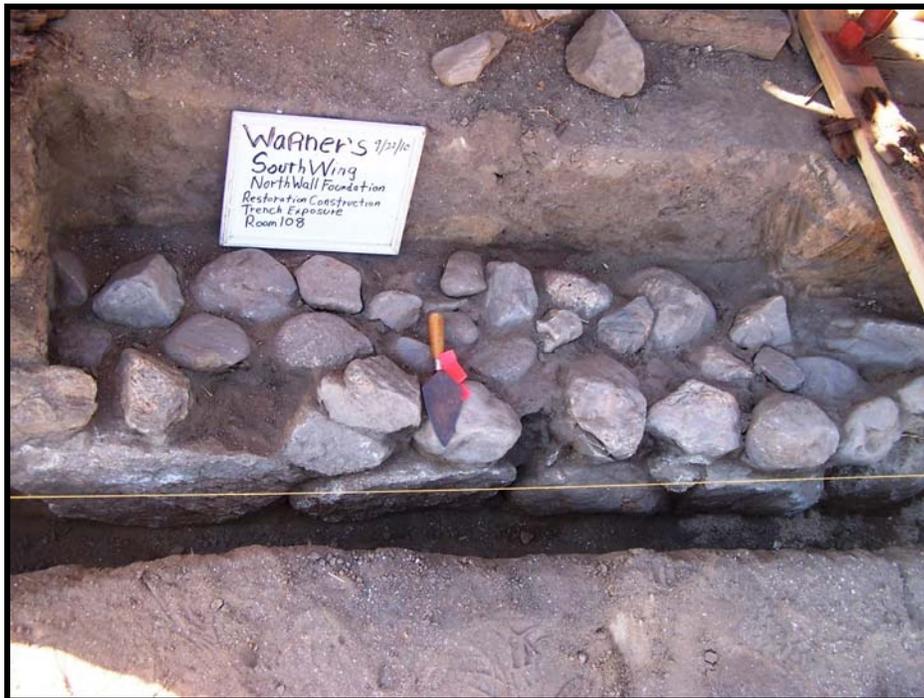
Figure 77: Photograph and profile of north wall foundation of Room 108 exposed in restoration construction trench.

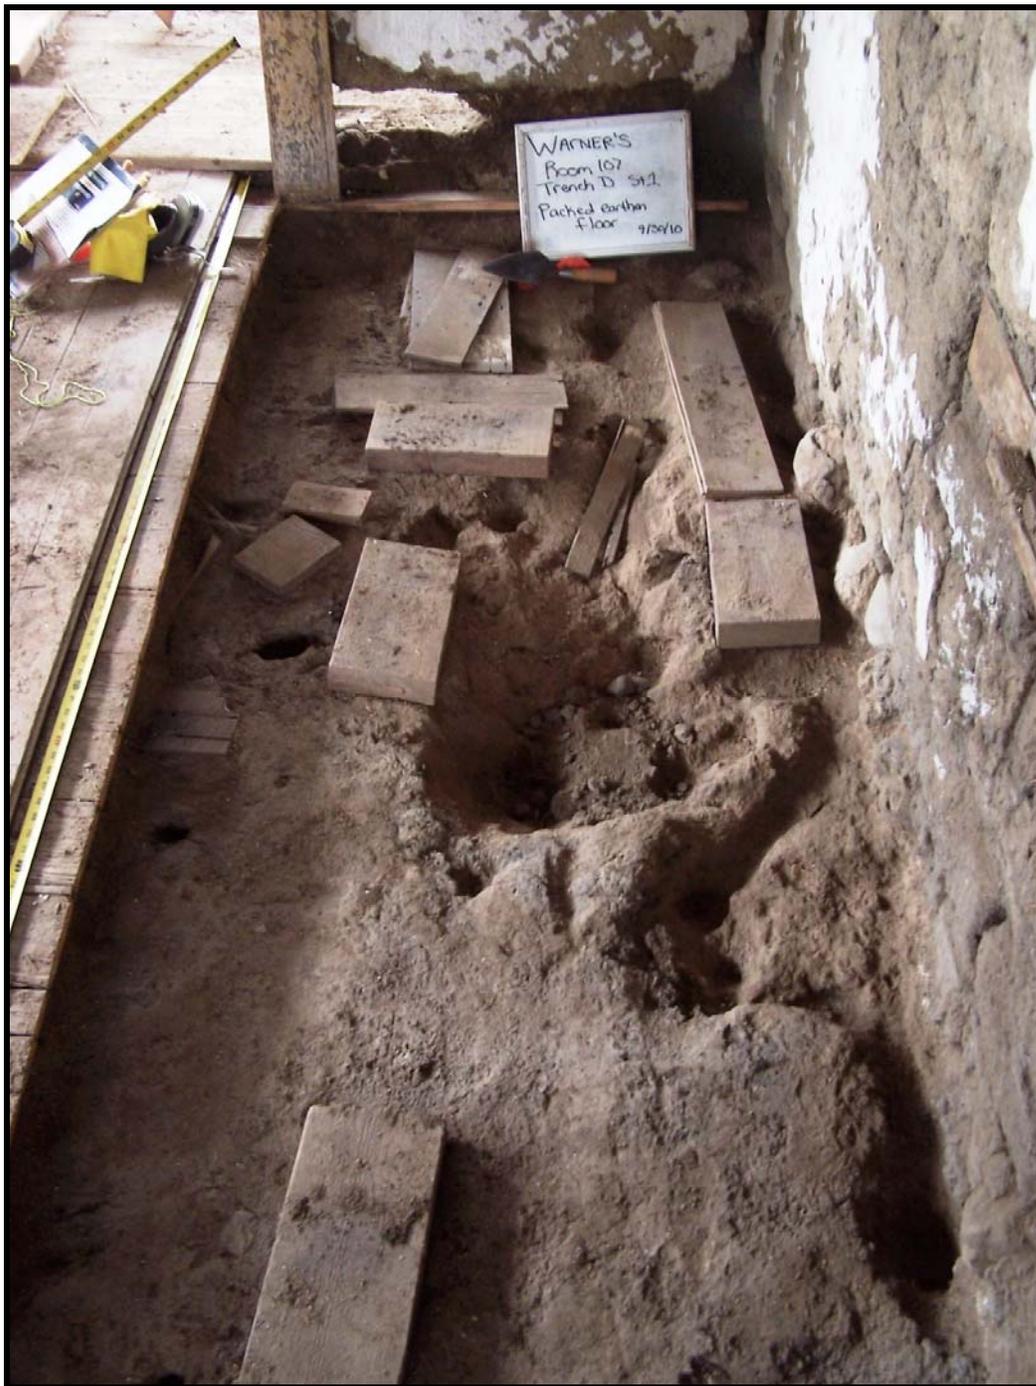
Figure 79: Packed earthen floor uncovered in Trench D, Room 107, looking east. Note the boards placed on the surface to hold sleepers for the later wooden floors and the large holes caused by rodent burrowing.

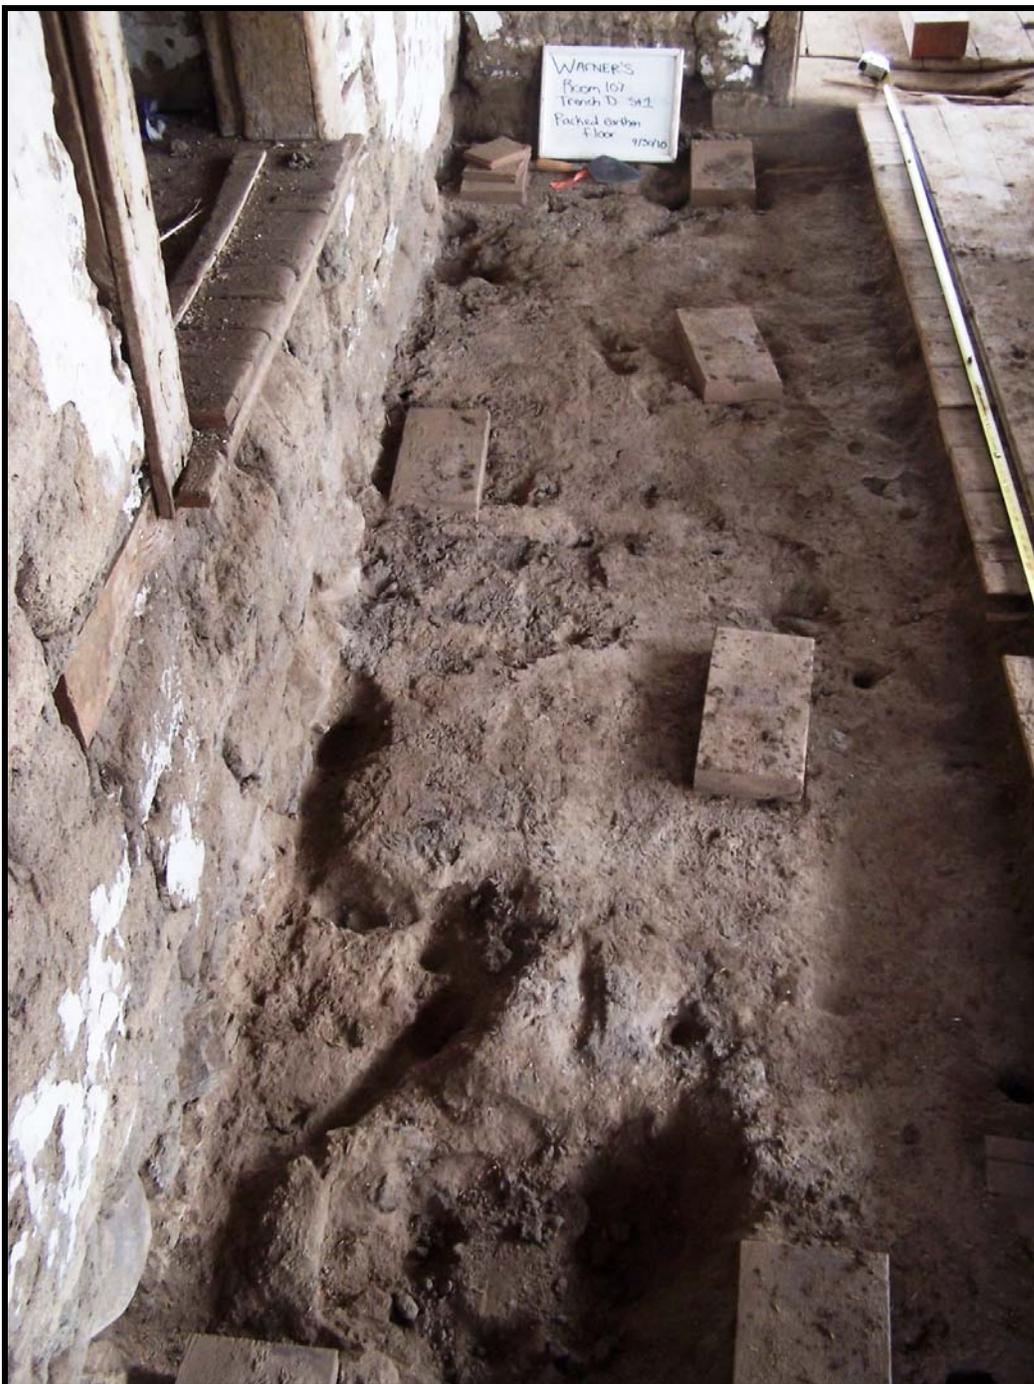
Figure 80: Packed earthen floor uncovered in Trench D, Room 107, looking west. Once again note the boards placed on the surface to hold sleepers for the later wooden floors and the large holes caused by rodent burrowing.

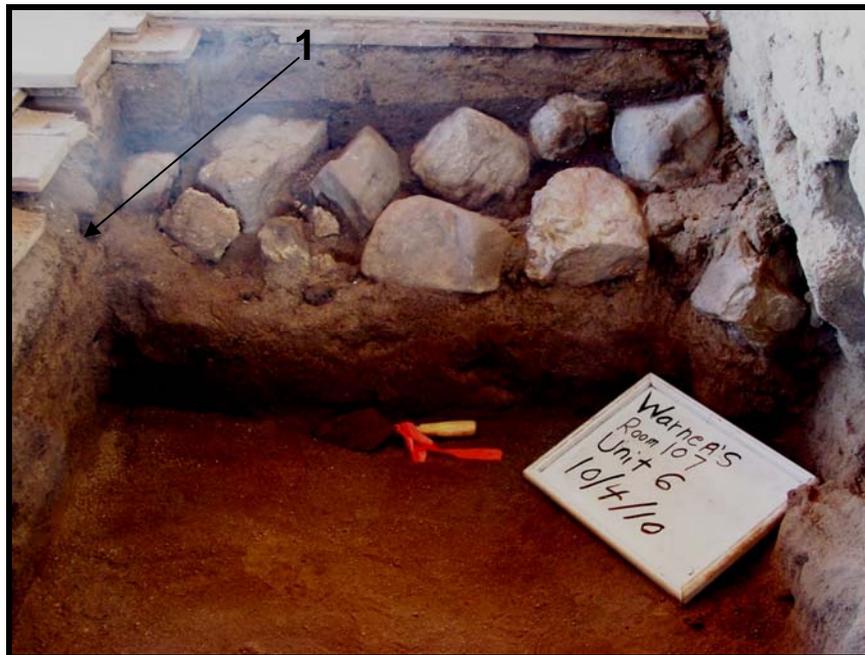
Figure 82: Interior dividing wall foundation between Rooms 107 and 108 as seen in the east sidewall of Unit 10-5 in Room 107. The dark brown band is the mud mortar in the south side wall profile shown above. Point 1 is the same location in both figures and shows the contact between the wall mortar and the earthen floor. The Photo ID Board is incorrectly labeled Unit 6.

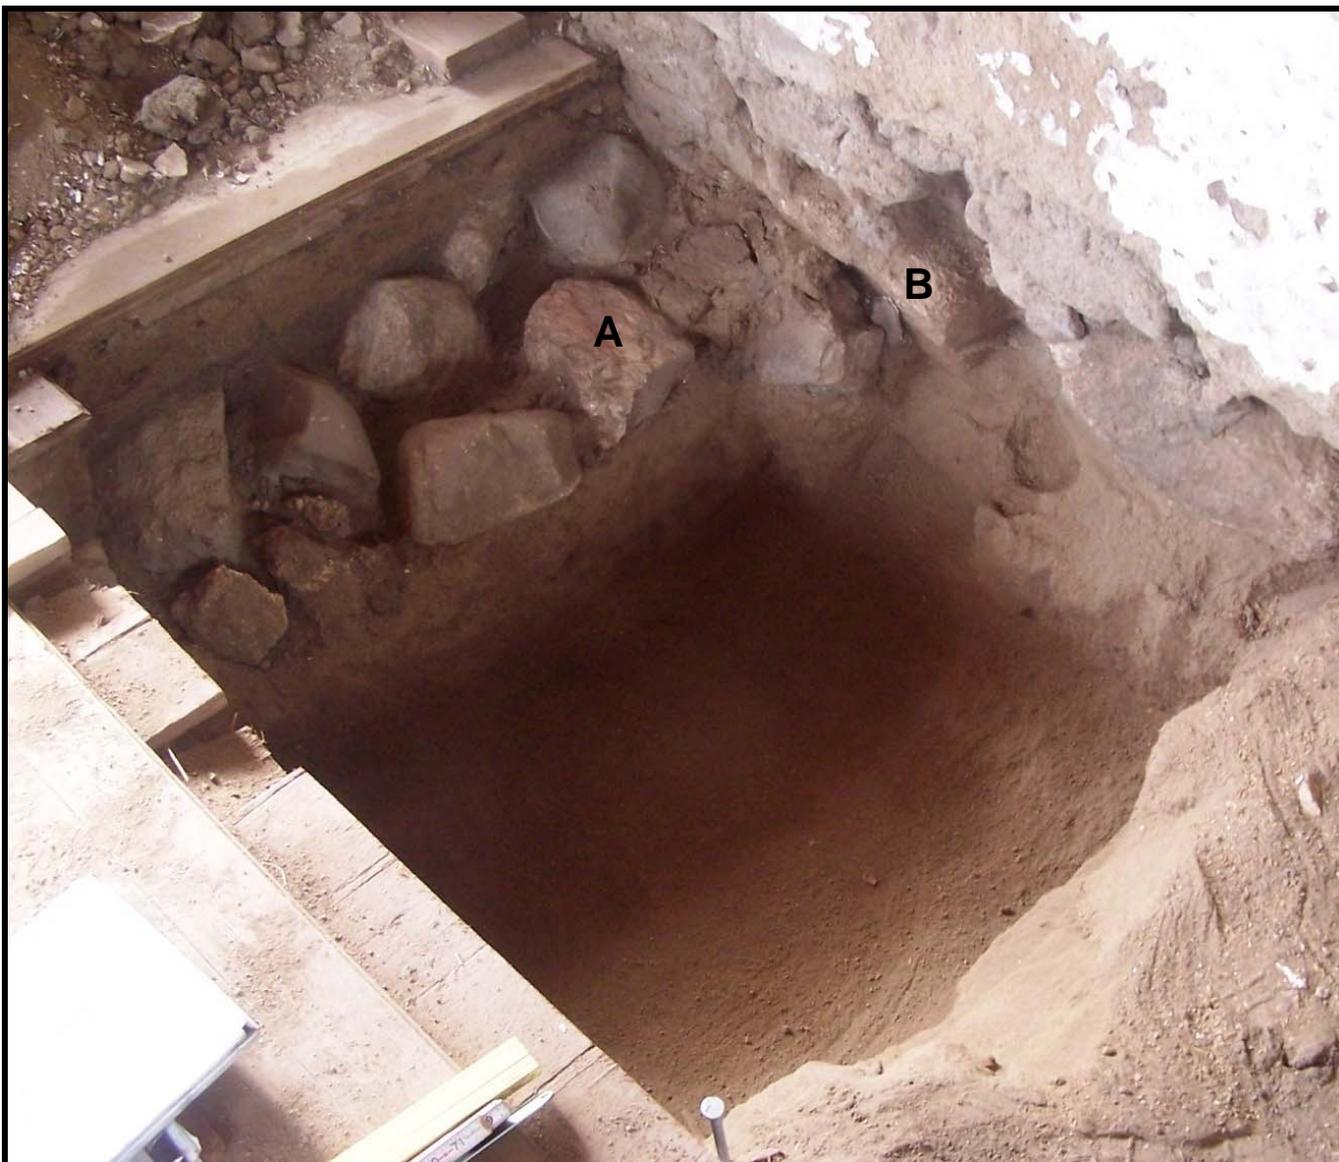
Figure 83: The single course cobble foundation for the dividing wall between Rooms 107 and 108 (A) built against the irregular granite field stone footing of the north wall of Room 105 (B).

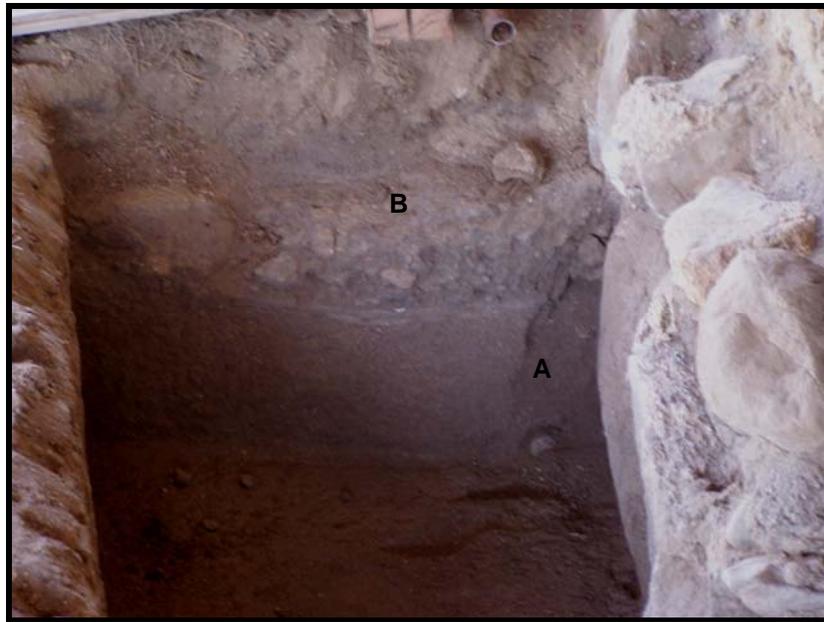
Figure 86: East sidewall of Unit 04-6, showing the builder's trench for the north wall foundation (A), and the packed mud surface of the original porch (B)

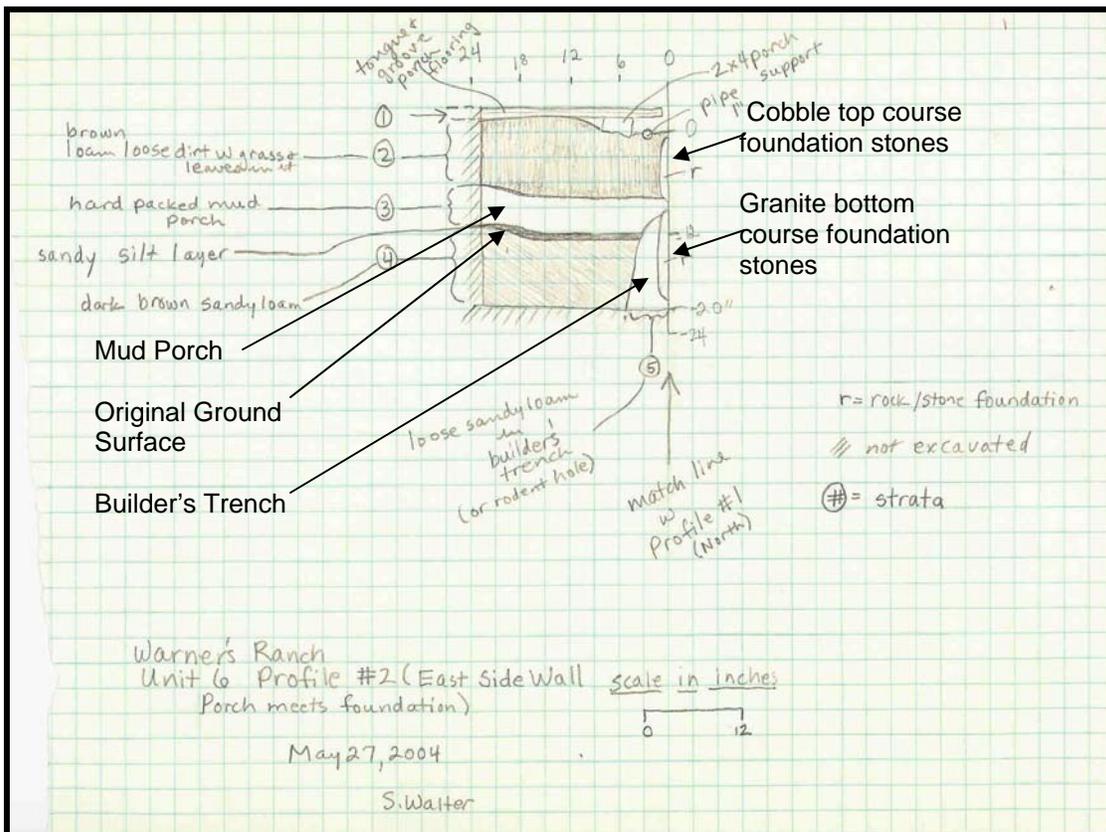
Figure 87: Unit 04-6 east sidewall profile. Note the packed mud porch (#3), the builder's trench (#5), and the sandy silt layer at the original ground surface.

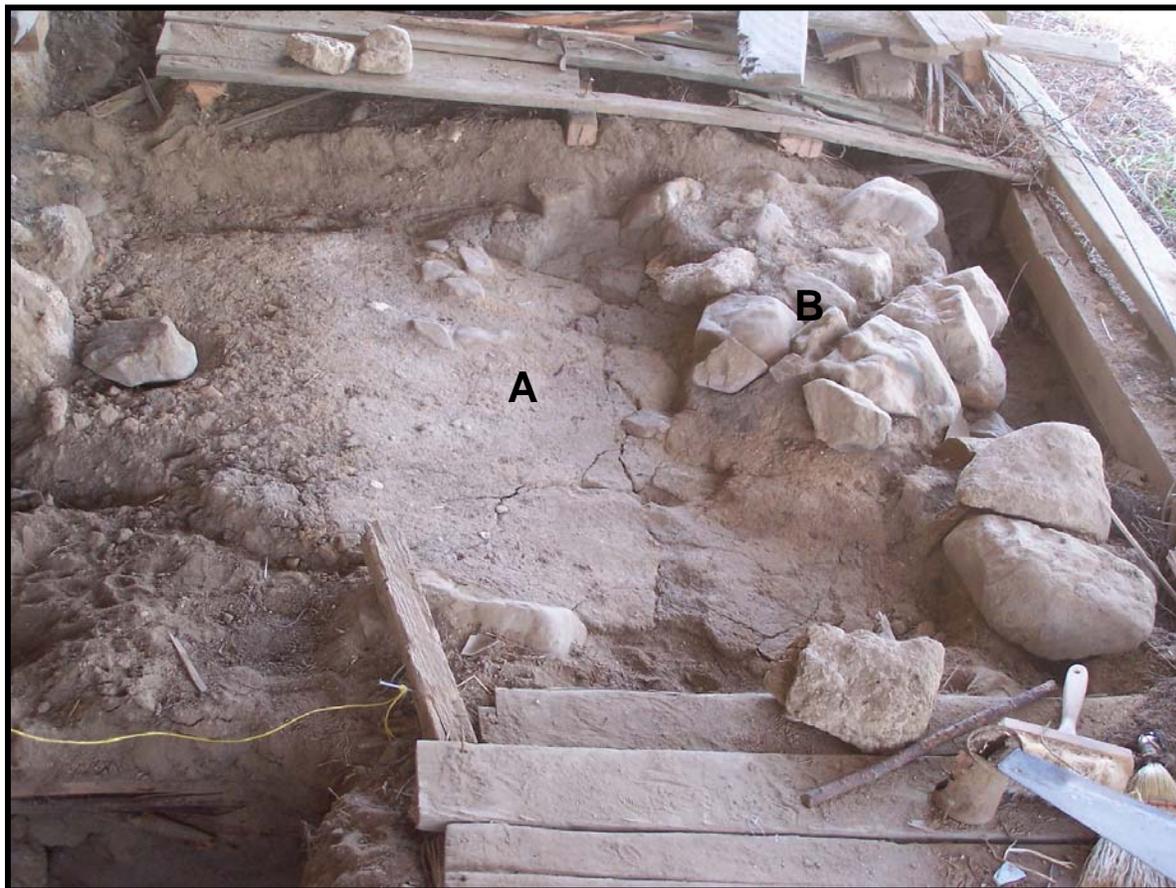
Figure 88: An area of the original porch cleared of debris. Note the hard packed earthen surface that appears to have been laid as a mud slurry (A) and the shallow cobble footing along the north edge (B).

ground surface. In places the tan colored slurry has been patched with dark brown mud, apparently to restore a level surface in areas that had become worn and rough (Figure 88).

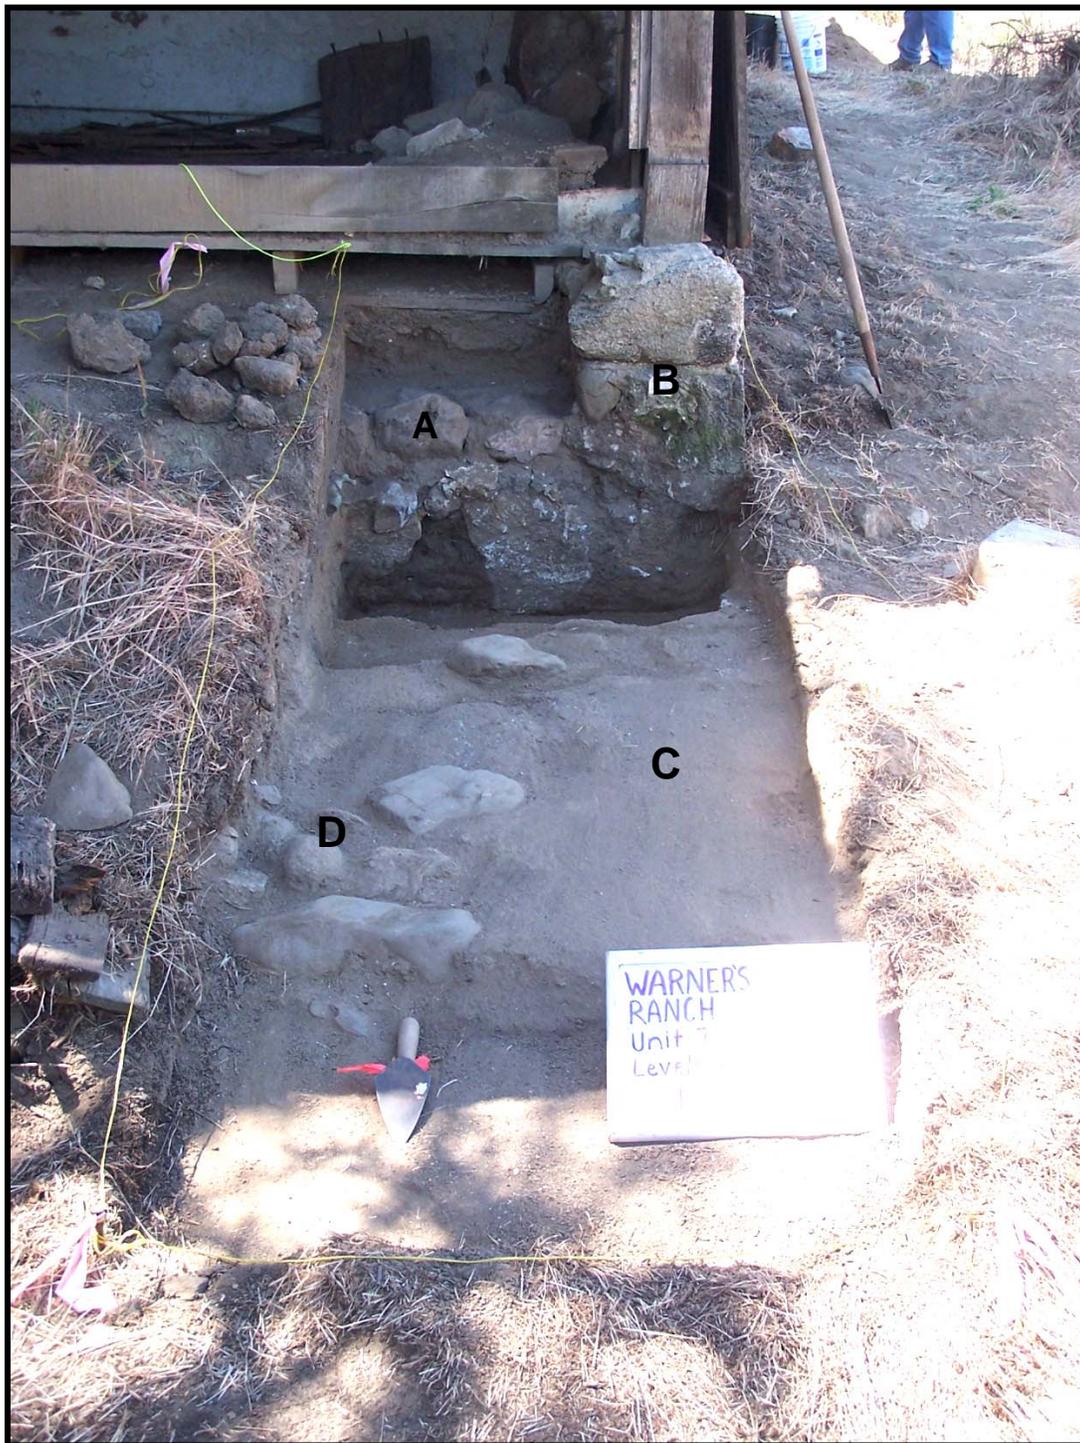
Figure 89: Unit 04-7, looking south. Note the stone foundation of the north wall (A), the north end of the cement mortared stone facing along the west wall (B), the original surface of the packed mud porch (C), and the cobble footing along the north edge of the mud porch (D).

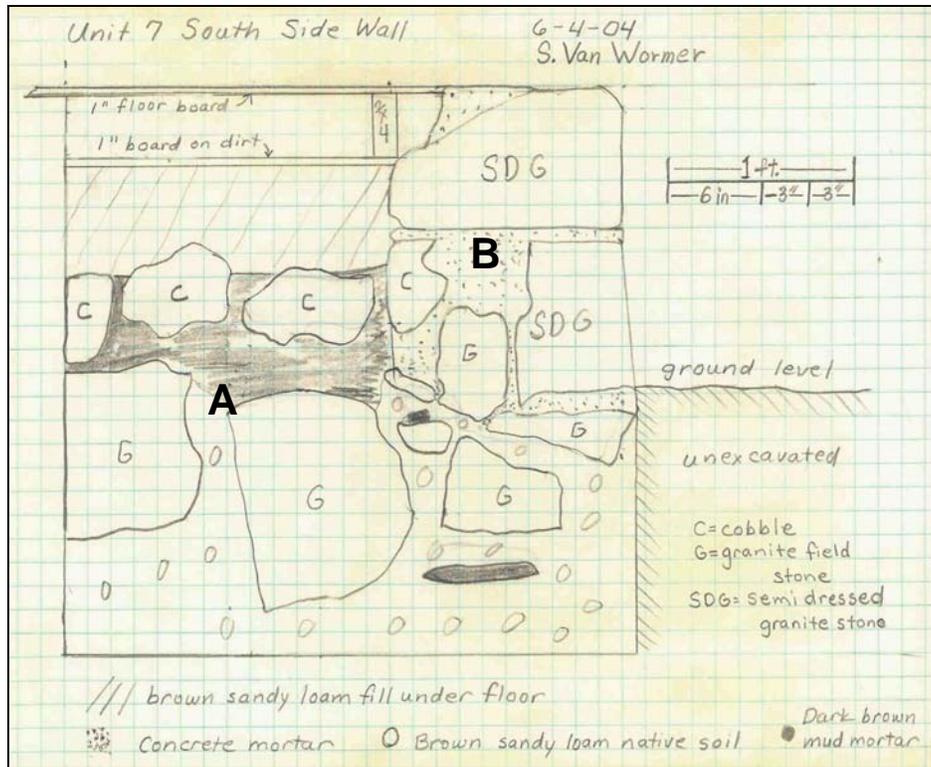
Figure 90: Unit 04-7 south sidewall profile showing the stone foundation of the North Wing's north wall (A), and the mortared stone facing of the east wall (B).

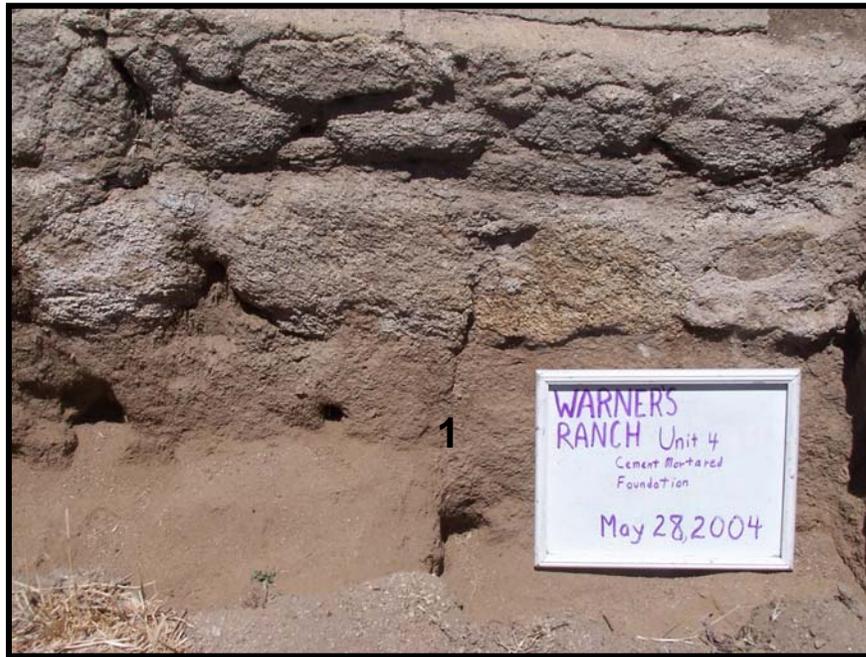
Figure 94: Photograph and profile of the cement mortared facing at the base of the Ranch House east wall in Unit 04-4. The number 1 indicates the same location in the drawing and photograph.

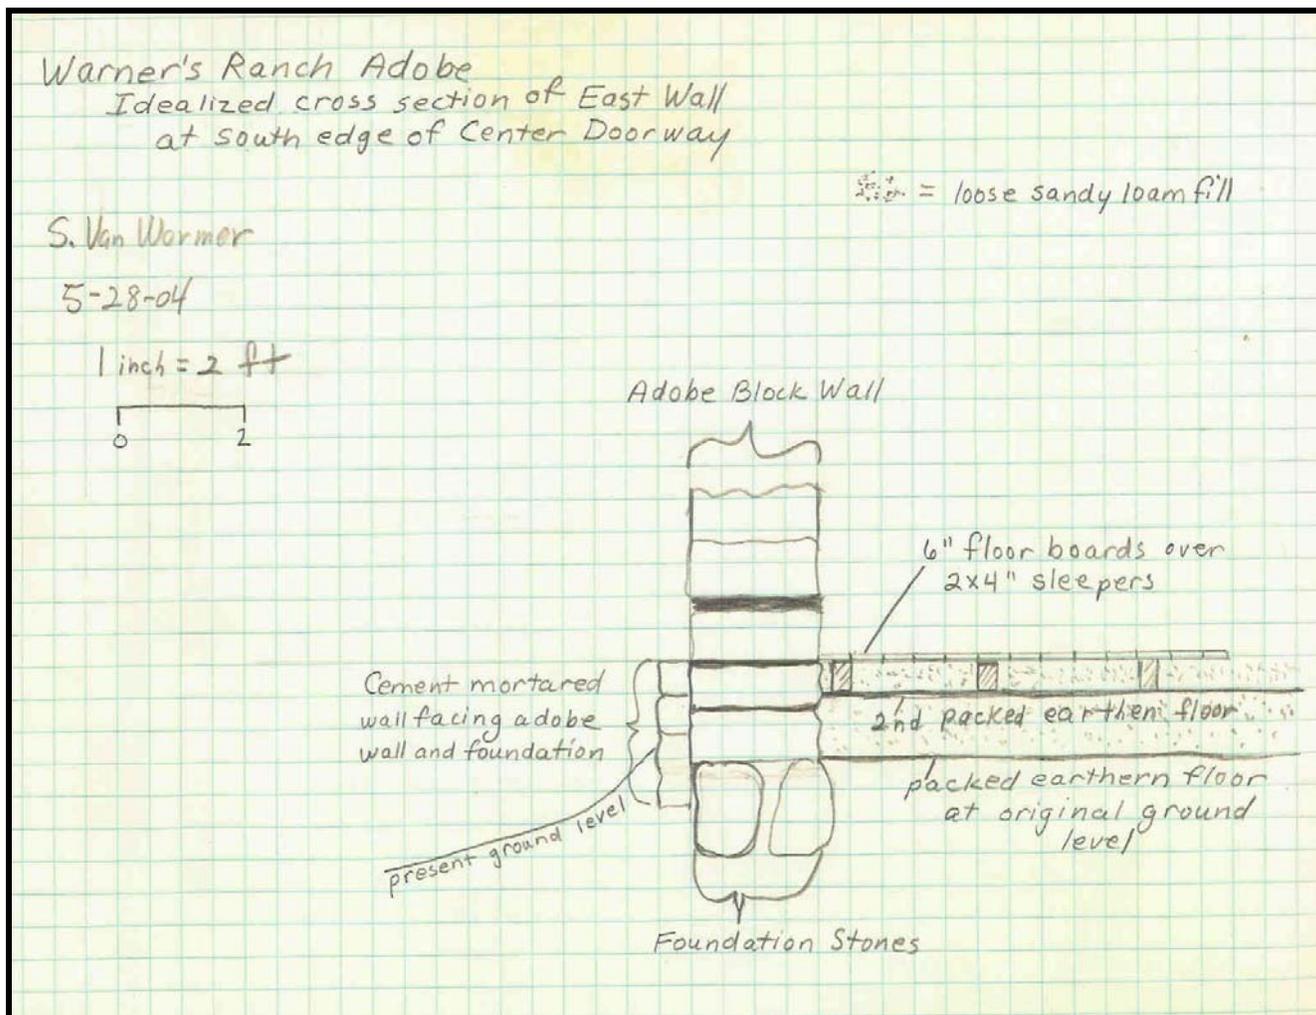
Figure 96: Idealized cross section of the base of the east wall of the Ranch House at the south edge of the center doorway, showing how the cement facing covers both bottom course of adobe block and the upper part of the original granite field stone foundation. The various levels of the packed earthen floors encountered while excavating the interior of the Entry Room (101), as well as the current wooden floor are shown.

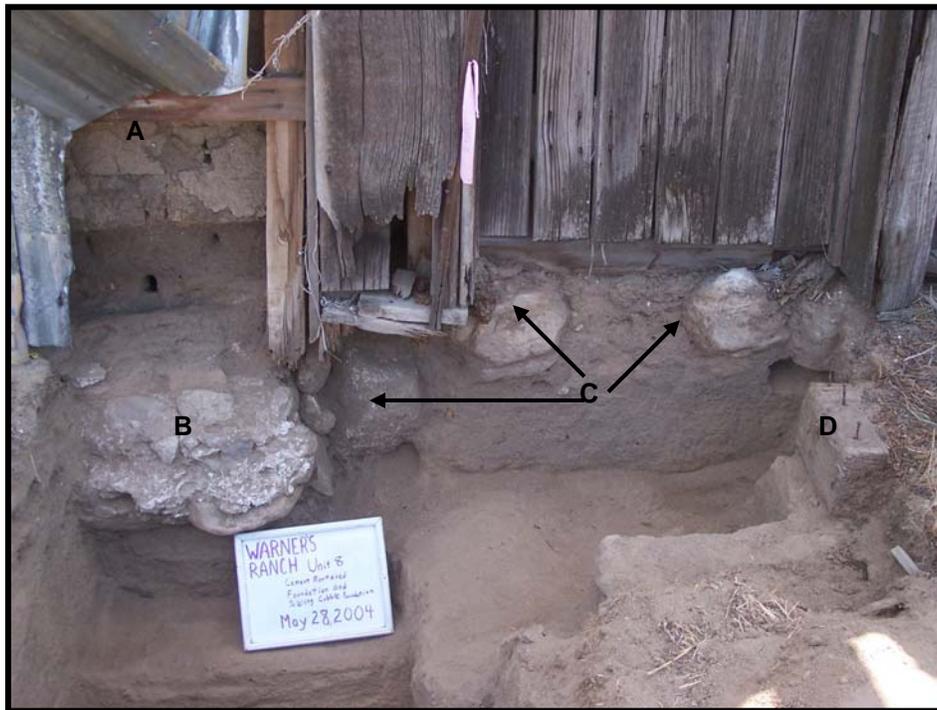
Figure 98: Unit 04-8, showing the adobe blocks of the west wall of the Central Wing (A), lime mortared cobble facing on the foundation of the Central Wing (B), and the remains of the cobble foundation for the original adobe wall on the west side of the South Wing (C), and wood support for the late 19th century addition (D).

The original exterior adobe west wall of the South Wing had been entirely removed. Two large rounded granite cobbles represent the remains of a stone foundation that originally supported an adobe wall, but even this foundation had been highly disturbed, and at this point was in worse condition than the footing remains along the south wall. As with the south wall, the interior board siding along this wall contains square nails where they were attached to the original adobe wall. The exterior construction was done with round nails. During the late 19th century a wooden addition was built onto this side of the Ranch House (see Figures 9-11). Two 4 by 6 by 12 inch wooden supports for this addition were still present on the ground surface prior to excavation (see Figures 98-99).

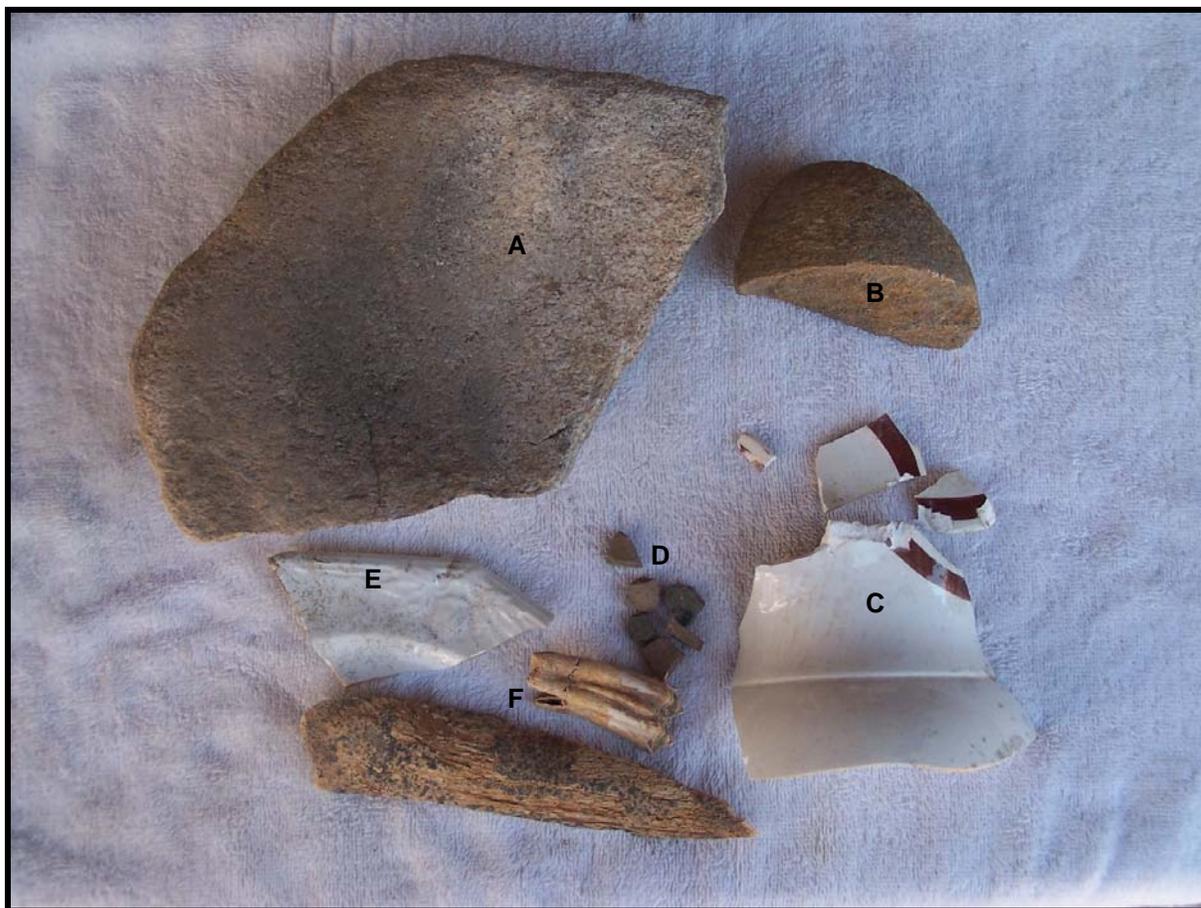
Figure 100: Artifacts from the refuse pit in Unit 04-8: (A) metate fragment, (B) mano fragment, (C) hand painted ewer, (D) Native American pottery sherds, (E) molded decorated plate, and (F) butchered beef bone fragments. The metate is approximately 10 inches across at its widest point.

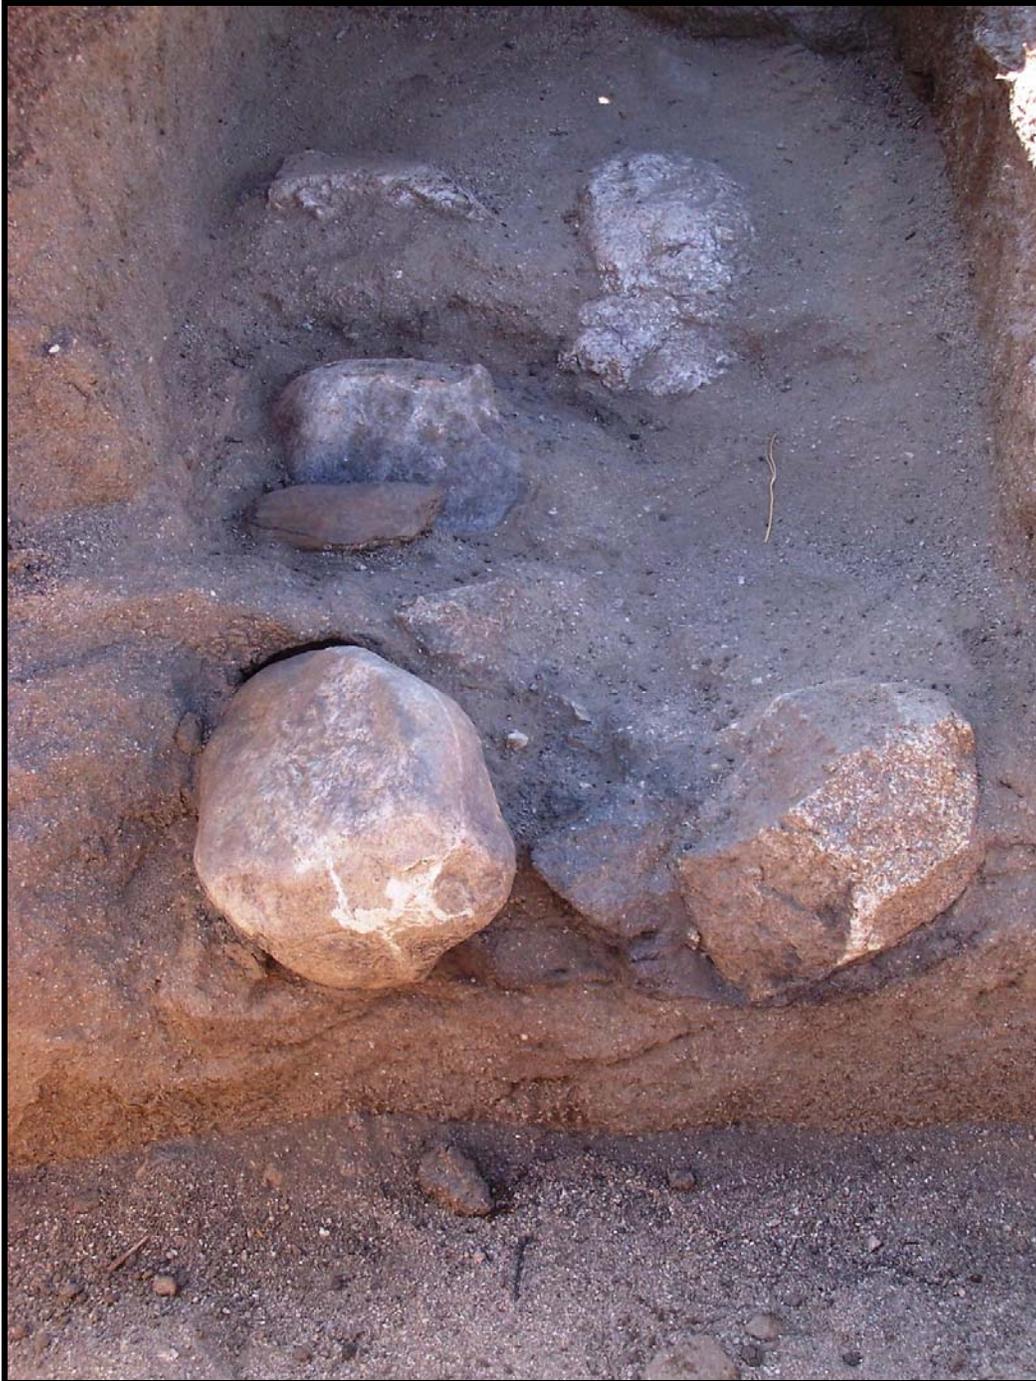
Figure 103: Southern portion of the cobble stone alignment in Trench D.

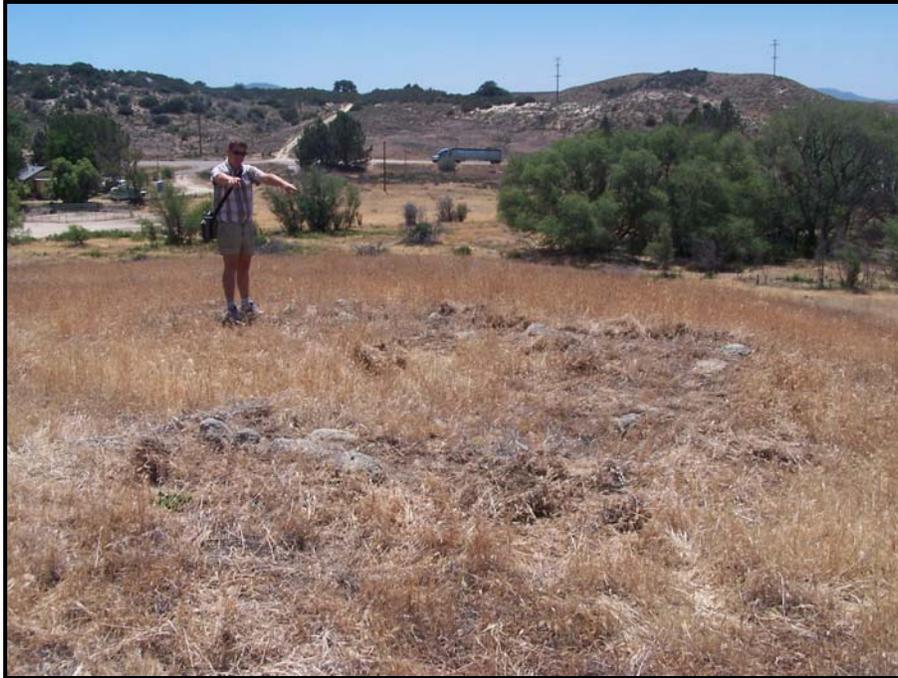
Figure 5: Historian Chris Wray points to the corners of a small rectangular cobble foundation (Feature A) near the location where Reynolds mapped the ruins of Warner's blacksmith shop in 1870.

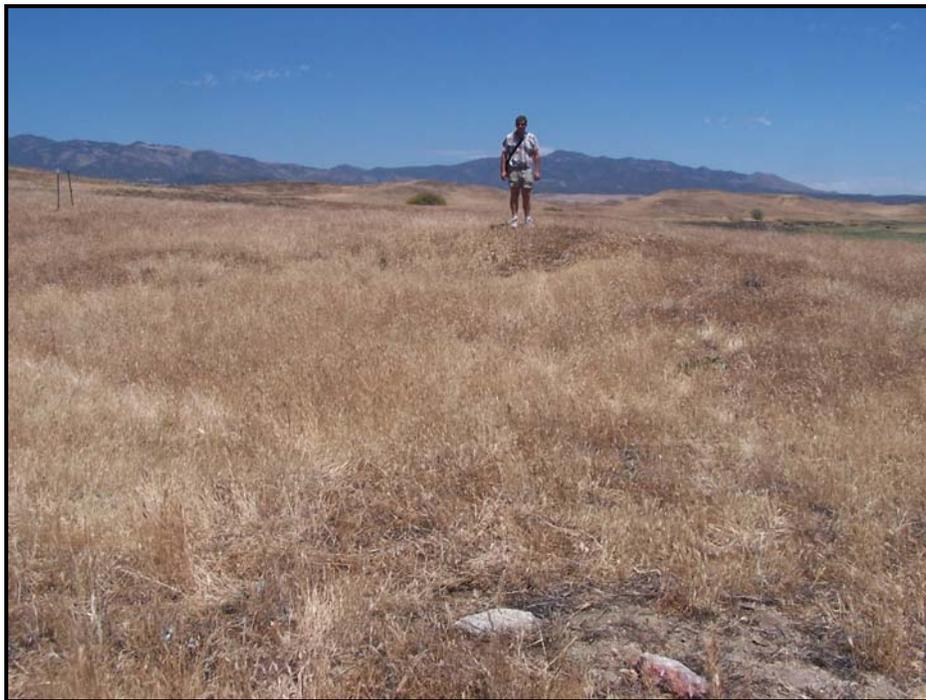
Figure 6: Chris Wray is standing on a rectangular earthen mound (Feature B) directly east of the cobble foundation shown in Figure 5.
