**TWO FORKS IN THE ROAD:
TEST EXCAVATIONS OF THE RANCH HOUSE
AT WARNER'S RANCH
(WARNER – CARRILLO RANCH HOUSE)
AND SITE OF
JONATHAN T. WARNER'S HOUSE AND STORE**

VOLUME I: The Ranch House

JULY 2011

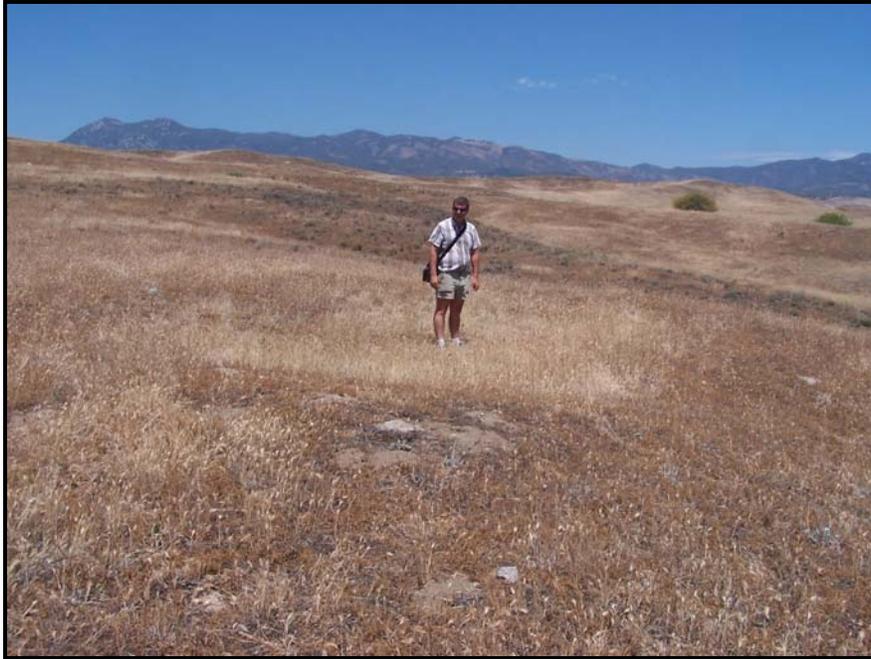
Figure 7: Chris Wray standing in one of several shallow rectangular depressions (Feature C) located approximately 100 feet east of the cobble foundation shown in Figure 5 and approximately 50 feet northeast of the reservoir shown in Figure 4.

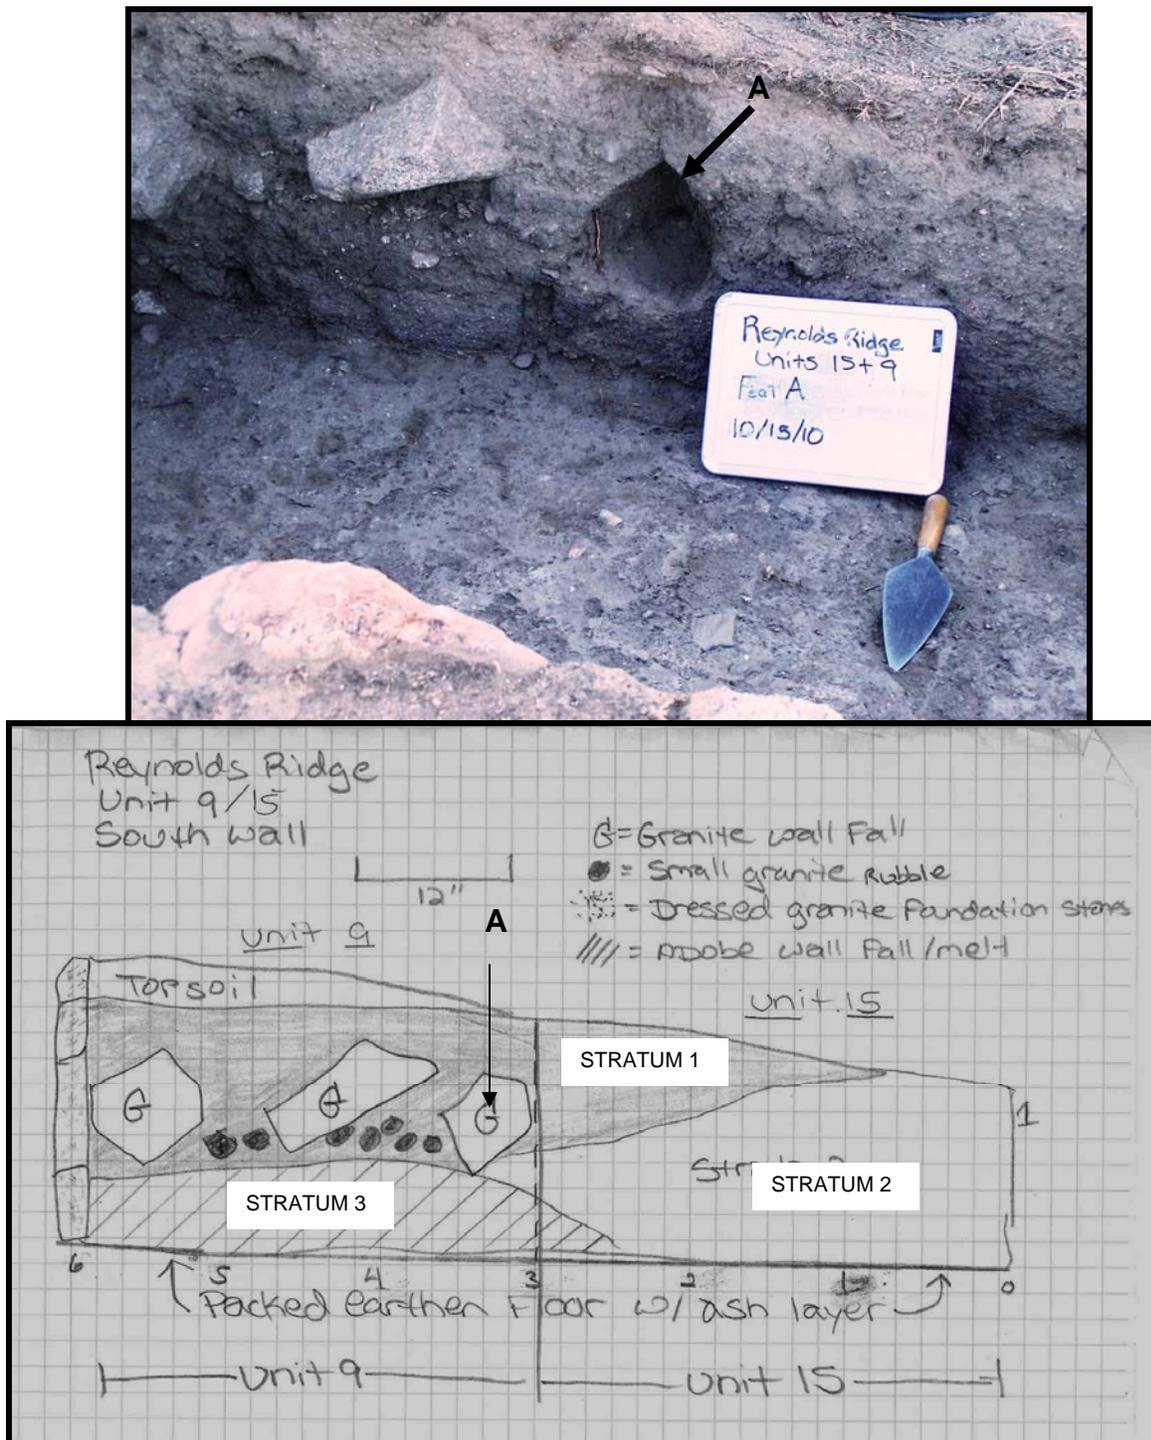
Figure 11: South side wall of Units 9 and 15 showing soil stratigraphy. Point A is the same in the photo and the sketch. The granite wall fall piece had fallen out of the side wall before the photograph was taken, leaving the hollow where it had been.

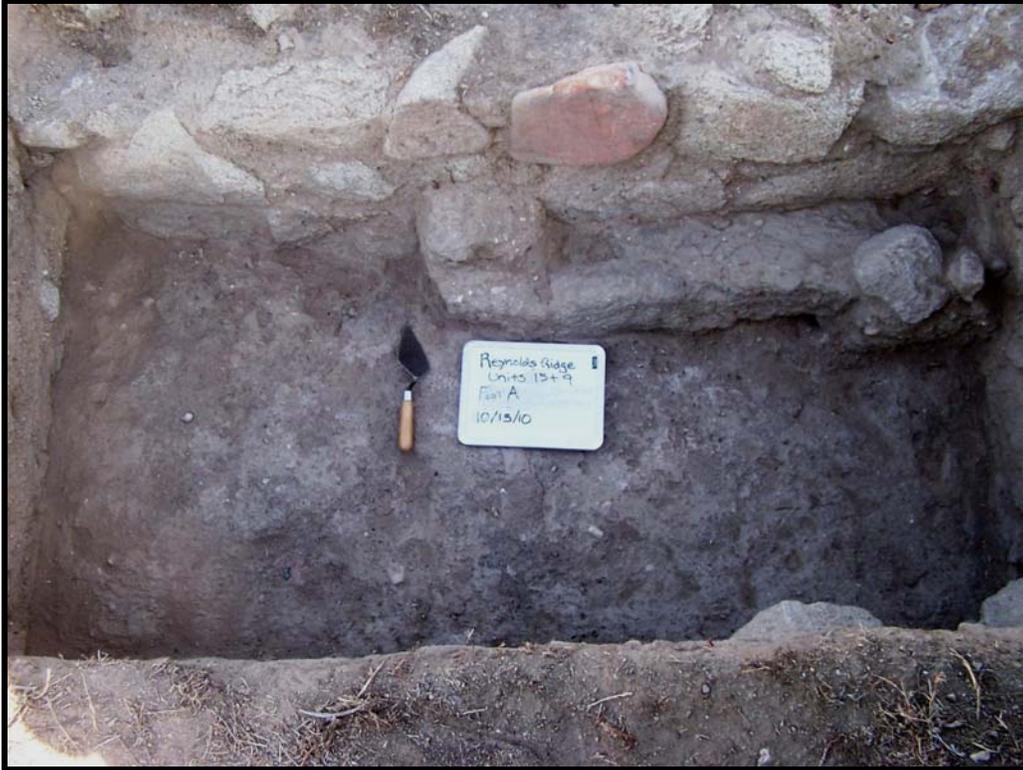
Figure 13: Feature A packed earthen floor in Units 9 (right) and 15 (left).

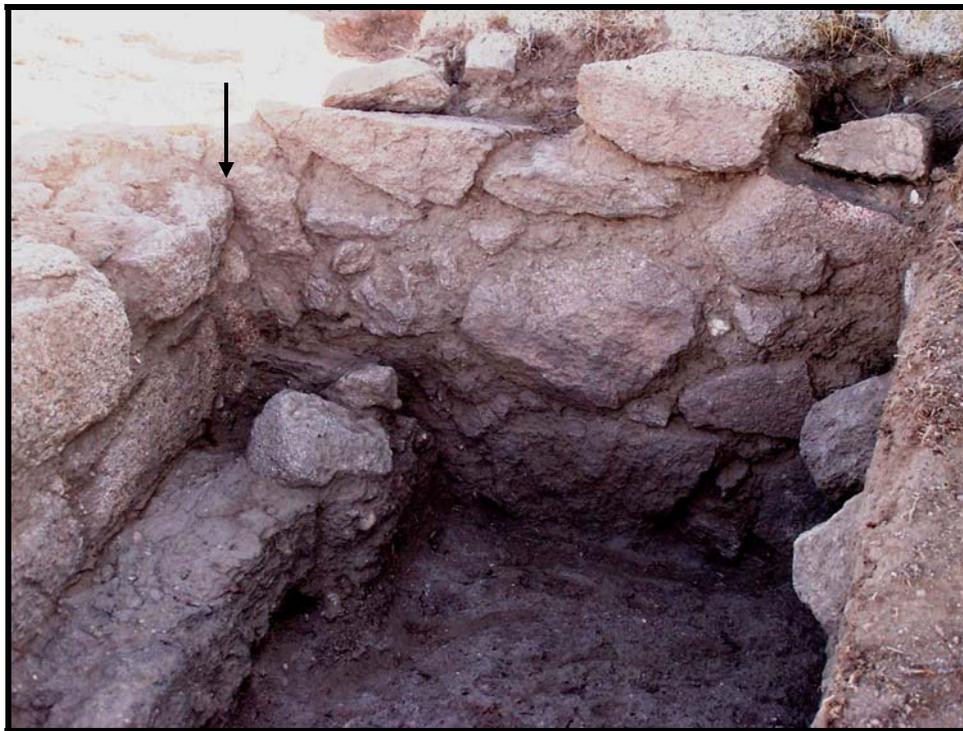
Figure 14: Northeast corner of Feature A in Unit 9. Note how well the corner is tied together as a single construction episode.

At the interior northeast corner, in Unit 9, the north and east wall were tightly tied together in a single unit suggesting a single construction episode for the feature (Figure 14). At the southeast and southwest corners in Units 18 and 26 no evidence for a southern cross wall was encountered indicating the structure may have been open on the south end (Figures 15 & 16).

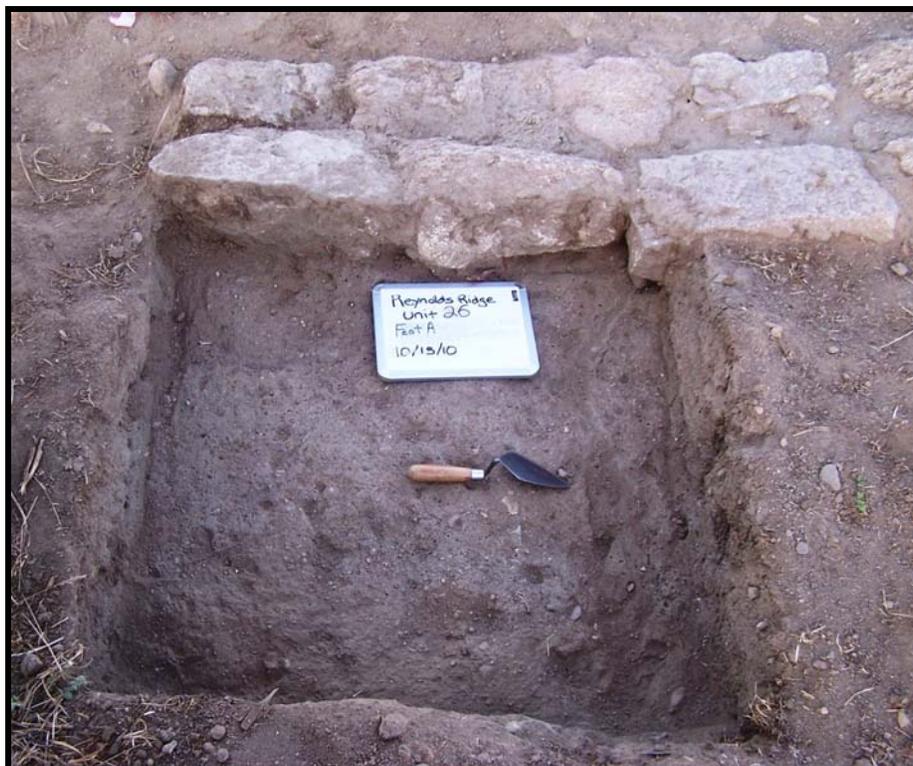
Figure 15: West wall foundation and packed earthen floor in Unit 26 at the southwest corner of Feature A. There was no evidence of a southern connecting wall.

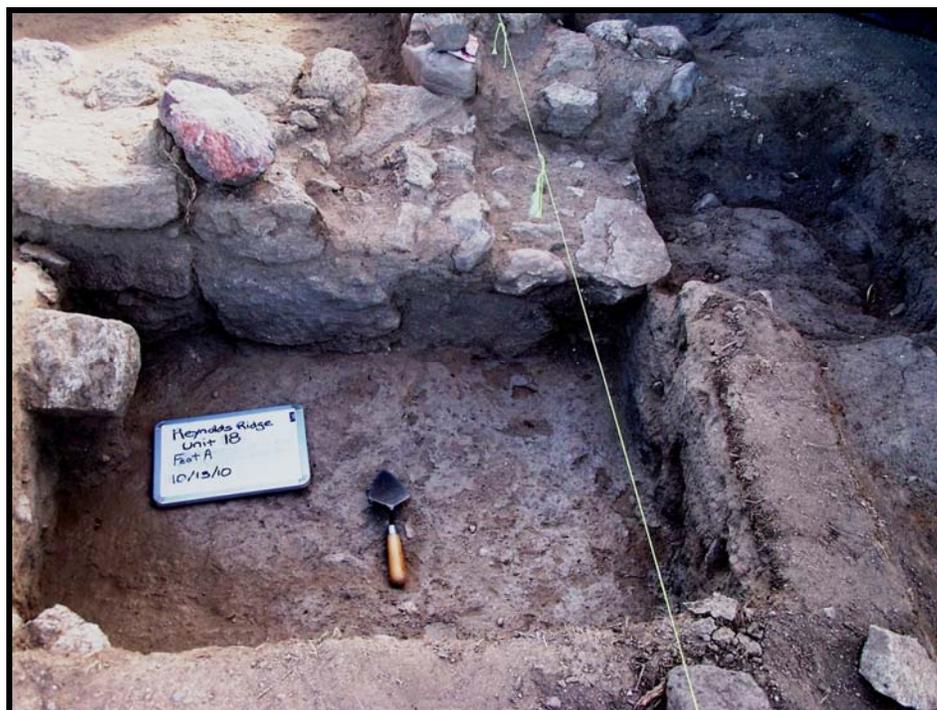
Figure 16: East wall foundation and packed earthen floor in Units 18 and 23, at the southeast corner of Feature A. As with the west wall foundation in Unit 26 the foundation ends here without evidence of there ever having been a wall to enclose the structure on the south side. The trowel is pointing east.

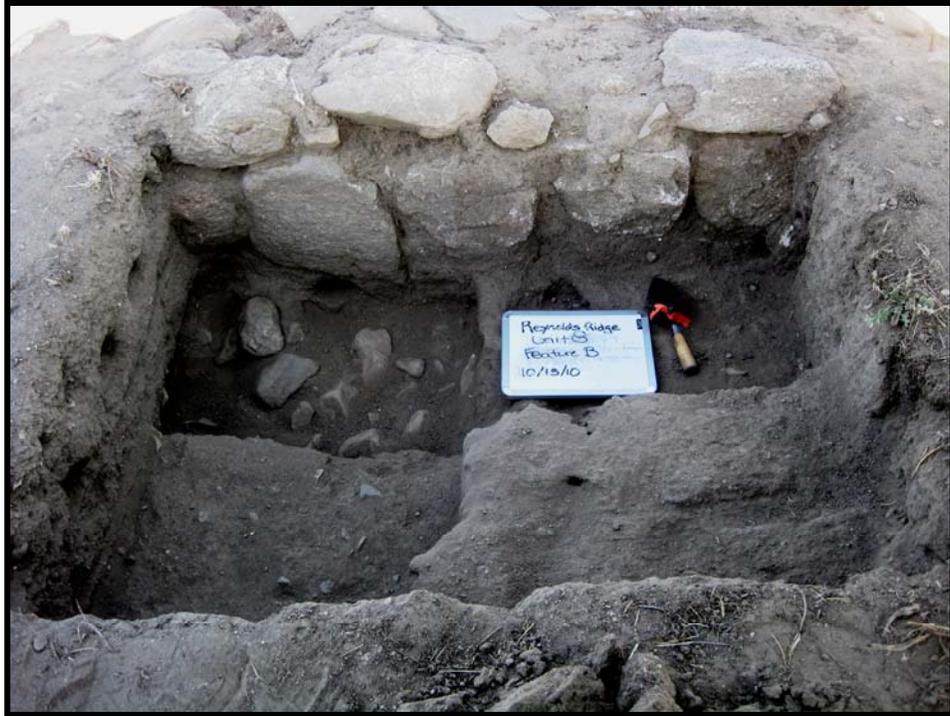
Figure 21: Exterior face and top of the Feature B south wall stone foundation exposed in Unit 8.

Excavations of Units 8 and 16 revealed details of foundation construction on the west end of the south wall (Figures 21-23). The south wall foundation at this edge of the building's remains was 15 inches across the top and consisted of two courses of granite field stones and cobbles. They were butted against the east wall of Feature A indicating that this wall had been built after Feature A was built. The bottom row was made up of larger rocks ranging from 10 to 12 inches wide and 10 to 16 inches in length. These bulkier stones were capped with a top course of smaller rectangular pieces of granite 4 to 6 inches in width and 10 to 14 inches long. The top of the footing lay about 6 inches below existing ground surface and it extended to a depth of about 26 inches, resting in the compacted grainy brown sandy loam base soil. Unit 8 was excavated to the cobble lens underlying the entire site which lay 4 to 6 inches below the bottom of the foundation.

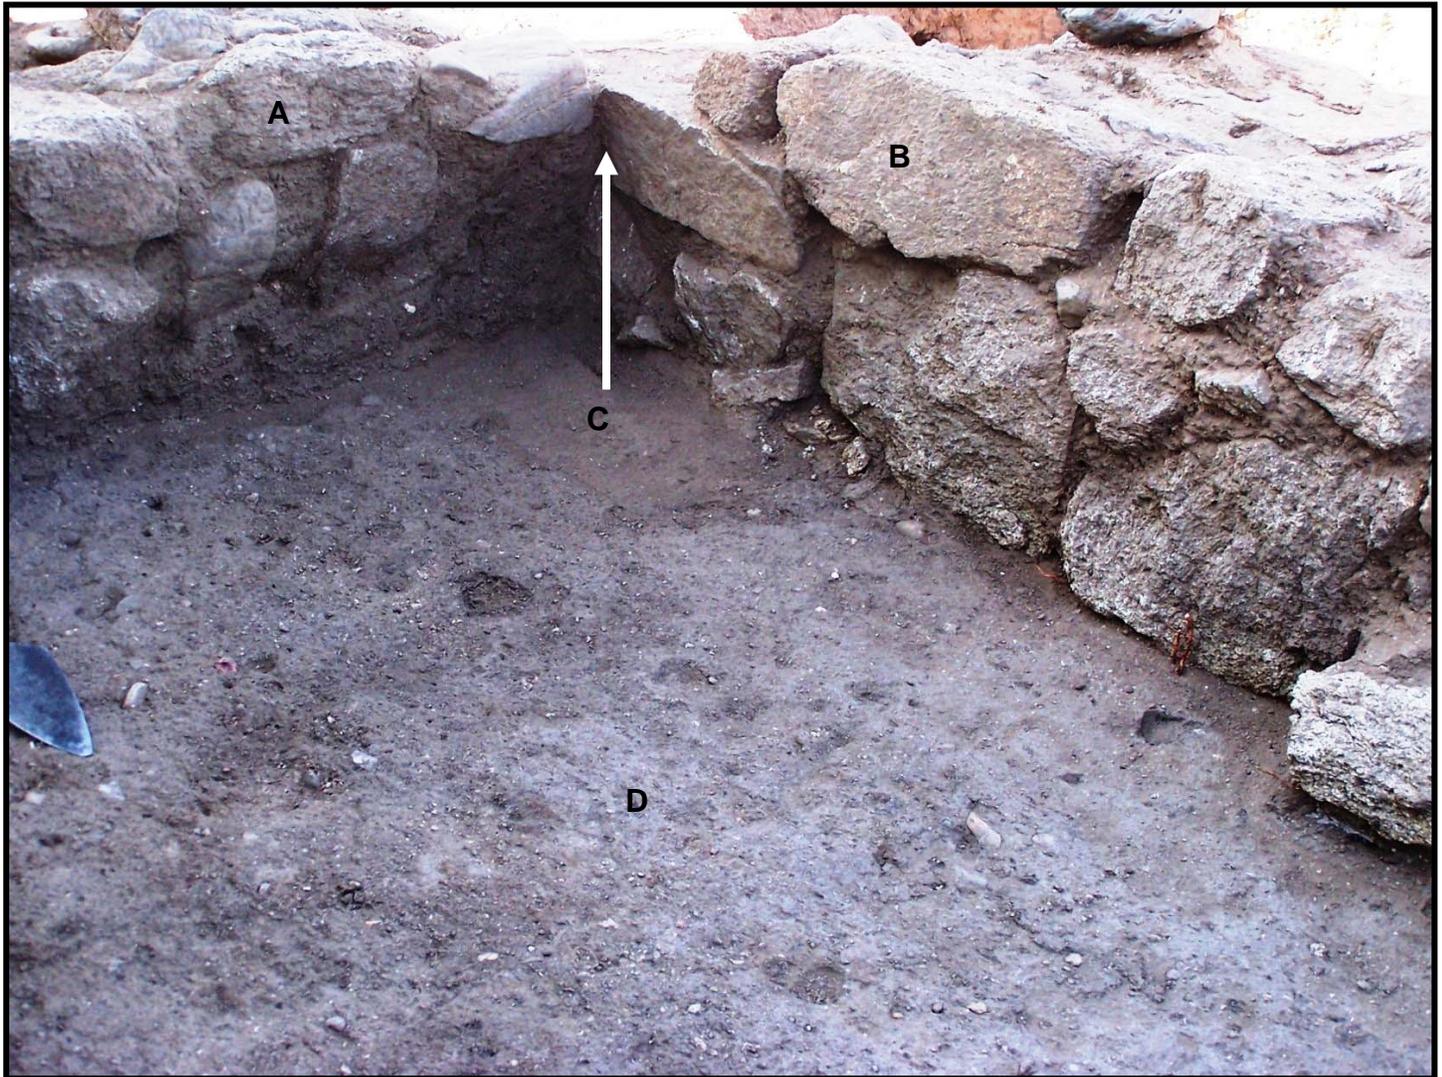
Figure 22: Unit 16, showing the south cobble stone wall of Feature B (A) built against the exterior of the granite east wall of Feature A (B). Construction of the south wall against the exterior wall of Feature A (C) indicates that Feature A was built and already existing when the Feature B footing was constructed. A packed earthen floor (D) was uncovered at the bottom of the unit.

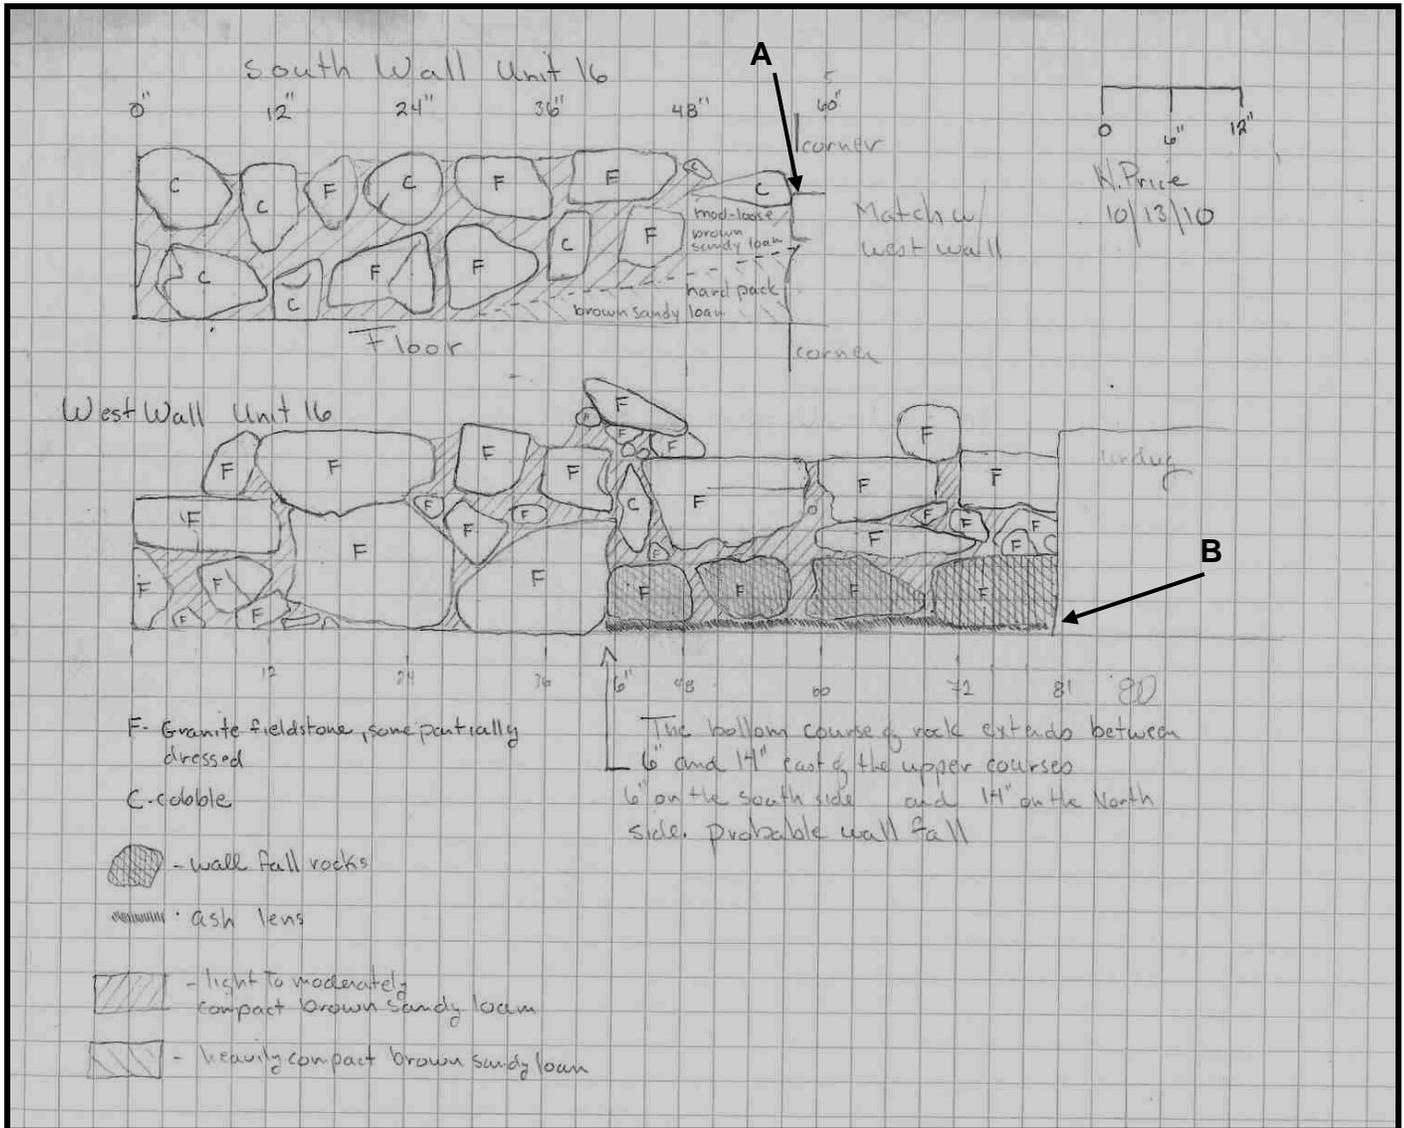
Figure 23: South and west wall footing profiles of Feature B in Unit 16. The west wall is the east granite field stone foundation of Feature A. The more rounded field stones of Feature B's south wall foundation have been built against it (A). Note the granite wall fall on the ash layer covering the floor against the west wall (B).

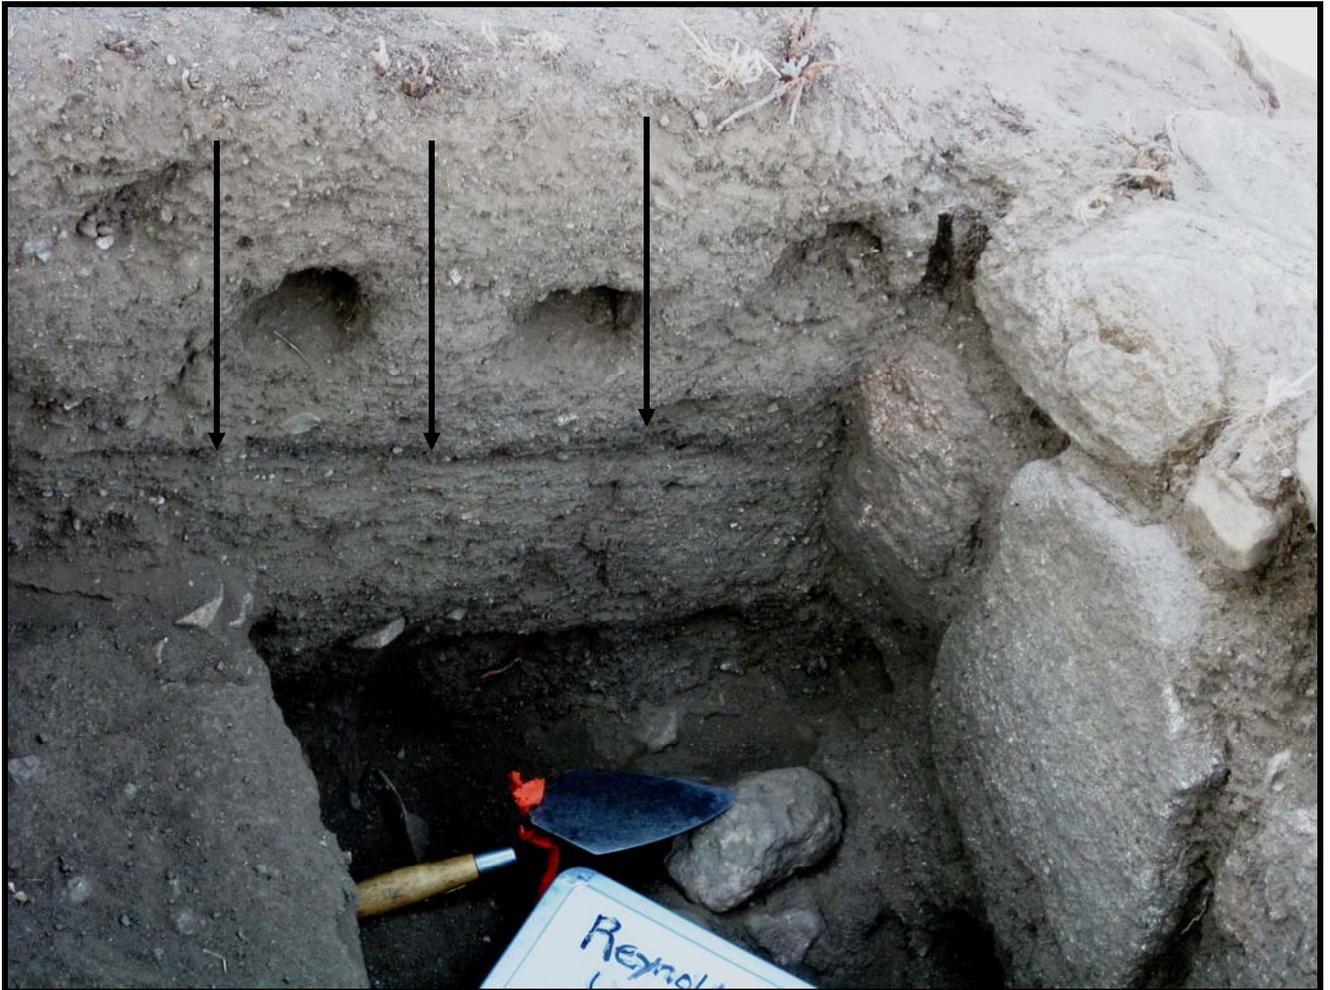
Figure 24: West side wall of Unit 8 showing the dark brown streak that probably represents original ground surface at the time of the footing construction.

Stratigraphy in the north sidewall of Unit 8 revealed a 2 inch wide gray soil lens 18 inches below the existing surface that probably represents the original ground surface at the time of construction (Figure 24). The tops of the foundation stones extended some 10 inches above this layer. It would appear, then, that during construction the bottom course of larger rocks were placed in a 10 to 12 inch deep trench and then capped with the small stones so that the top of the foundation stood approximately 10 inches above the then existing surface of the ground. In spite of their elevated height above original ground level no obvious mortar material was detected. The soil between both courses of stone is the same light to moderately compacted brown sandy loam found throughout most of the rest of the site, suggesting this same soil was mixed with water and used as a mud mortar to hold the top layer of foundation stones.

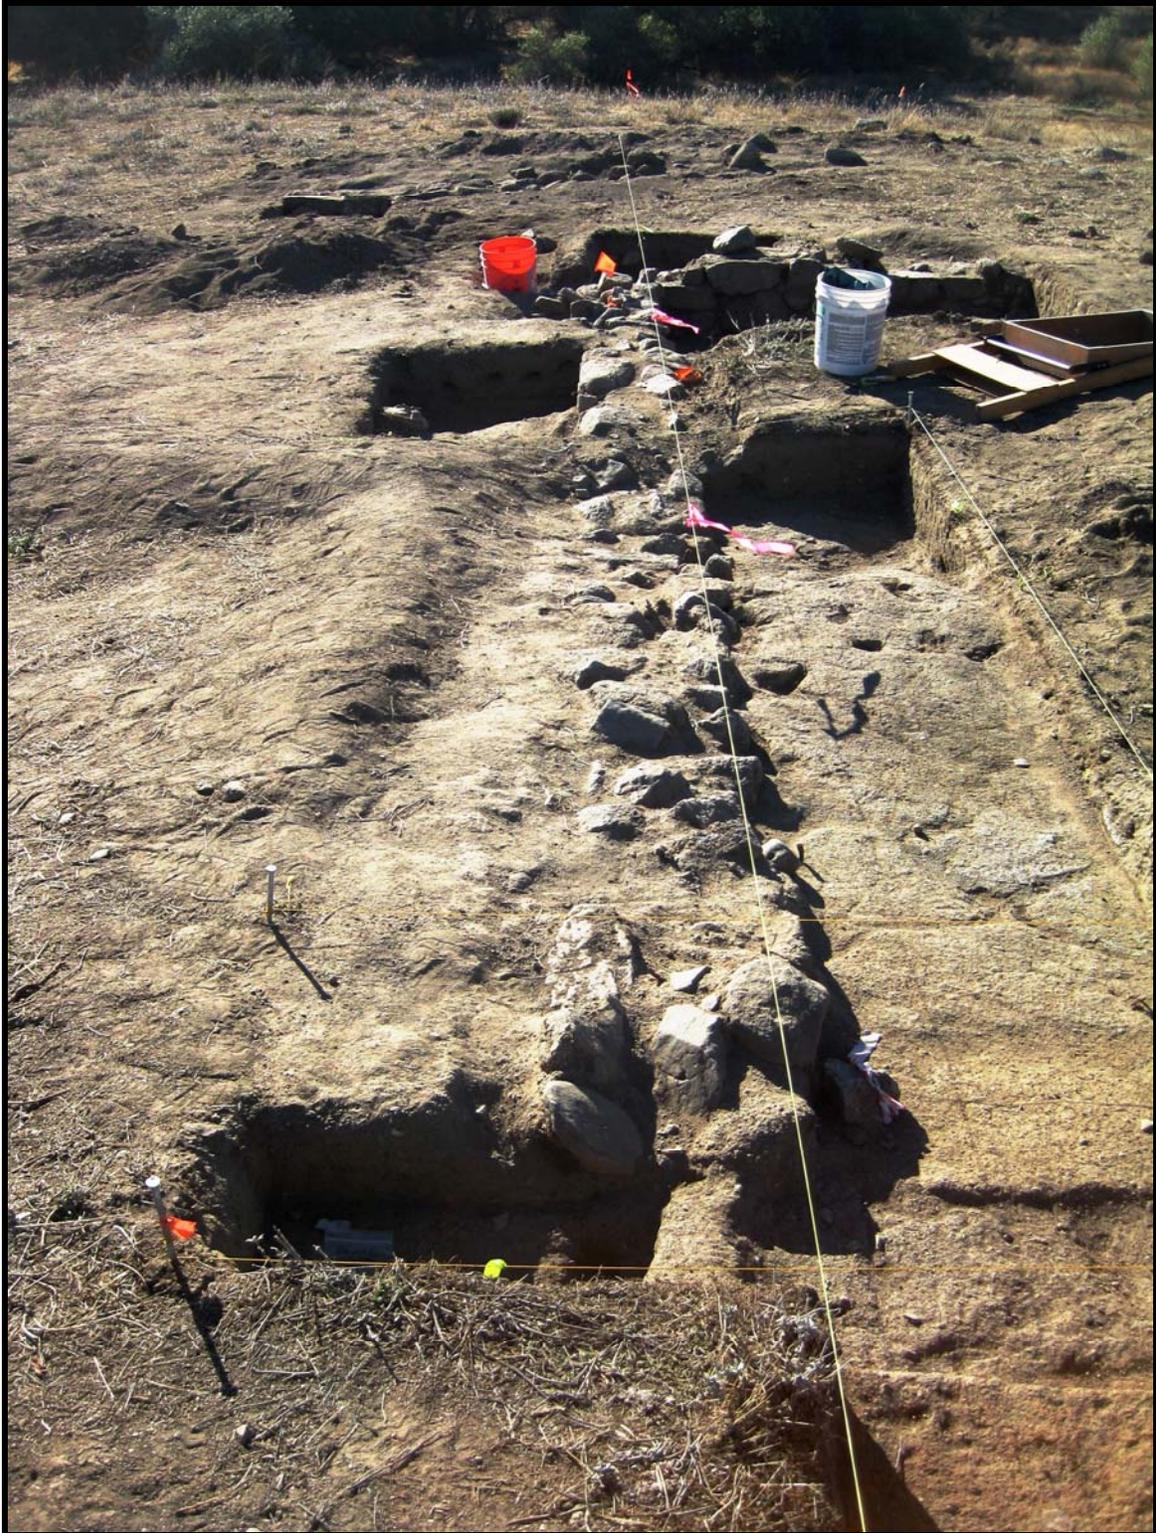
Figure 25: Overview of the stone footing under the western portion of the south wall mound of Feature B, looking west and showing the abrupt end to the alignment in the foreground.

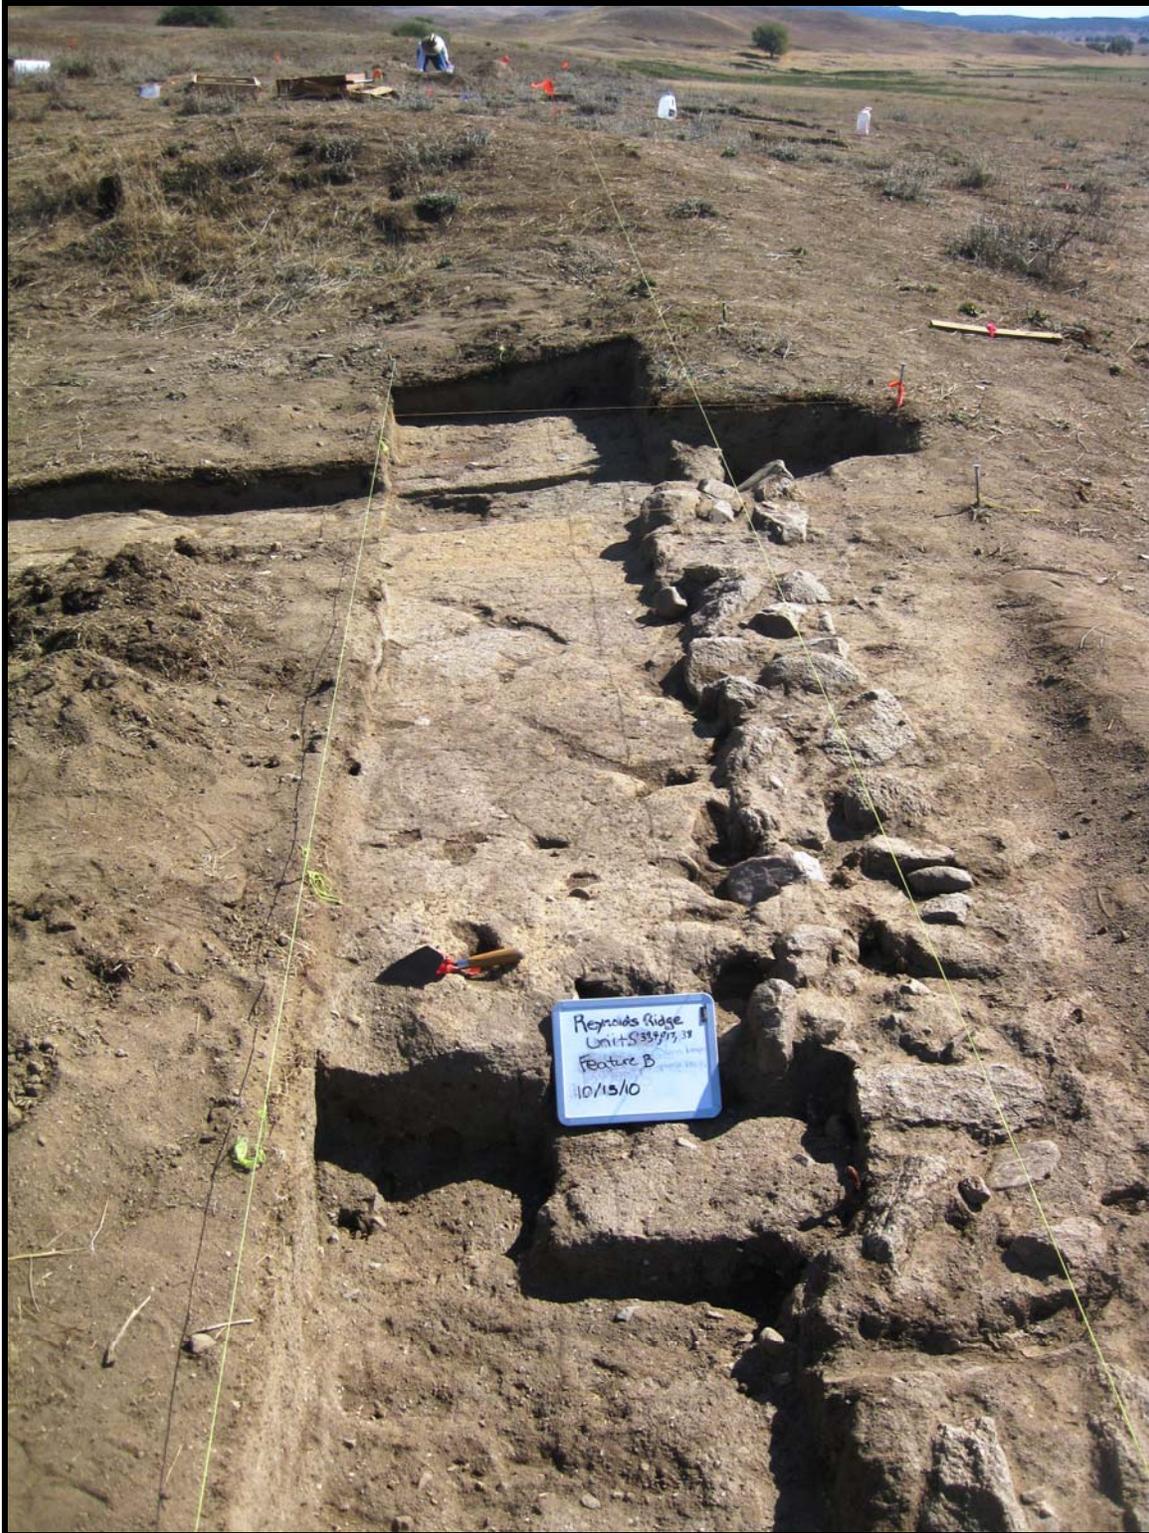
Figure 26: Exposure of the stone footing under the western portion of the south wall mound of Feature B, looking east. Note how the south wall mound continues beyond the foundation under the string on the right.

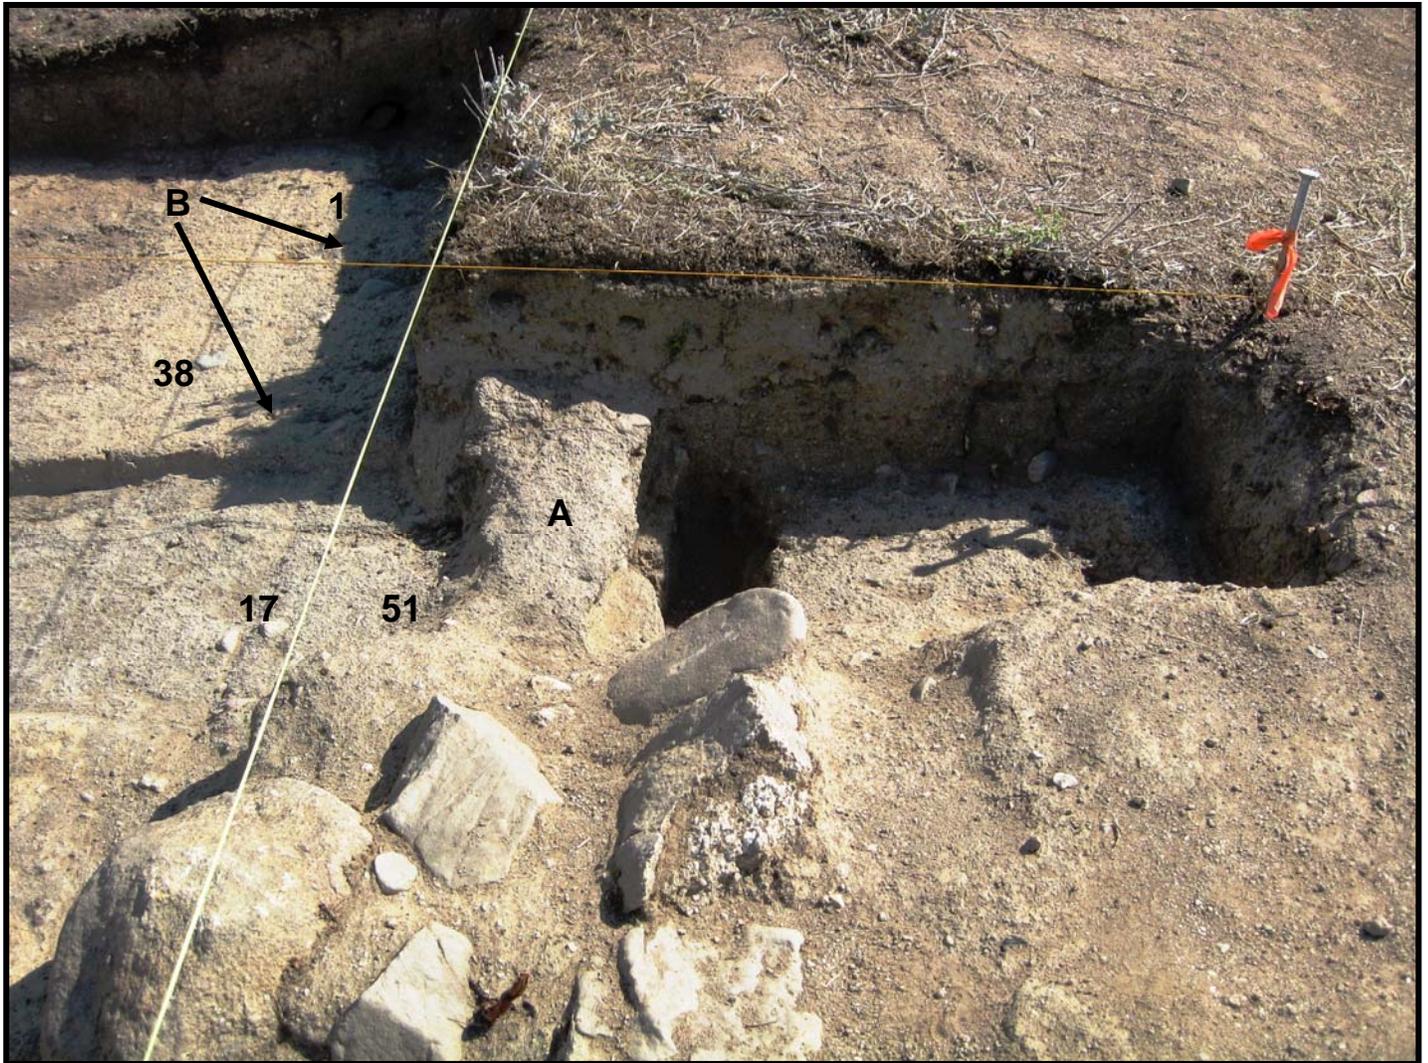
Figure 27: Units 17 and 51, showing the abrupt end of the stone wall foundation underlying the western portion of the south wall. Adobe block remains (A) can be seen projecting from the side wall. They could also be seen in the south wall of Unit 38 on to the east of Unit 17 (B). Those are shown more clearly in the following figure. Point 1 is the same location in this and the next figure.

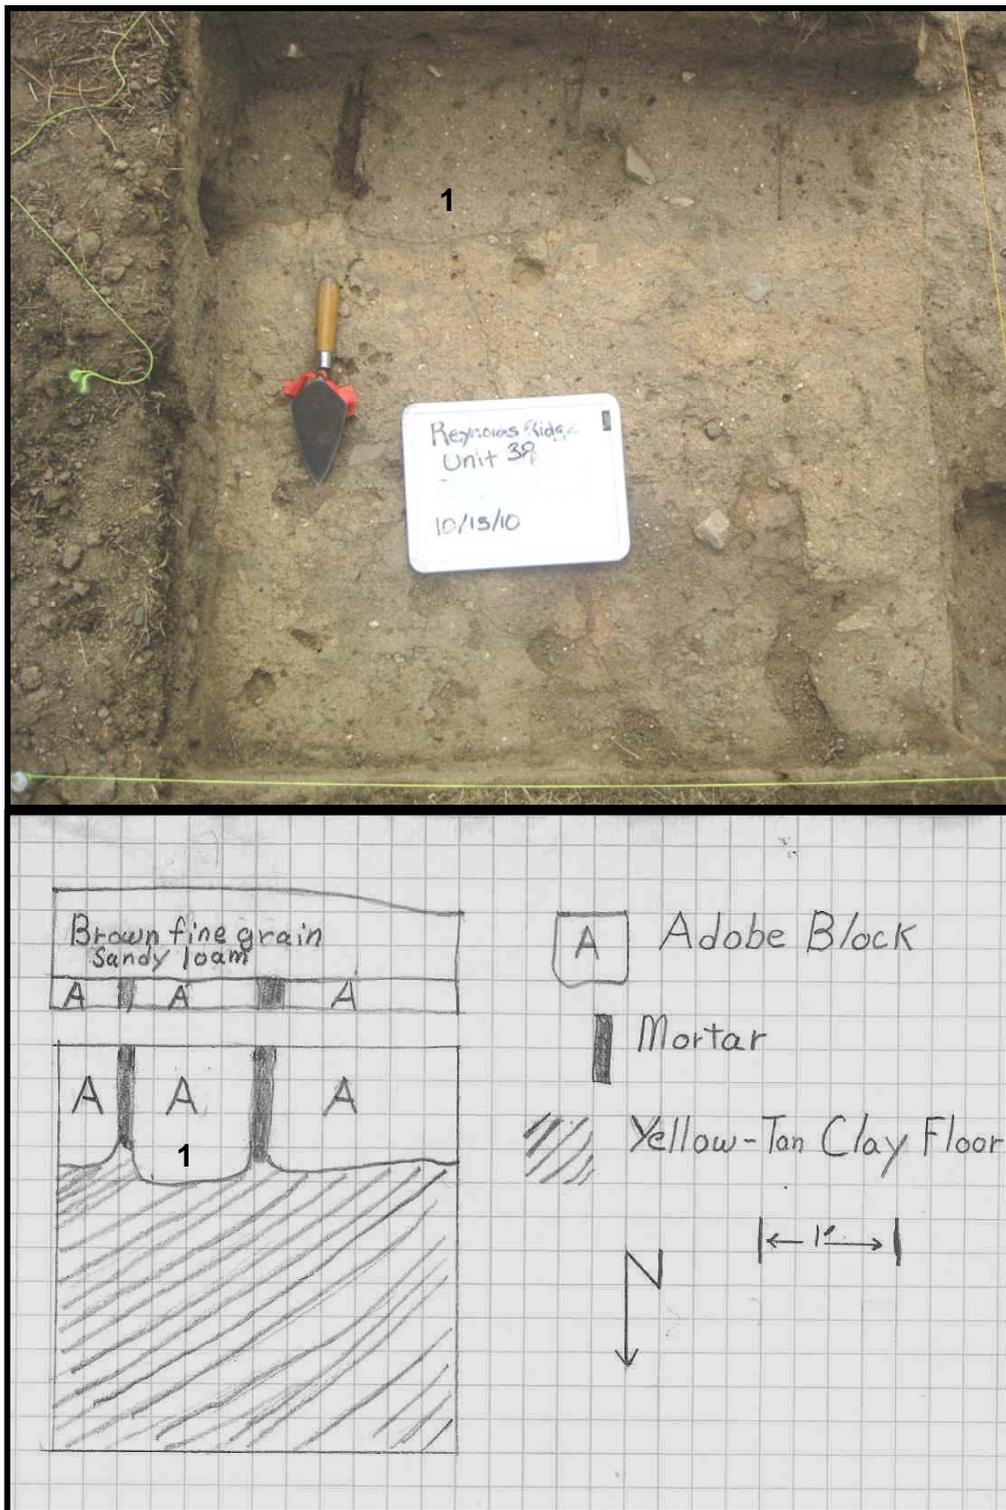
Figure 28: Photograph with plan view and south sidewall profile sketch of Unit 38 showing the edges of the gray adobe blocks underlying the south wall mound of Feature B to the east of the end of the stone foundation. Point 1 is the same in the photograph and drawing in the preceding figure.

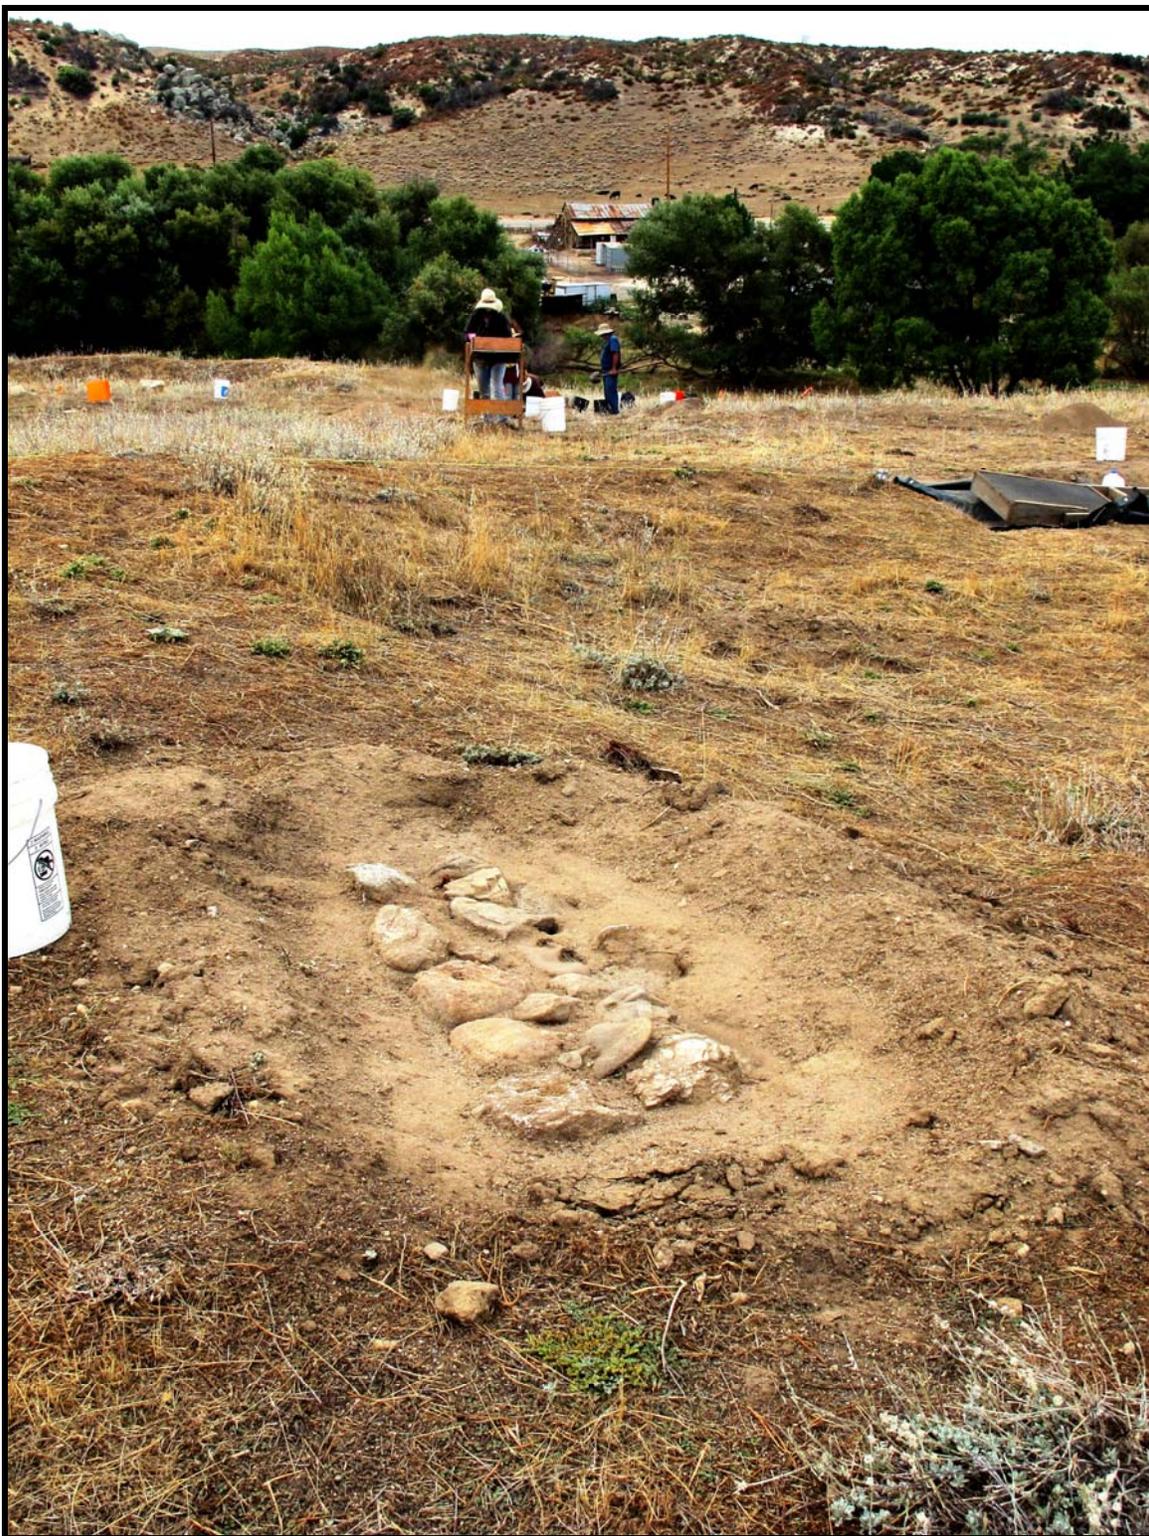
Figure 29: Short cobble alignment at Unit 60 in the east wall mound of Feature B.

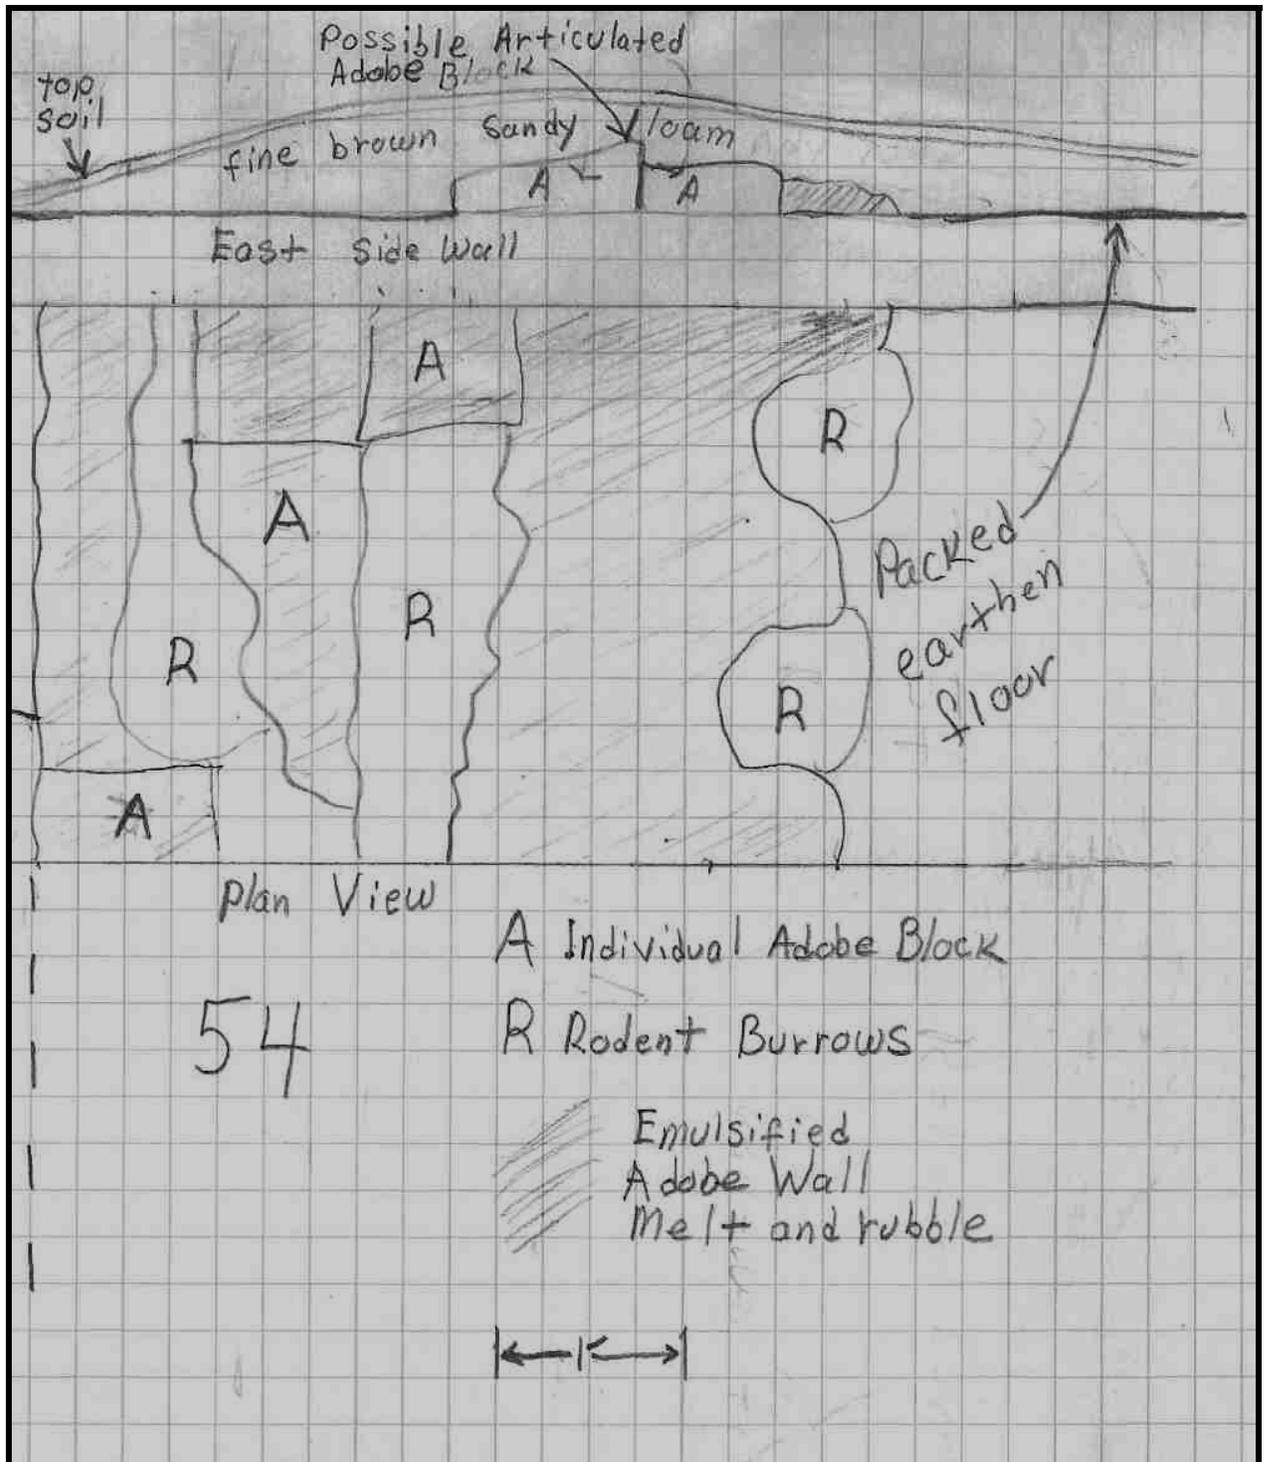
Figure 30: Plan view and east wall profile of Unit 54 on the north wall mound of Feature B. Note the remains of articulated adobe block in the side wall, and the packed earthen floor, running up to the edge of the adobe wall fall melt and rubble.

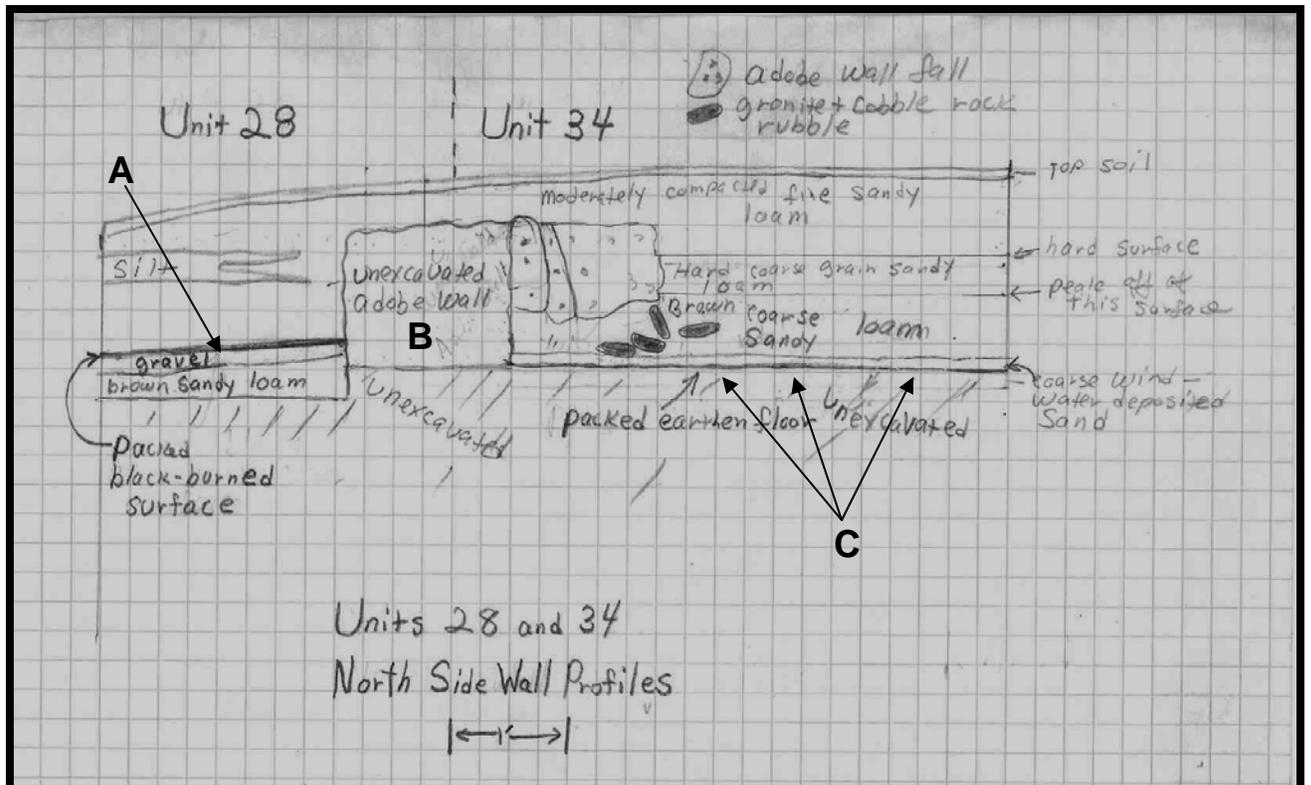
Figure 31: Stratigraphic profile of the north walls of Units 28 and 34, showing the packed burned surface or Feature J uncovered in Unit 28 (A), ending abruptly at the remnant adobe west wall of Feature B (B), and the packed earthen floor on the interior side of Feature B (C) covered with layers of gravel, coarse sandy loam soils, and wall fall.
