**TWO FORKS IN THE ROAD:
TEST EXCAVATIONS OF THE RANCH HOUSE
AT WARNER'S RANCH
(WARNER – CARRILLO RANCH HOUSE)
AND SITE OF
JONATHAN T. WARNER'S HOUSE AND STORE**

VOLUME I: The Ranch House

JULY 2011

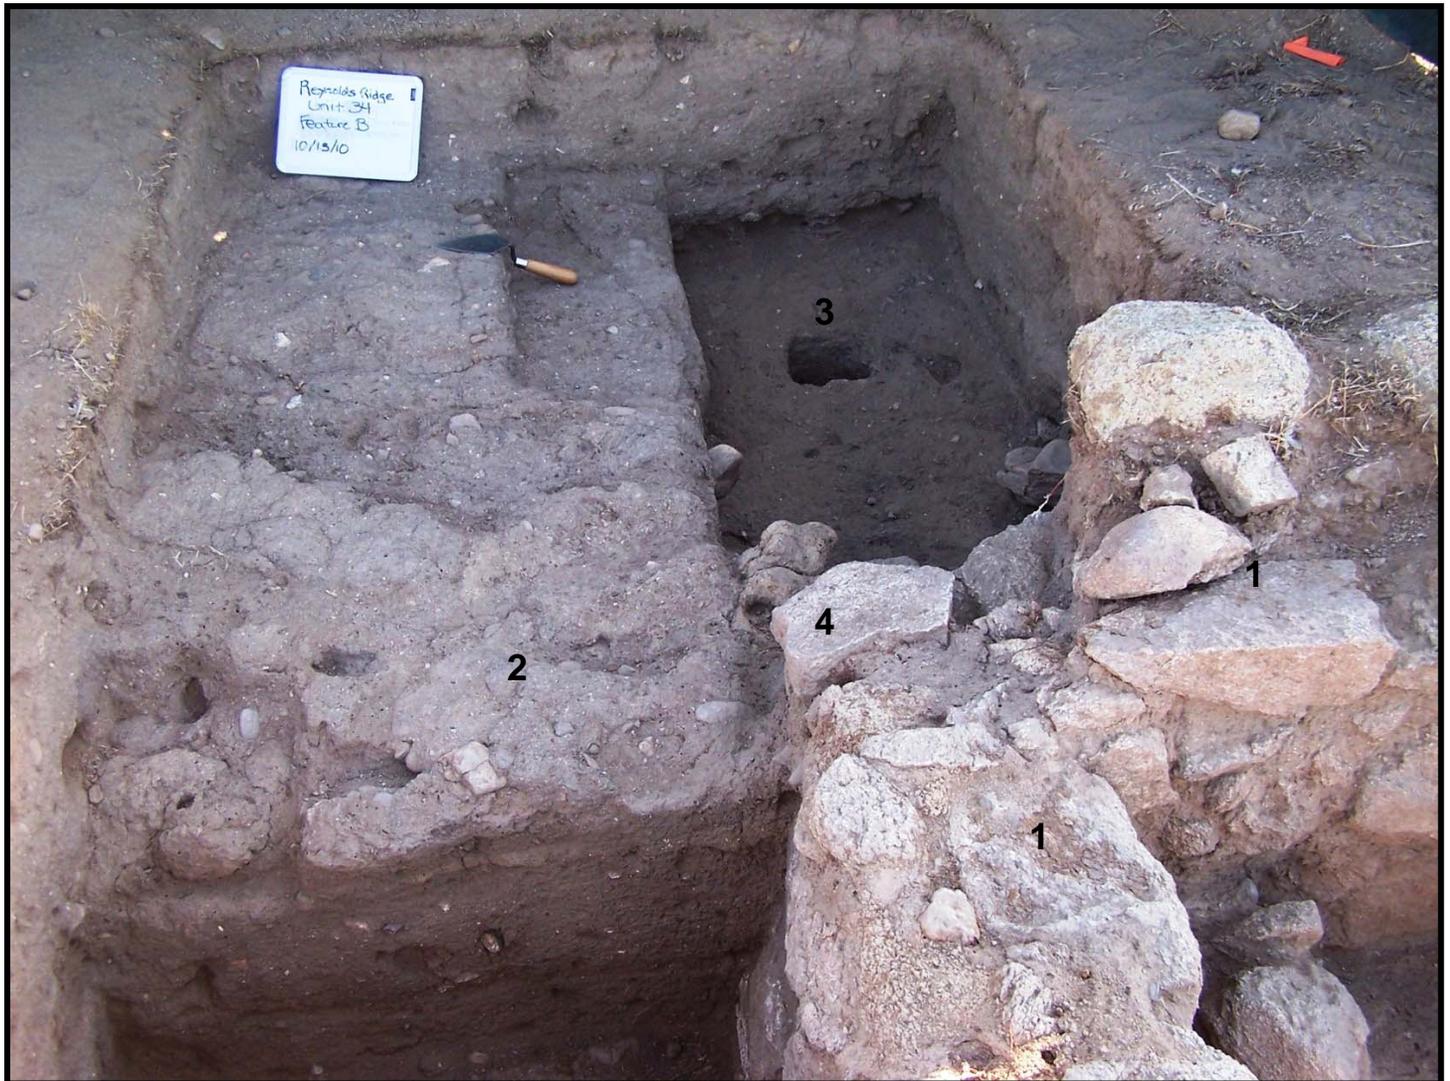
Figure 33: Portions of Units 9, 28 and 34 looking east, and showing the northeast corner of Feature A (1), with the adobe west wall remnant of Feature B (2) built against the exterior north face of the granite footing. The packed earthen floor of Feature B with the post hole mold can be seen in the upper right (3). Point 4 represents the same stone in this photograph and the drawing in the preceding figure.

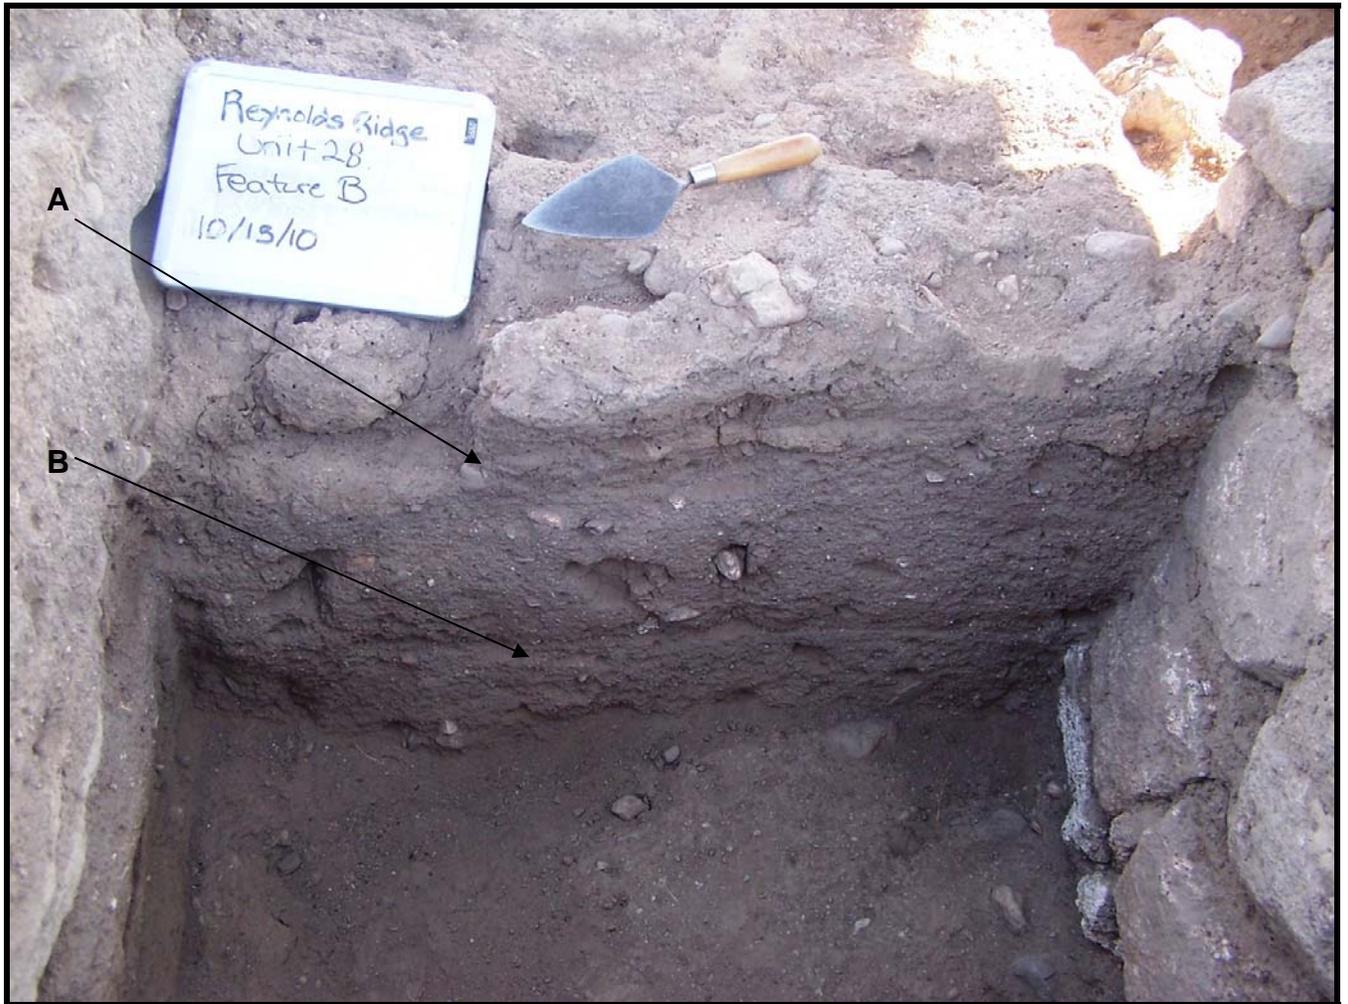
Figure 34: Close up of the adobe west wall remnant of Feature B built against the exterior north face of the Feature A granite footing. Note the harder clay mortar joint in the emulsified adobe wall remains (A) and the line at the bottom of the wall resting on the underlying soil (B).

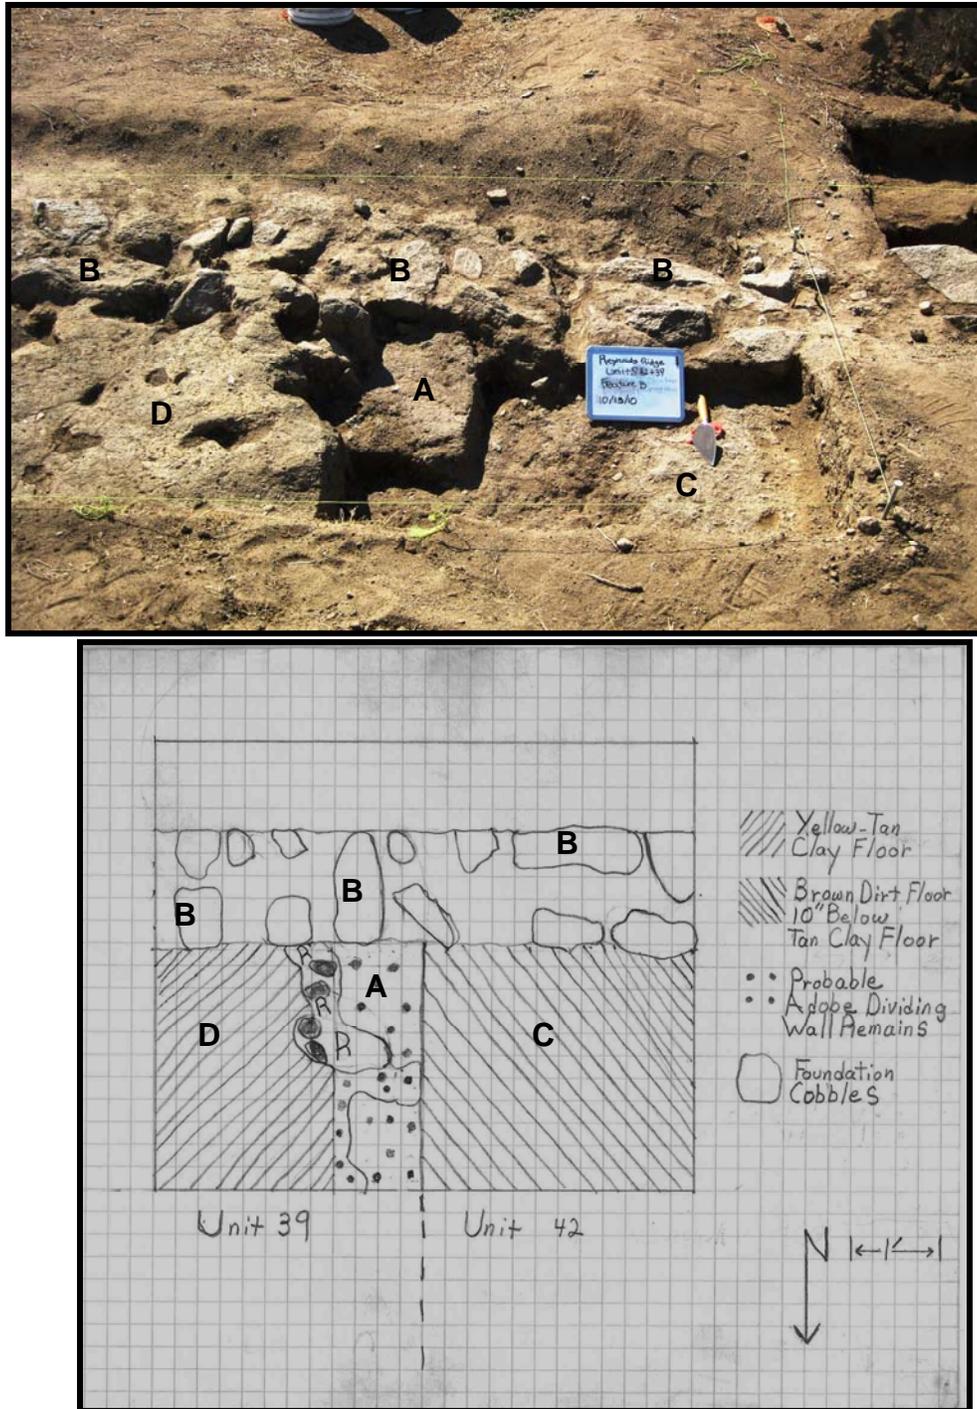
Figure 36: A photograph of Units 39 and 42, looking south, and plan view sketch, showing alignment of adobe blocks (A) butted against the south wall stone foundation of Feature B (B). The lower packed earthen floor is on the west (right) side of the adobe block (C). The higher elevated yellow-tan clay floor is on the east (left) side (D).

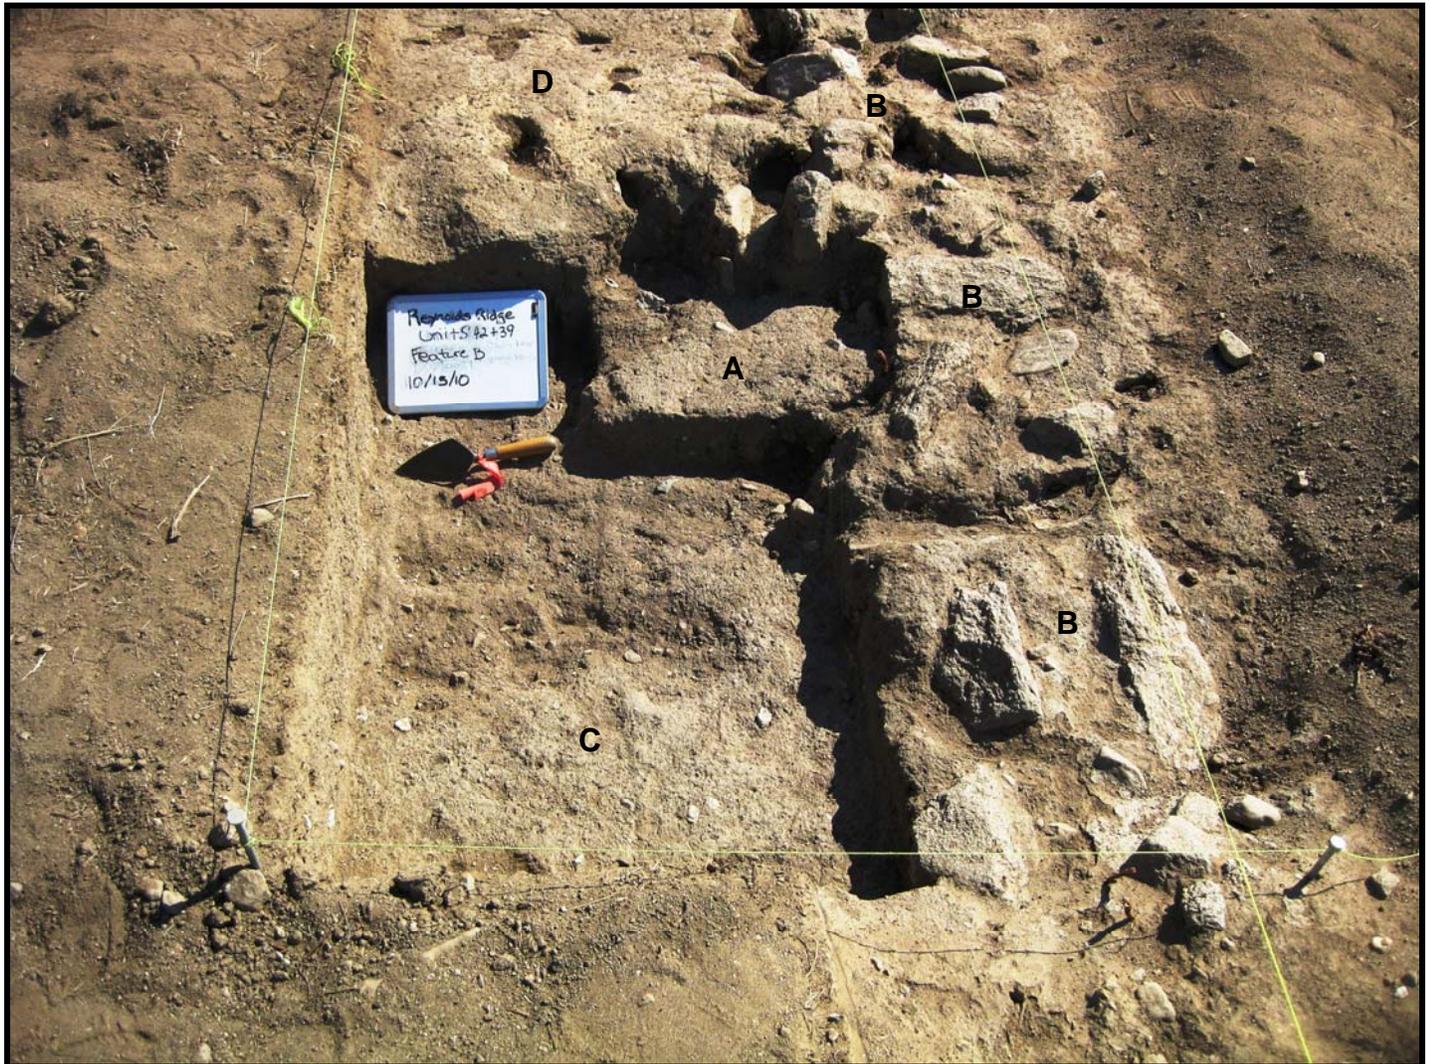
Figure 37: Units 39 and 42, looking east. Note the alignment of adobe blocks (A) butted against the south wall stone foundation of Feature B (B). The lower packed earthen floor is in the lower foreground to the west of the adobe block (C). The higher elevated yellow-tan clay floor is on the east (top) side (D).

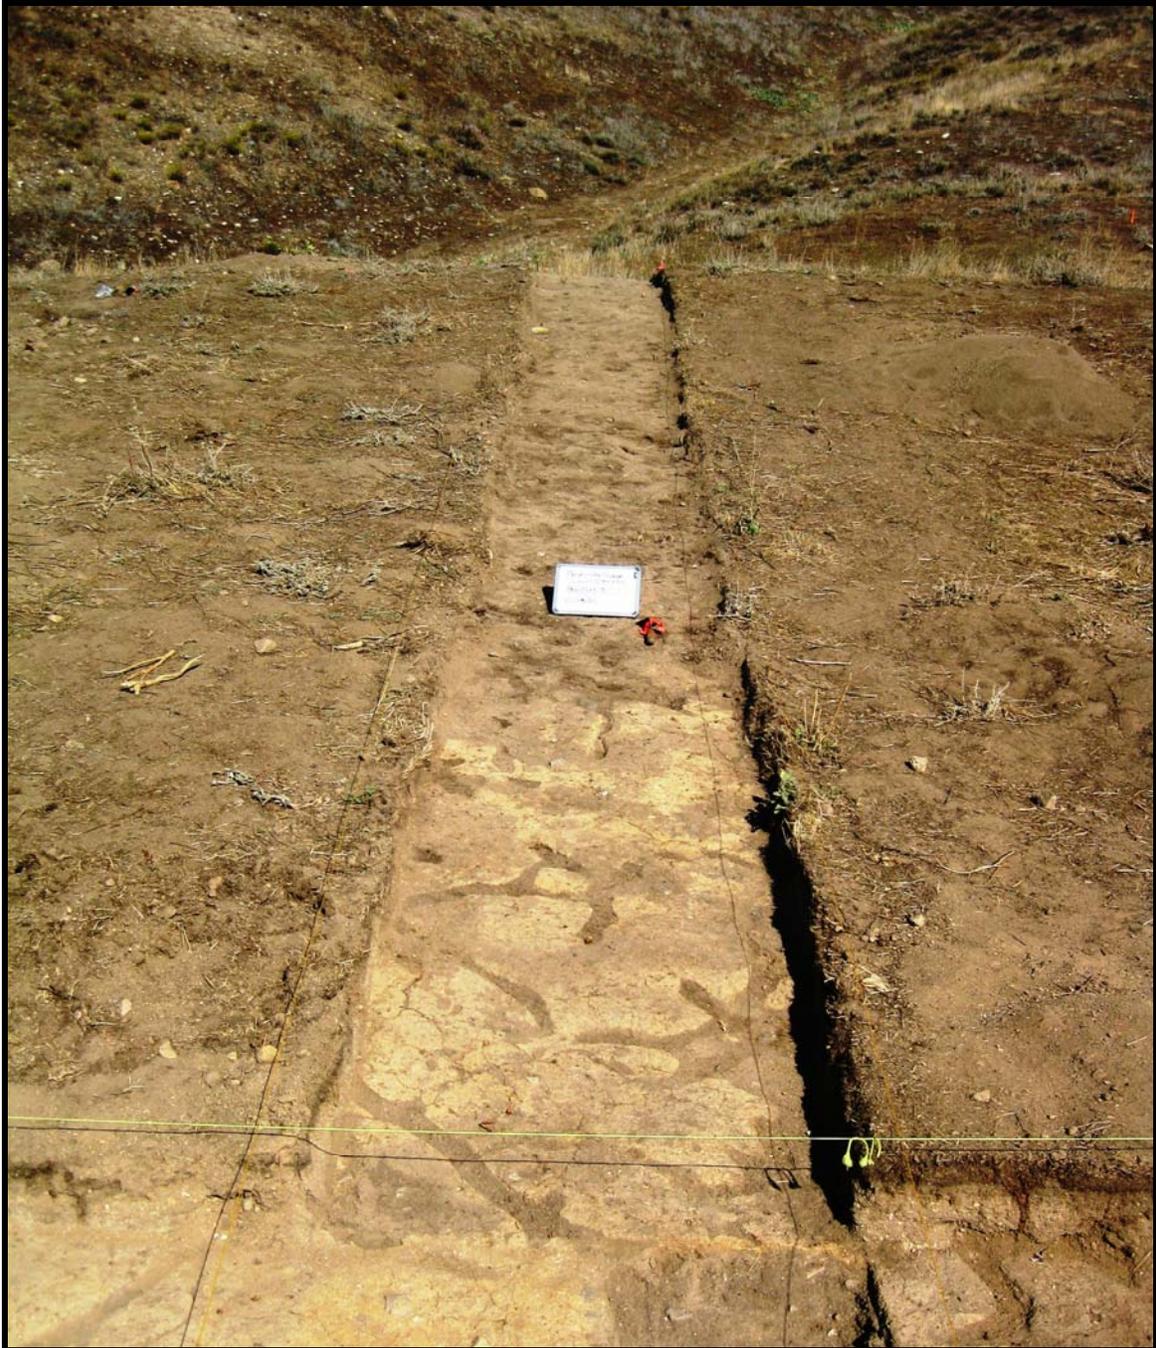
Figure 38: Packed earthen floor exposed in Units 54 and 55, running across the center of Feature B from south to north.

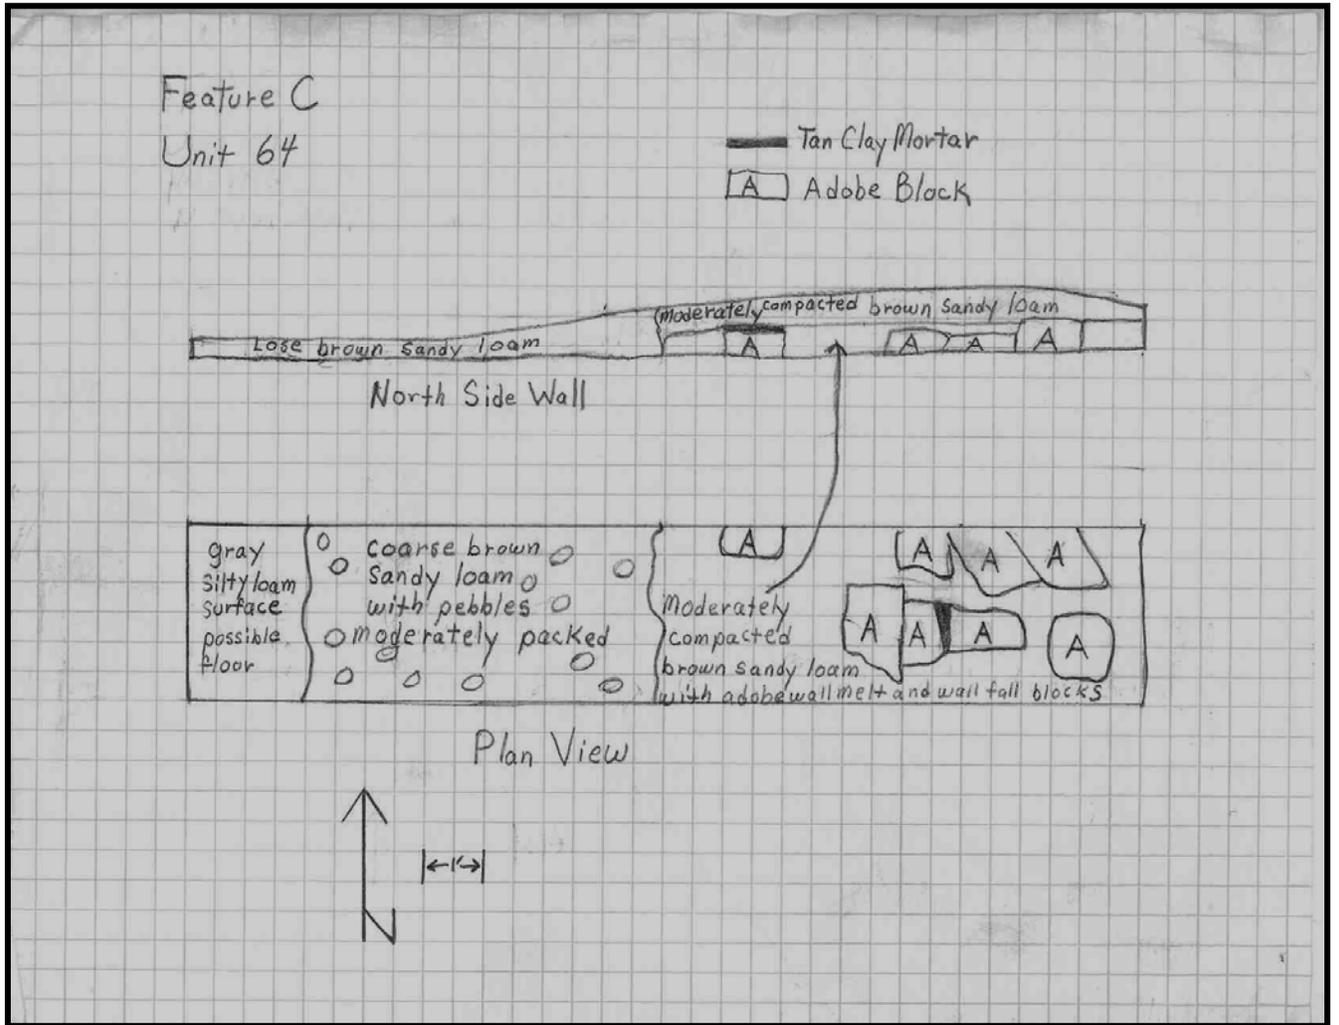
Figure 42: North wall profile and plan view sketch of the north end of Feature C, Unit 64, showing the articulated adobe wall fall.
