“At-a-Glance” Report Summary

Resource Name (per HRB naming policy): 4040 5th Avenue

Resource Address: 4040 Fifth Avenue, San Diego, CA

*P10. Survey Type: (Describe)
 Historical Resource Research Report

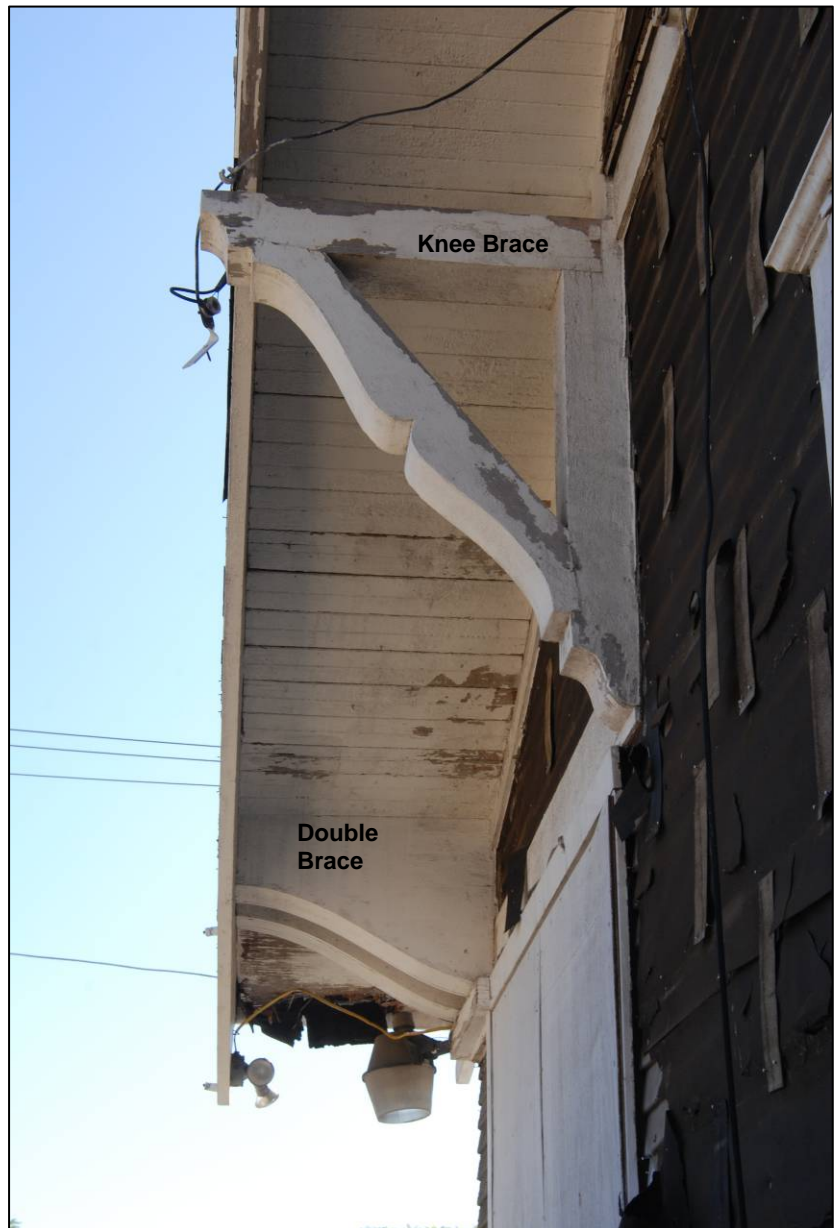
Eave overhang varies, with the maximum being approximately 36 inches at the front. At the east end of the north and south walls (the corners at the front of the house) are double braces extending under the eaves (Photo 5). These are solid, 4 inches thick, and are cut with a decorative curve on the bottom. They are aligned to appear as extensions of heavy beams that hold up the front of the roof. There are large, centered gable dormers at both front and back sides of the main roof. These dormers have exposed rafters finished like those on the main roof. There are four triangular knee braces on each of the rake ends of both the main roof and the dormer roofs. The diagonal piece on the braces is decoratively cut (Photo 5).

Photograph 5
Roof Eave, Showing
Double Braces and Knee
Brace

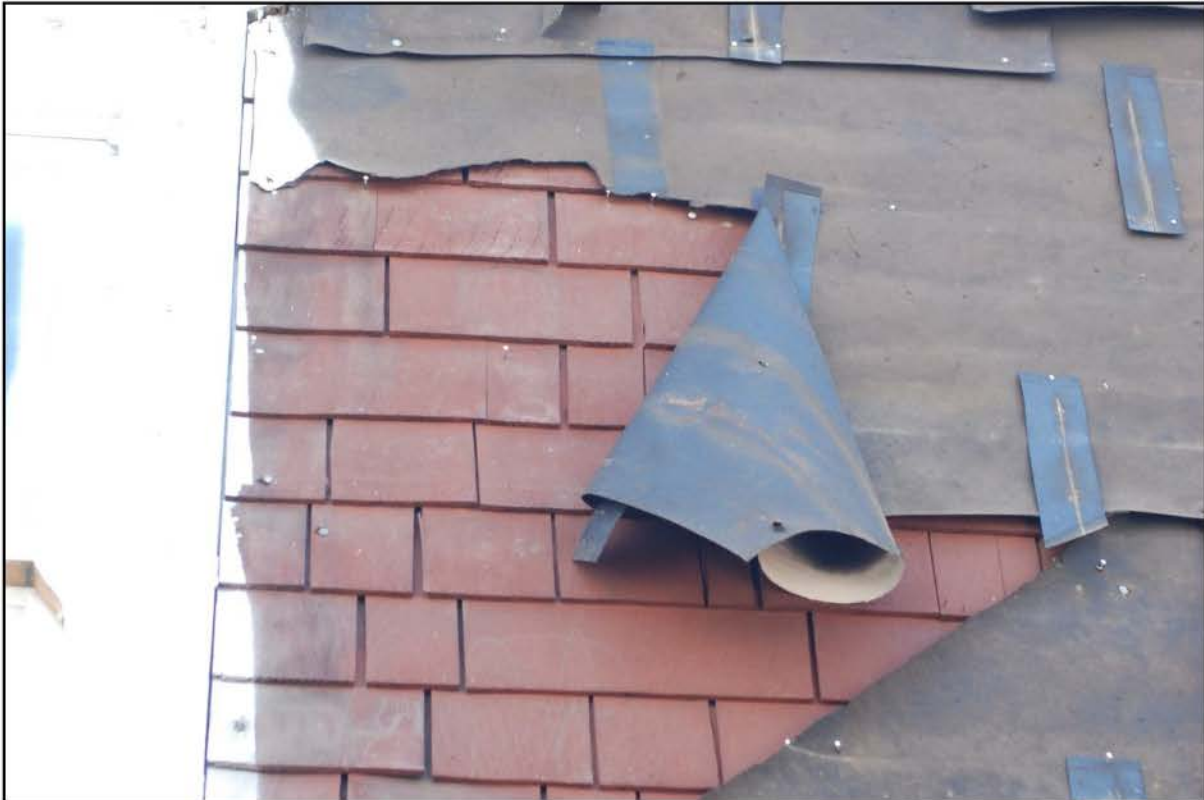
Currently the house is covered in tarpaper. In some areas the tarpaper has been removed and the siding beneath is revealed. Areas revealed on the first floor are clad in beveled clapboard siding. The clapboard is 4 inches wide and painted a light grey. Exposed areas of the second floor on the rear of the house are clad in shingle siding. The shingles vary in width and are painted a terra cotta color. The clapboard and shingles may be the original claddings of the house (Photo 6)

Photograph 6
Probable Original
Clapboard and
Shingles under
Tarpaper

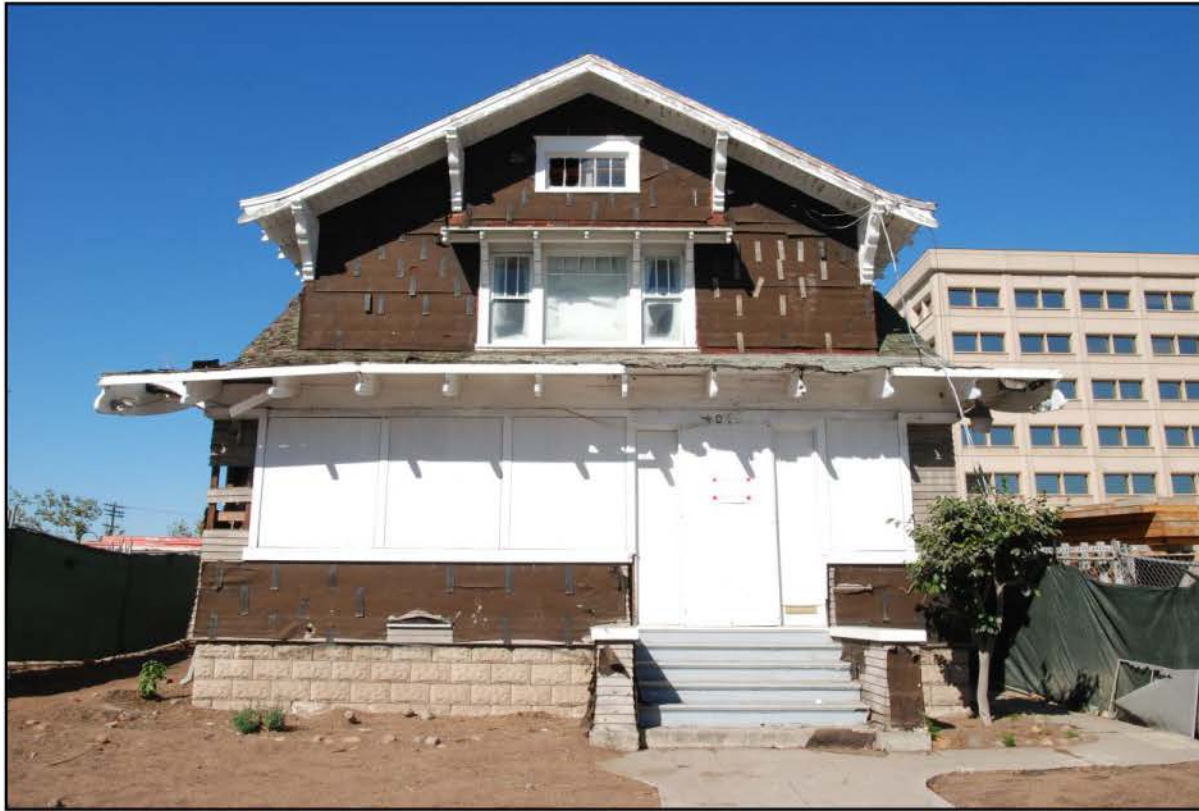
The front of the house is on the east side. The first floor of the house was originally an open porch, which was enclosed in 1945. The residential building report lists Permit 12148 obtained for glassing in the porch. The front door is offset to the right of center (Photo 7). The door has sidelights. Both the door and the sidelights are covered with plywood so no details are visible from the outside except the outside of the trim. The door and sidelights together measure 6 feet wide. There are four windows on the first floor, three grouped together on the left side of the door, and one smaller window on the right side of the door. These windows are also covered by plywood. The casing on the windows and door are similar. The sides are 2½ inches wide and 1 inch thick, and the top is 3¾

Photograph 7
East (Front)
Side of House

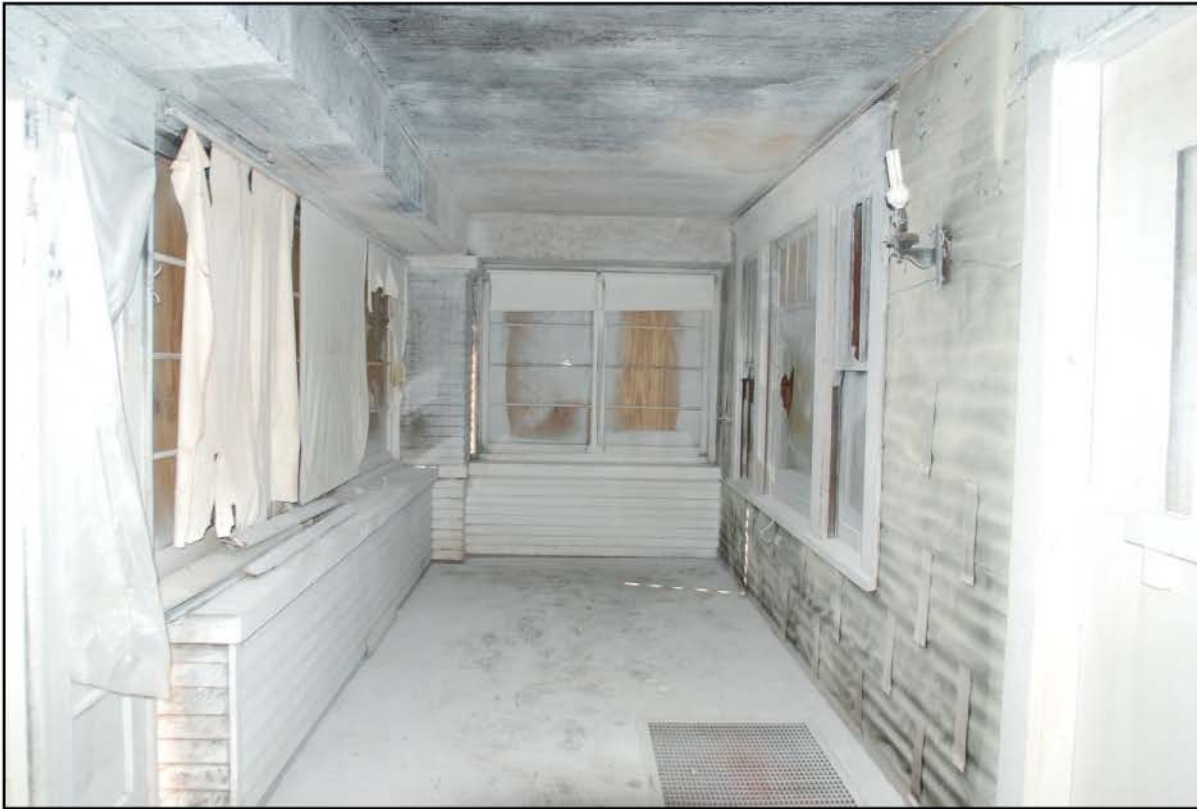
The interior of the porch does not appear to have been significantly altered after it was enclosed. The walls are still covered in clapboard, and the front window and door are still in place. Photographs 9 and 10 show the interior of the porch. The door, sidelights, and windows have been inserted between the pillars, ceiling, and ballustrade with no inletting or moulding on the inside, so there are gaps between the window frames and the clapboard (Photo 11). The front door is now missing. The sidelights are five light, divided horizontally, with narrow wood sash. The windows are four light divided horizontally. With narrow wood sashes. Photographs 9 and 10 show the south and north end windows, respectively, and Photograph 12 shows the east (front) triple window.

Photograph 9
Interior of Porch,
Looking South.
Note South Side
Window

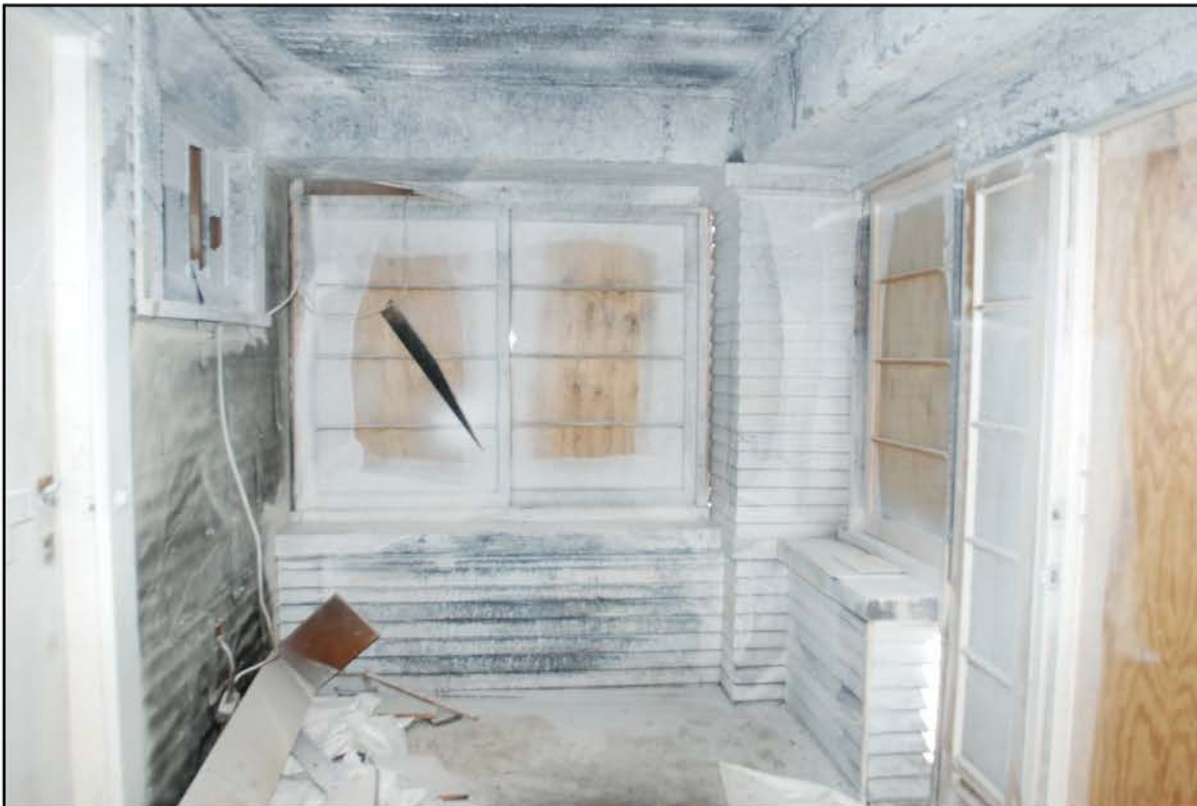
Photograph 10
Interior of Porch,
Looking North

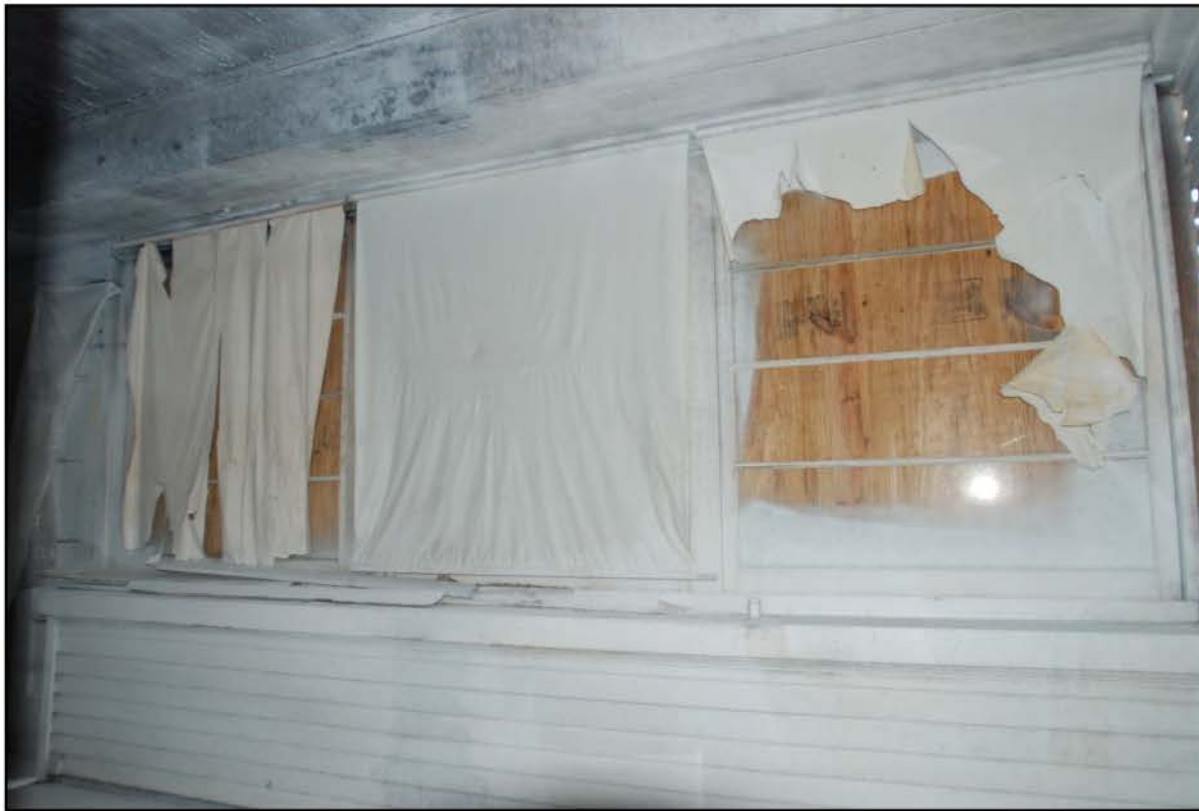
Photograph 12
Interior View of
Front Triple
Window,

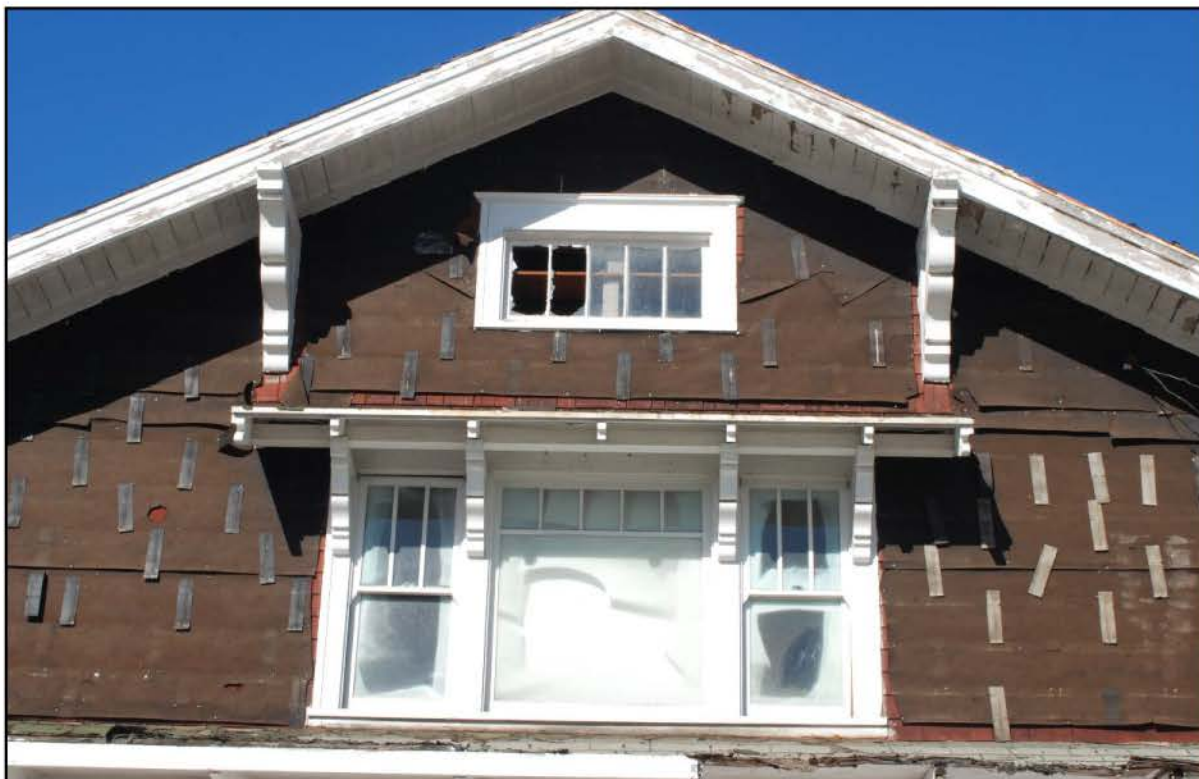
There is a three-sash ribbon window in the second floor (Photo 13). It is centered and has a small shed roof over it. The center window is approximately twice the size of the side windows. The center sash is fixed, with a large main light and a row of five small lights above. The side sashes are double hung, the bottom a single light and the top three light. Casings appear to match those on the first floor of the house described below. The window sill is at the roofline. There are four knee braces, similar in style to the roof braces, which support a horizontal square beam. The seven rafters that support the shed roof rest on this beam. Above the three-sash window is a small, five-pane fixed rectangular window that appears to be for admitting light to the attic.

Photograph 13
Second Floor and
Attic Windows on
West Side (Front)
of House

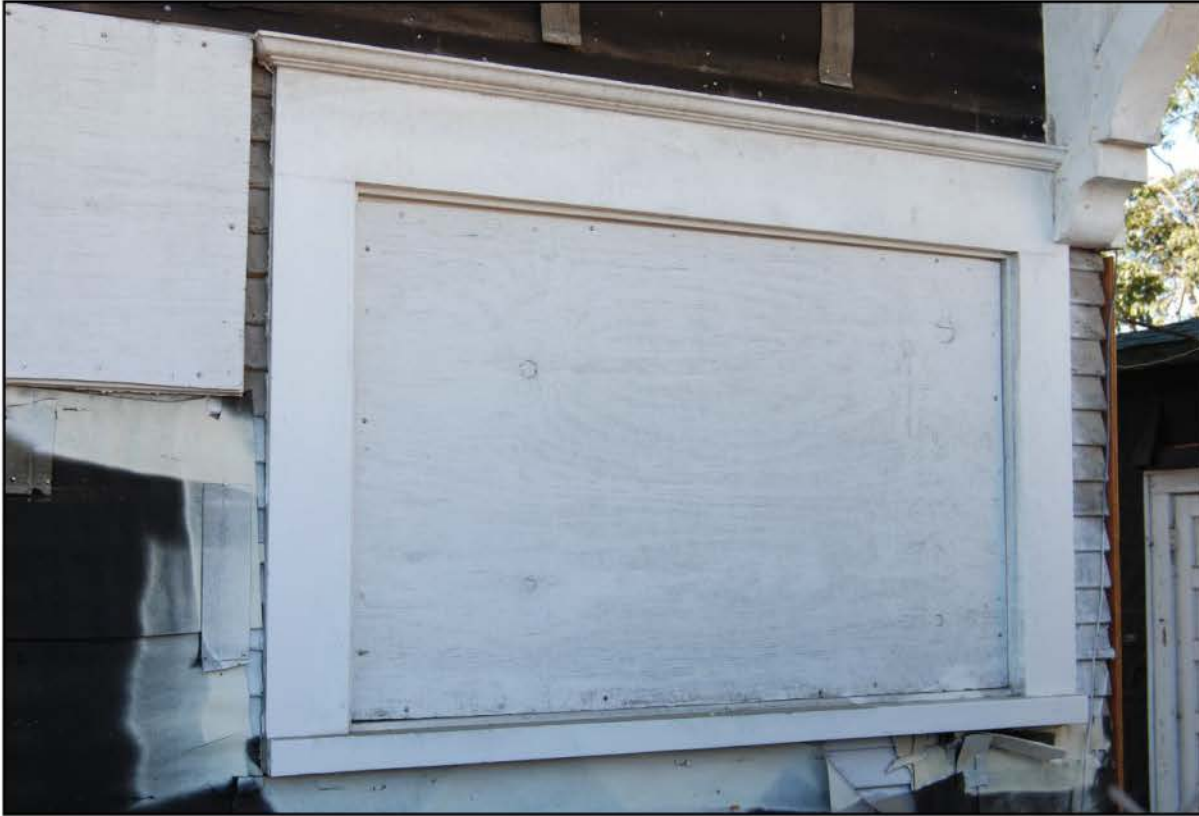
Photograph 14
Casing on
Windows on Main
Portion of House.
Note wide side
and top casing
boards and
decorative trim at
top.

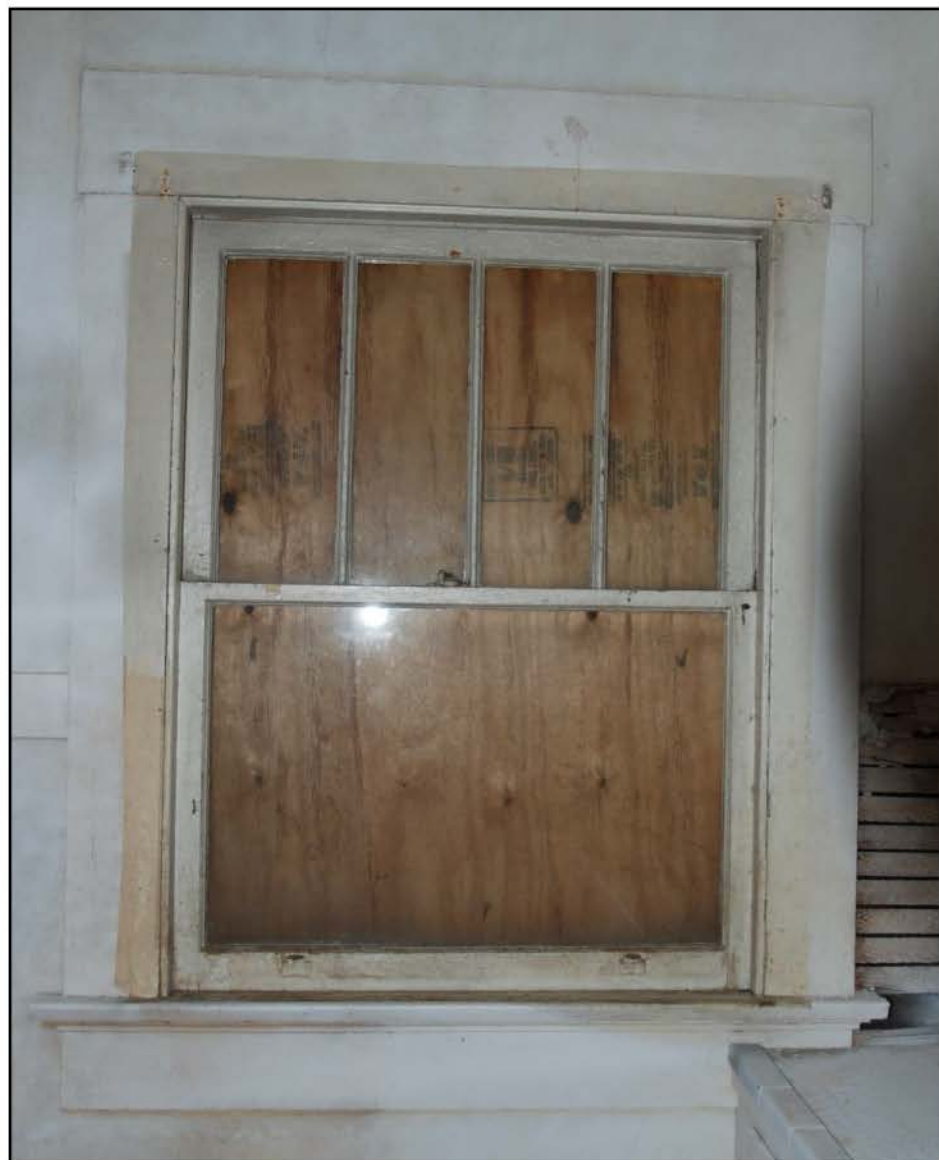
Photograph 16
North Side Window 3,
Interior shot.

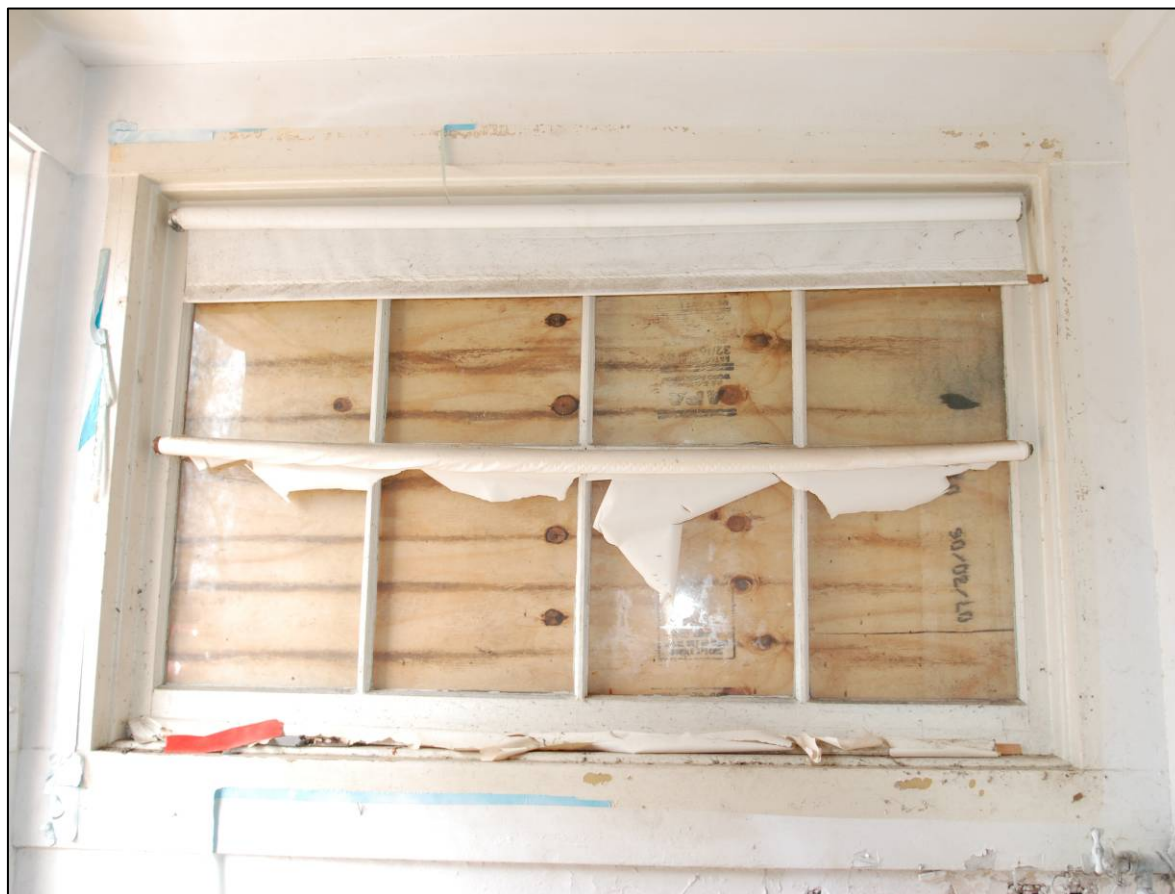
Photogrtaph 17
Window 4, Interior
Shot

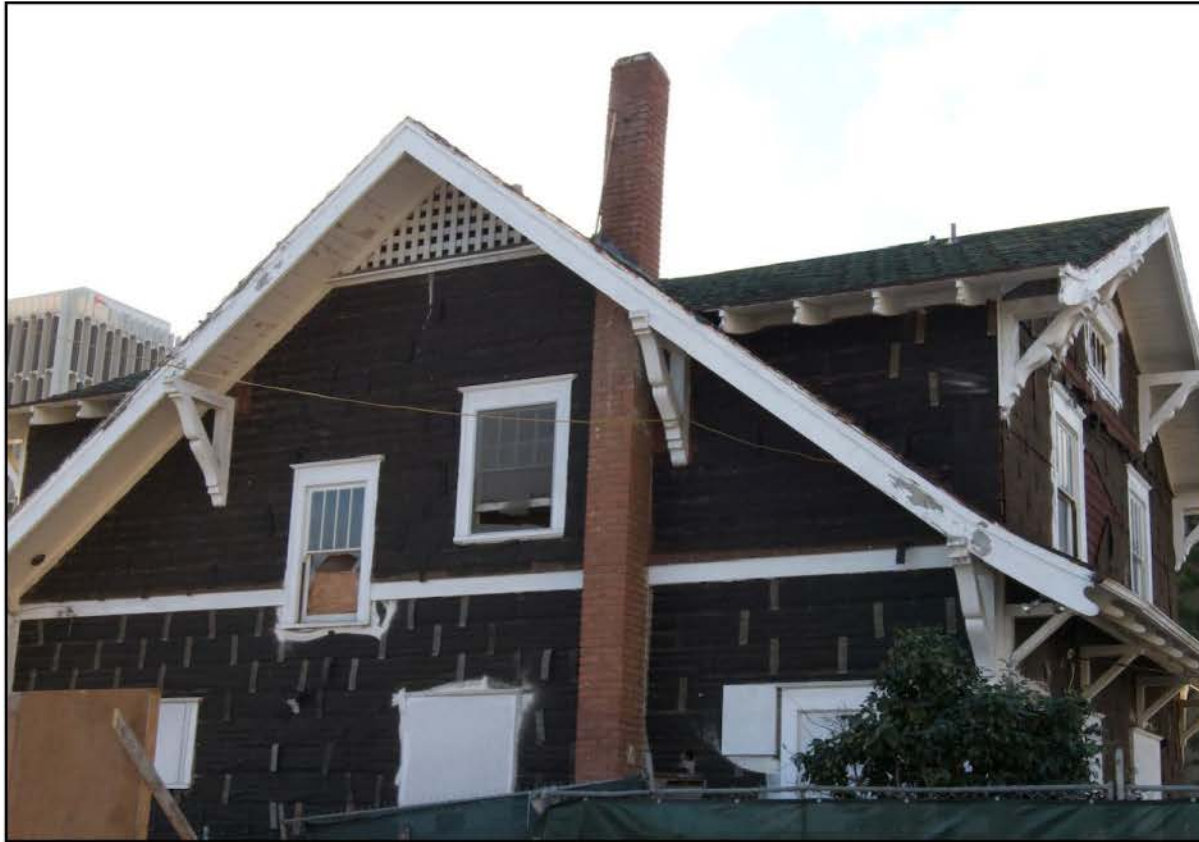
Photograph 18
Northeast
Corner of
House, Showing
Small Chimney
on North Wall

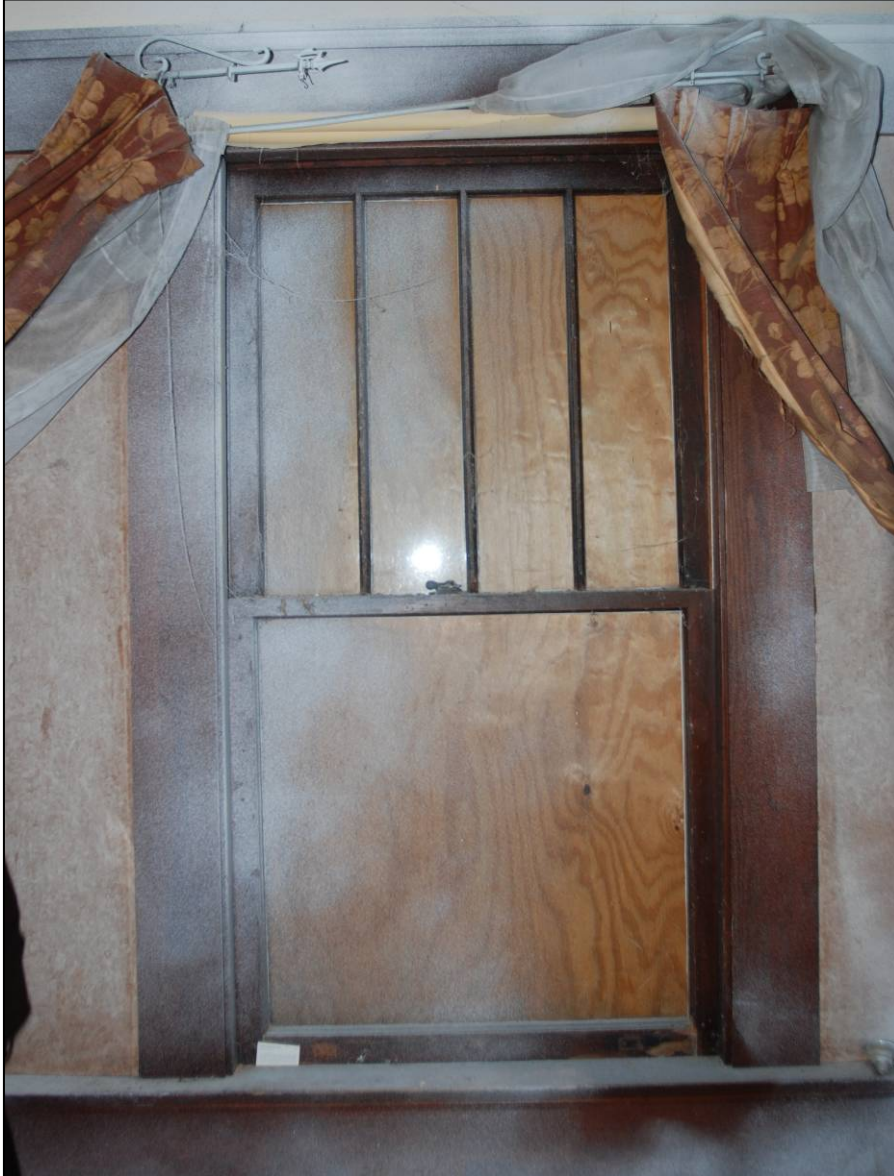
Photograph 20
South Side Window 1,
Interior Shot

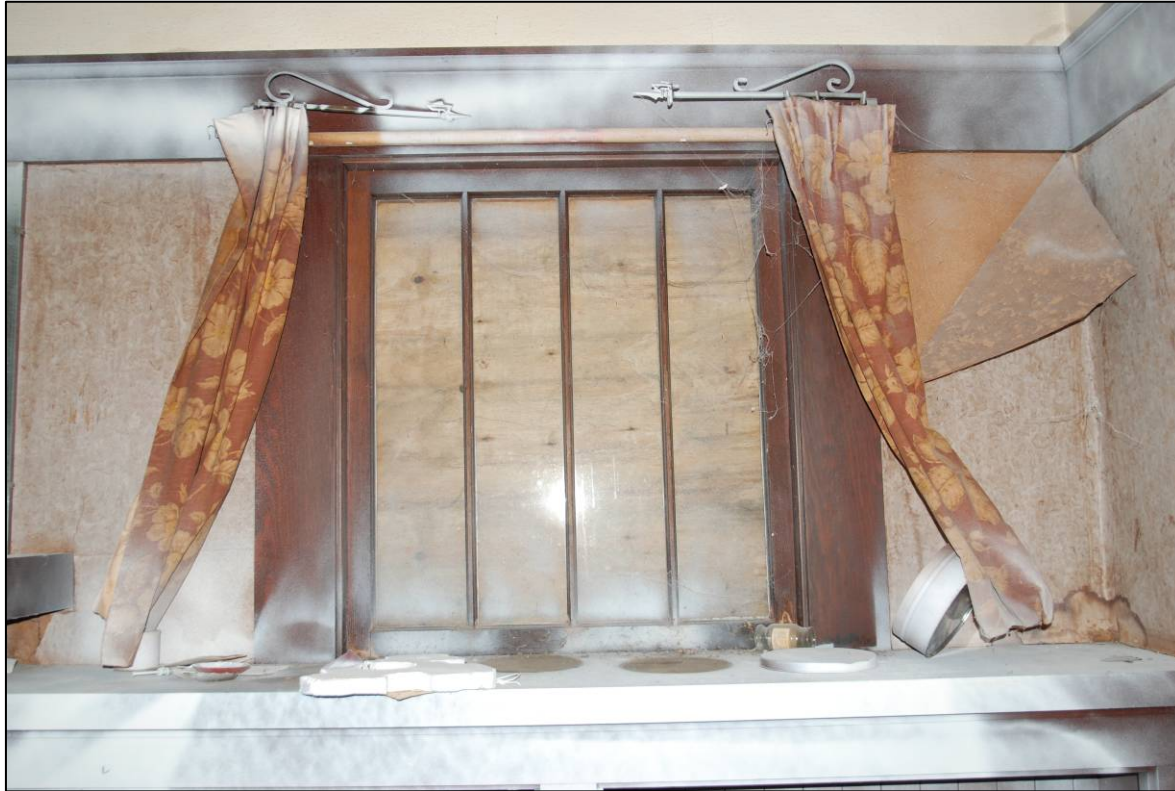
Photograph 21
Southe Side
Window 2, Interior
Shot.

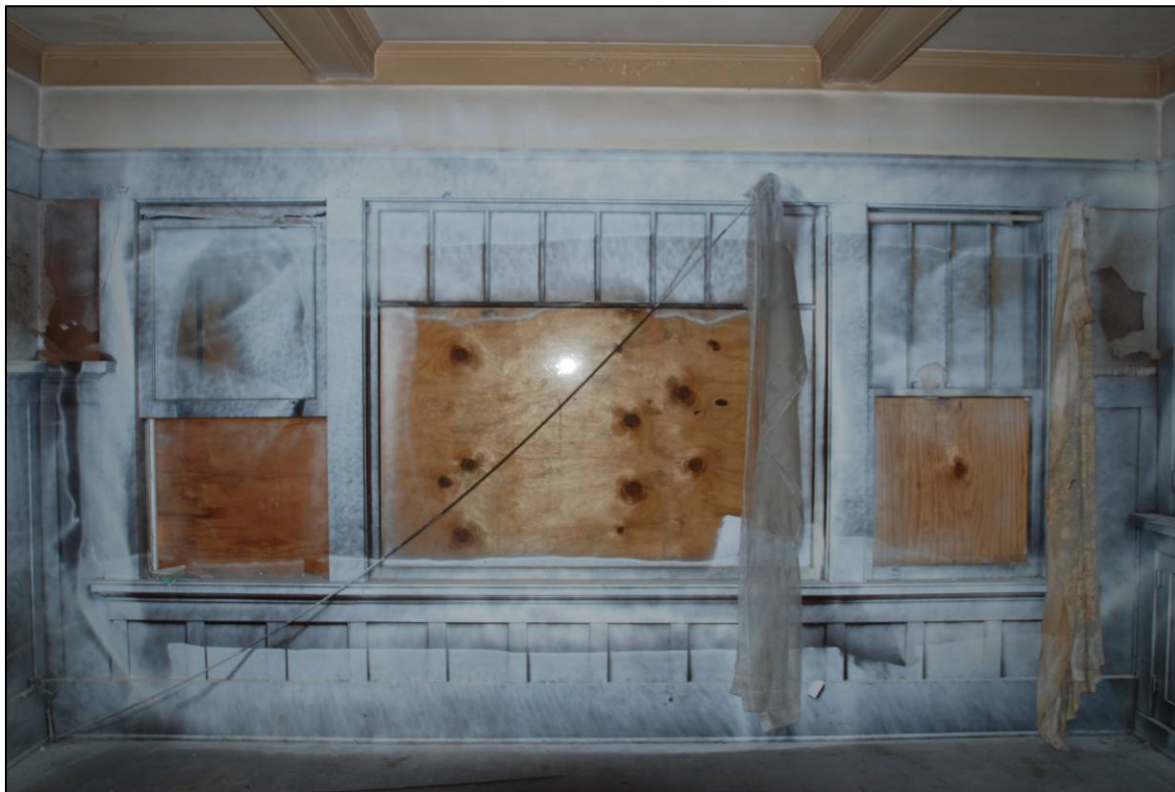
(Photo 22). On the second floor there is a small window between the chimney and the front roofline and a three sash window to the rear of the chimney. The small window sash is hinged at the top (awning hung) (Photo 23). In the large window the center sash is slightly wider than the side sashes. The center sash is fixed and has a single large light with five small lights across the top. The side sashes appear double hung with a single pane on the lower sash and triple panes on the upper sash. These appear to be original windows. As with the north side, there are no windows in the dormer sides.

Photograph 22
South Side
Window 3
Interior Shot

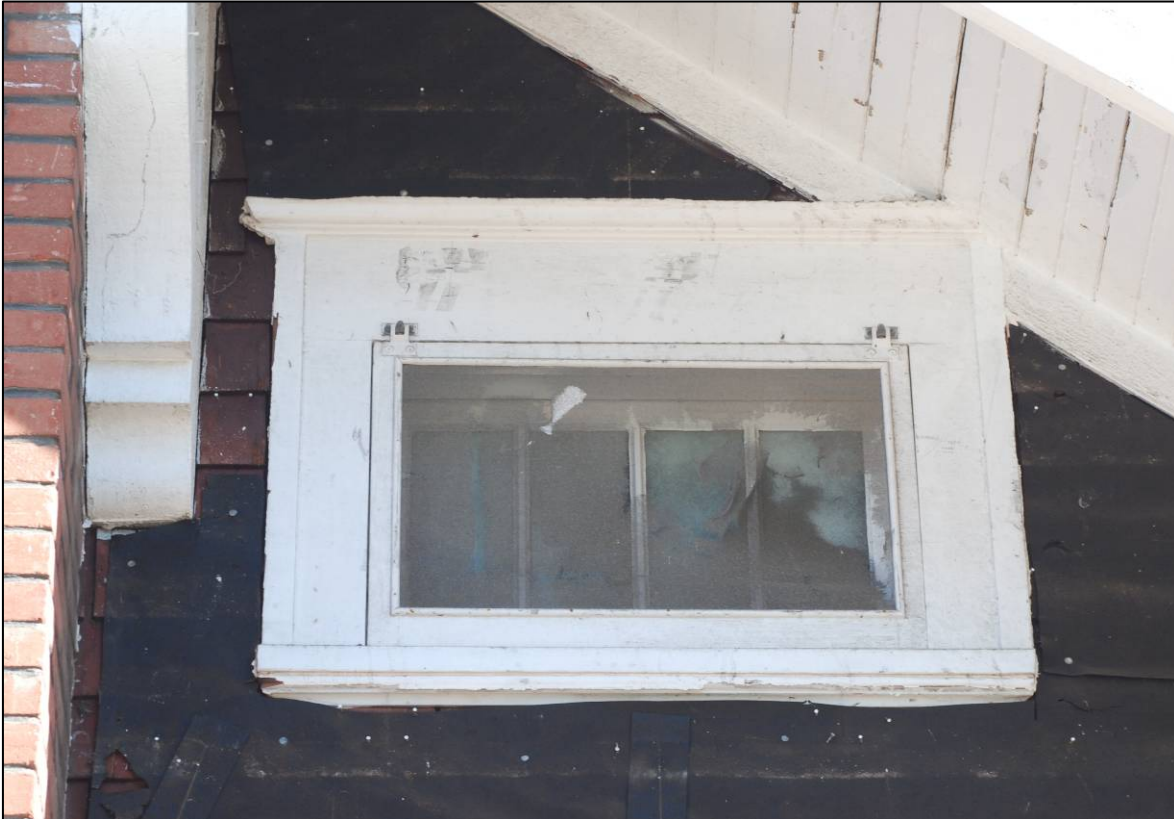
Photograph 23
Second Floor Top Hinged
Window. Note typical main
house window casing.

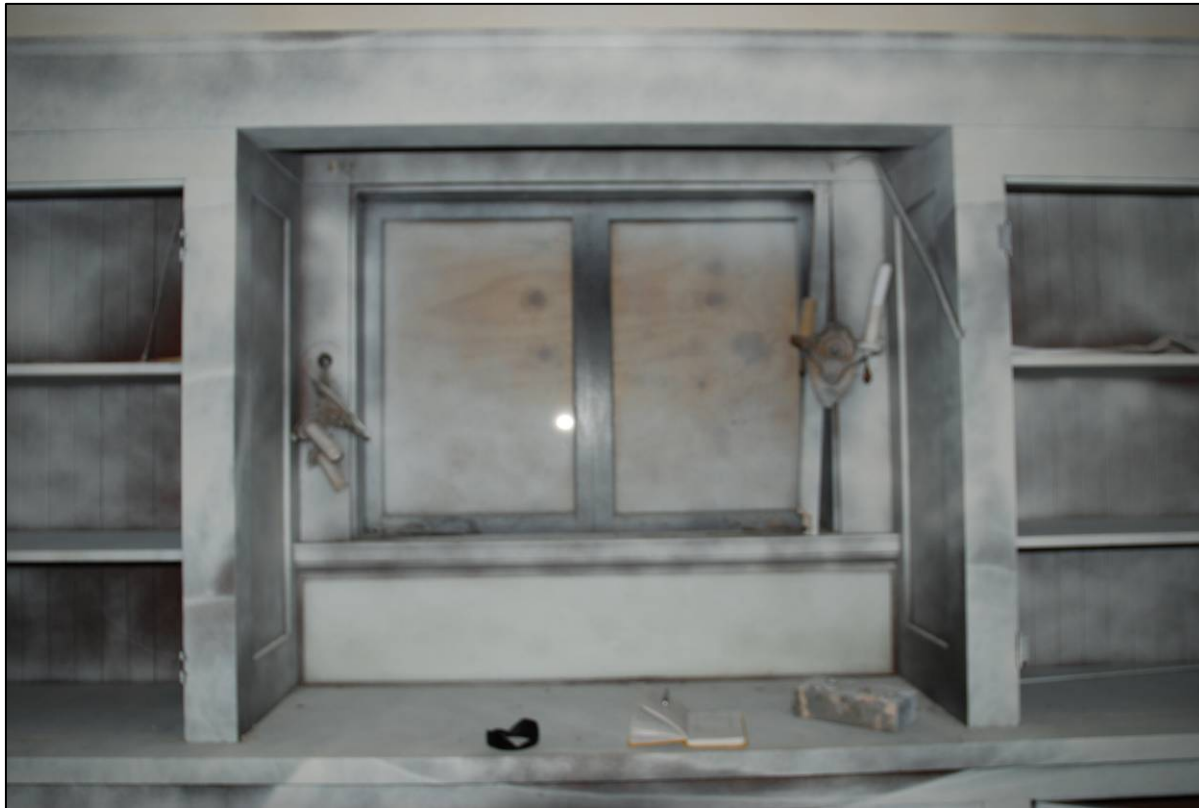
The first-floor windows are different sizes and have the wide casing and decorative top trim found on the majority of the other house windows, as do the second-floor windows. The first-floor windows are covered by plywood. The southern window is casement hung, and each sash has a single light (Photo 26). The northern window is double hung with a single pane on the lower sash and triple panes on the upper sash (Photo 27). The two second-floor windows are evenly spaced off the center line of the wall, and have the same sash layout as the first floor windows (see Photo 25). There is a small, five-pane fixed rectangular window above these two windows. Like the similar window in the front, it appears to be for lighting the attic. The back door has been removed. The casing of the door matches the windows. There are two concrete steps leading up to the door. There is a small crawl space/vent hole in the foundation next to the steps.

Photograph 26
West Side, South
Window, Interior
Shot

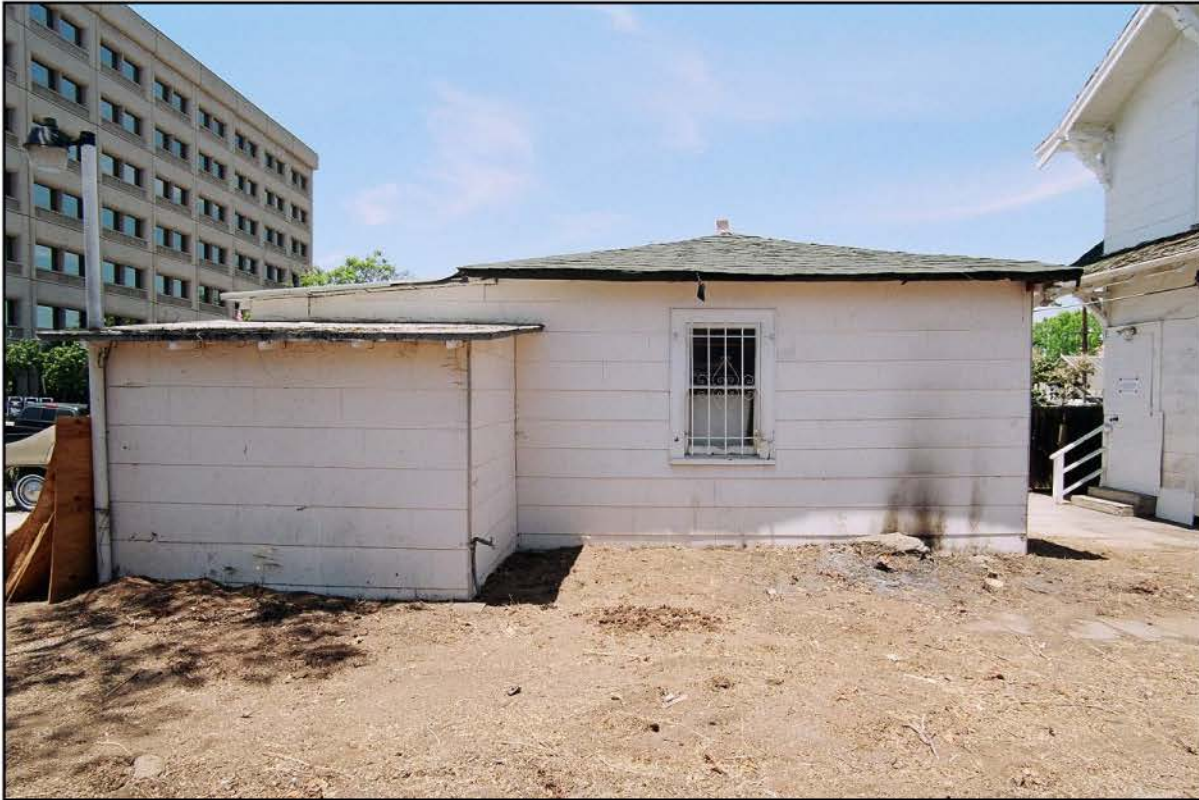
Most of the garage is currently covered in tarpaper. In several areas, the tarpaper is missing and the original clapboard is visible. There are also a series of 1"x4" runners nailed to the clapboard for attachment of siding. The cladding below the tarpaper on the addition is vertical board and batten, with some of the batten missing.

Photograph 30
Overview of
Garage
Building, Taken
Before Siding
Was Removed,
Showing
Relationship of
Addition (on
Left) to Original
Garage

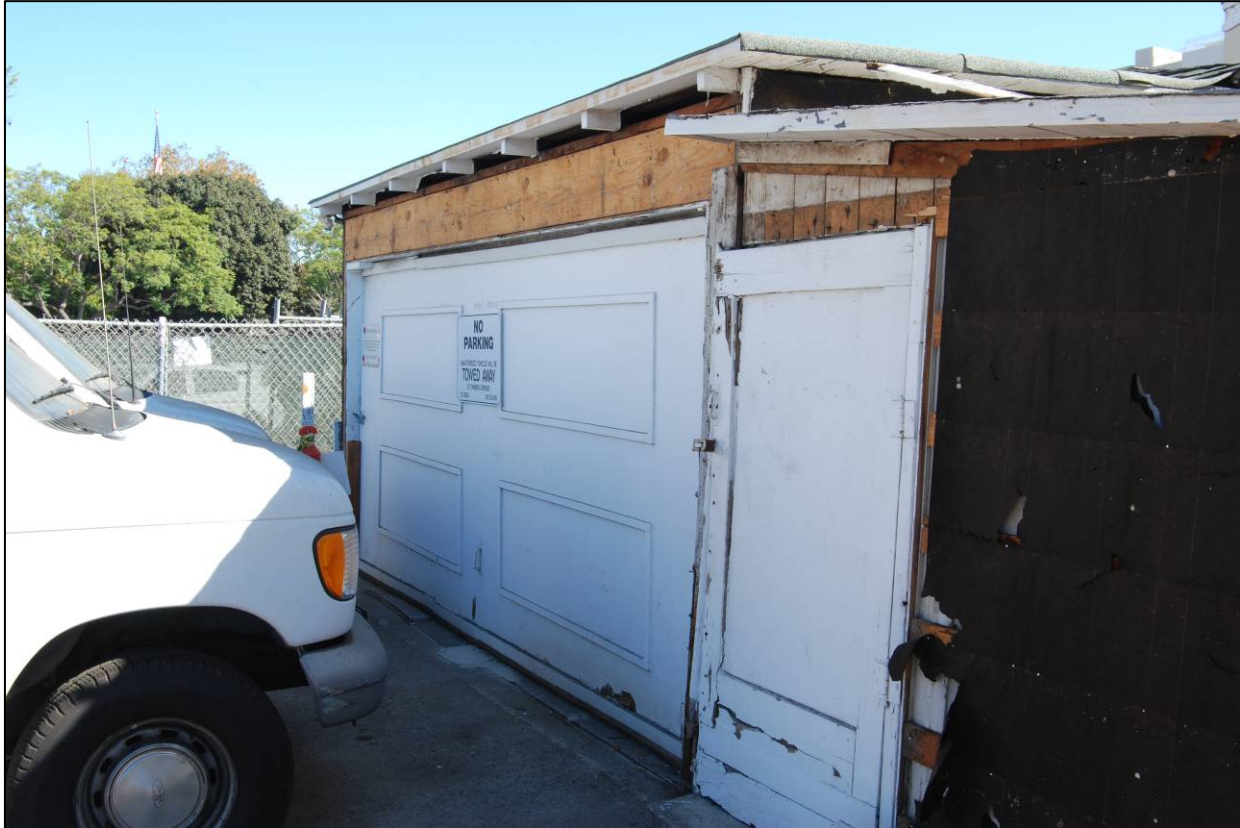
Photograph 32
West Side of Garage
Showing Both West
Addition and South
Addition.
